REPLACEMENT: REAR UPPER ARM – BMW 5 TOURING (E61). LIST OF THE TOOLS YOU'LL NEED:

Replacement: rear upper arm – BMW 5 Touring (E61). AUTODOC experts recommend:

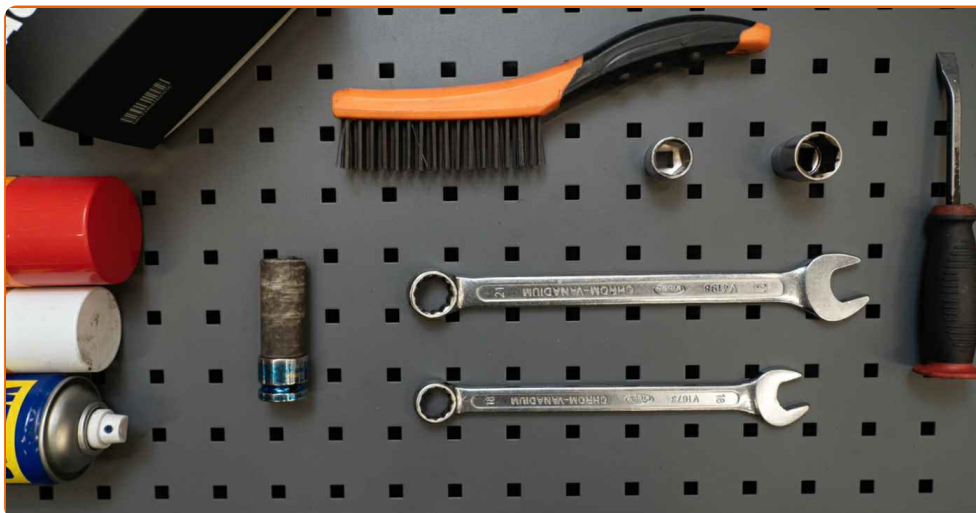
- Wire brush
- WD-40 spray
- Brake cleaner
- Copper grease
- Combination spanner #18
- Combination spanner #21
- Drive socket # 18
- Drive socket # 21
- Torx bit T40
- Wheel impact socket #17
- Ratchet wrench
- Torque wrench
- Tap wrench
- Crow bar
- Wheel chock

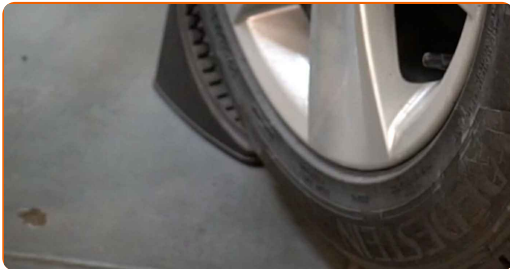
1

Secure the wheels with chocks.

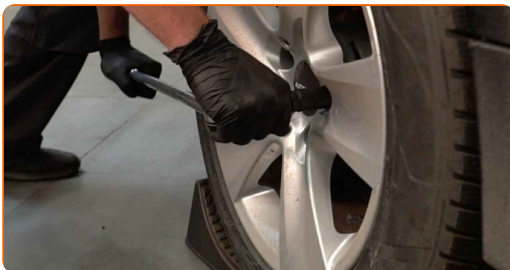
2

Loosen the wheel mounting bolts. Use wheel impact socket #17.

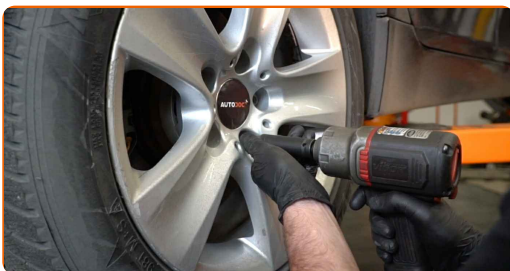
4

Unscrew the wheel bolts.

- Important! Hold the wheel while unscrewing the fastening bolts. BMW 5 Touring (E61)

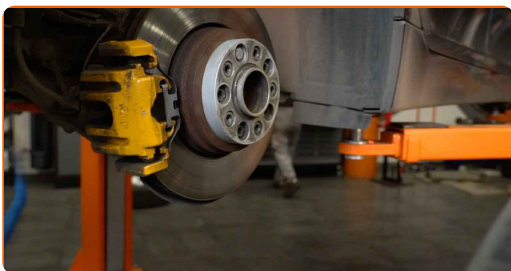
5

Remove the wheel.

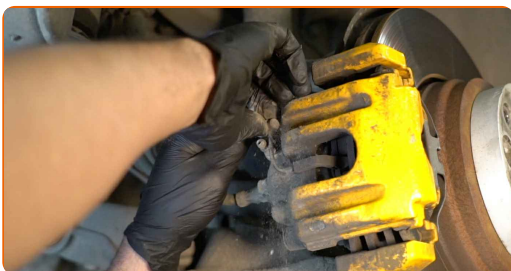
6

Disconnect the brake pads wear sensor.

- Some cars are not equipped with the brake pad wear sensor.

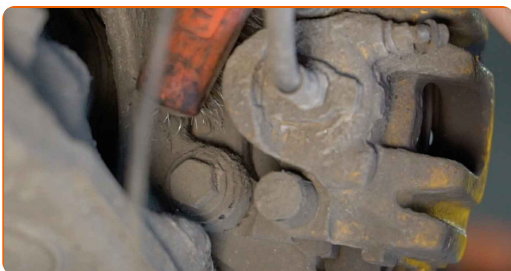
7

Clean the brake caliper bracket fasteners. Use a wire brush. Use WD-40 spray.

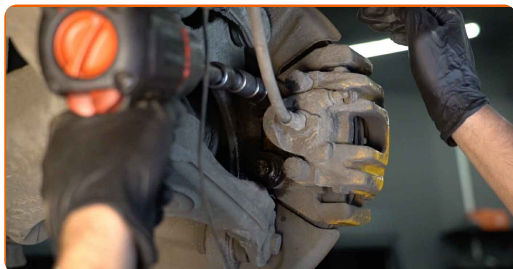
8

Unscrew the caliper bracket fastening. Use a drive socket #18. Use a tap wrench.

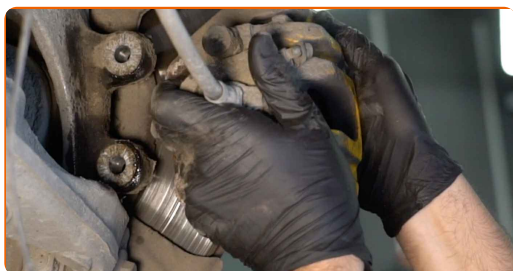
9

Remove the brake caliper together with its bracket.

- Tie the caliper to the suspension or to the body with a wire without disconnecting from the brake hose to prevent depressurization of the brake system.
- Make sure that the brake caliper is not hanging on the brake hose.
- Don't press the brake pedal after the brake caliper has been removed. As a result, the piston can fall out from the brake cylinder, and brake fluid leakage and depressurization of the system may occur.

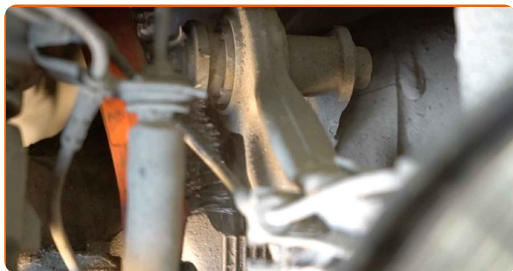
10

Clean the fasteners connecting the control arm to the subframe. Use a wire brush. Use WD-40 spray.

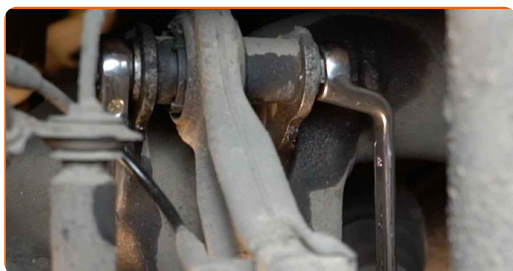
11

Unscrew the arm fastening from the subframe. Use a combination spanner #18 (2 pieces).

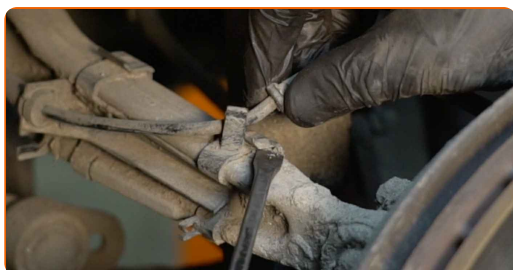
12

Disconnect the ABS sensor wiring. Use a crowbar.

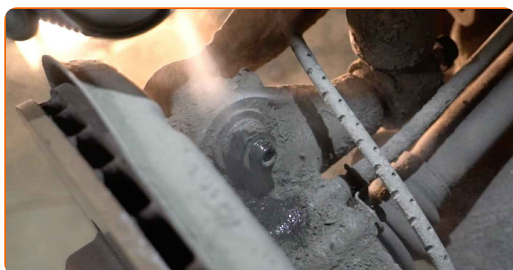
13

Clean all joints of the arm. Use a wire brush. Use WD-40 spray.

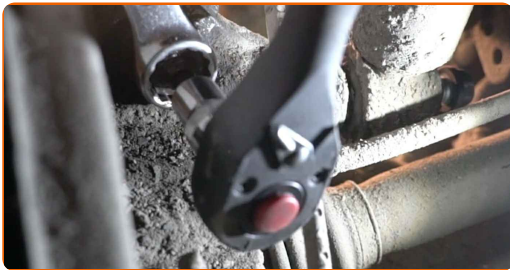
- 14** Unscrew the fastener connecting the control arm to the rear knuckle. Use a combination spanner #21. Use Torx T40. Use a ratchet wrench.

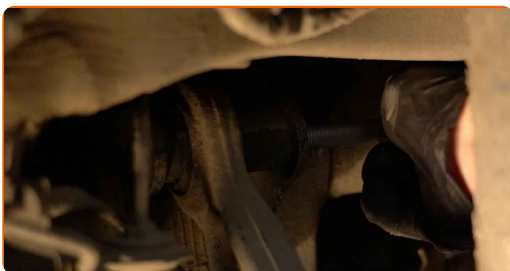
- 15** Remove the fastening bolt.

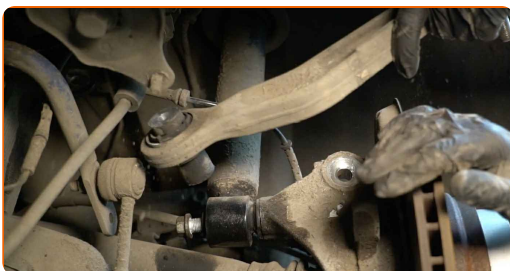
- 16** Remove the rear upper arm.

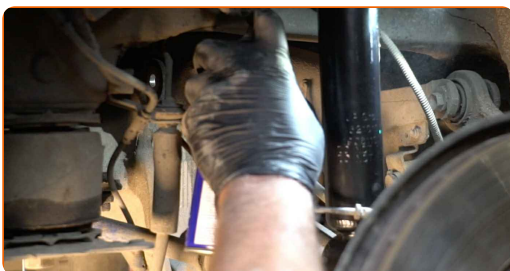
- 17** Clean the mounting seats and the thread of the suspension arm. Use a wire brush. Use WD-40 spray.

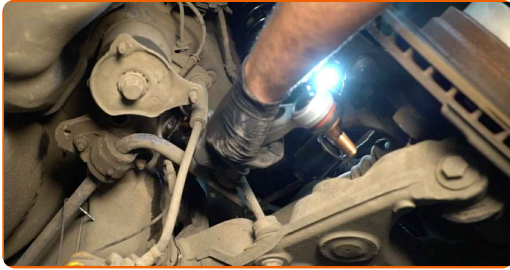
18

Mount the rear upper arm.

- During the installation process, use only new bolts and nuts.
- Do not damage the ball joint cover.

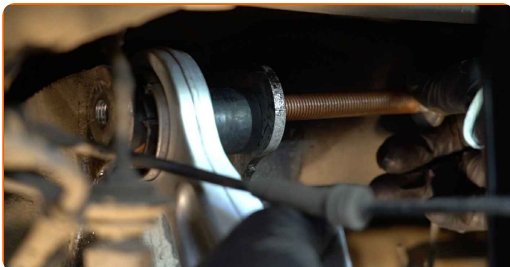
19

Install the fastening bolt.

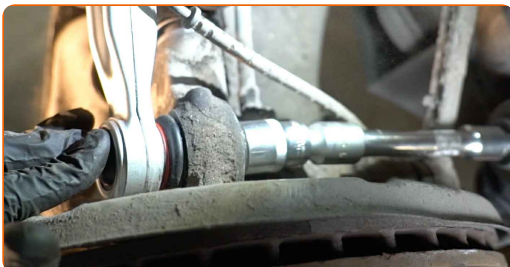
20

Screw in the fastener that connects the control arm to the rear knuckle. Use a drive socket #21. Use a ratchet wrench.

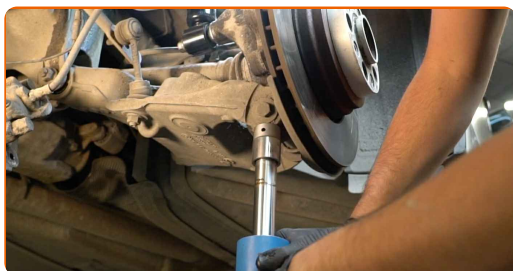
- 21 Support the stub axle. Use a hydraulic transmission jack.

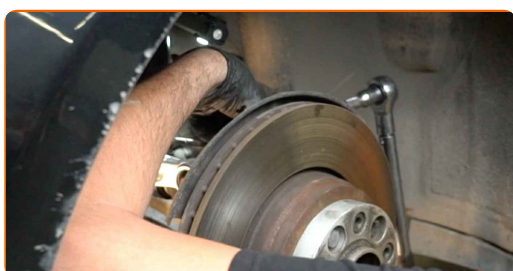
- 22 Tighten the fastener connecting the suspension arm to the rear knuckle. Use a drive socket #21. Use a torque wrench. Tighten it to 165 Nm torque.

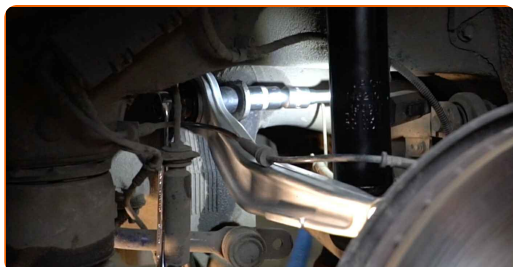
- 23 Tighten the arm fastening to the subframe. Use a combination spanner #18. Use a drive socket #18. Use a torque wrench. Tighten it to 100 Nm torque.

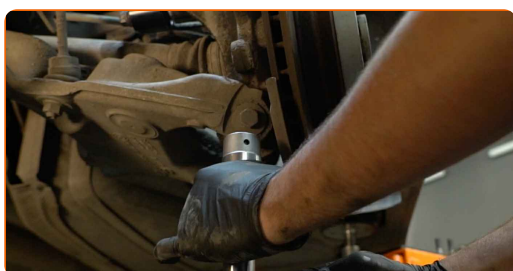
- 24 Remove the support from under the stub axle.

- Replacement: rear upper arm – BMW 5 Touring (E61). Lower the transmission jack smoothly, without jerks, to avoid damaging components and mechanisms.

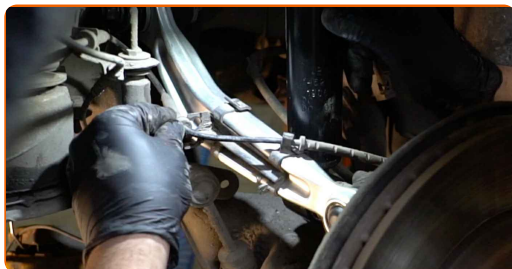
- 25 Connect the ABS sensor wiring.

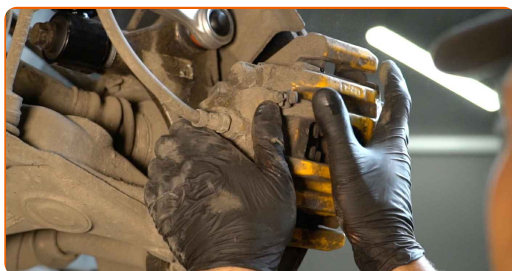
- 26 Install the brake caliper together with its bracket.

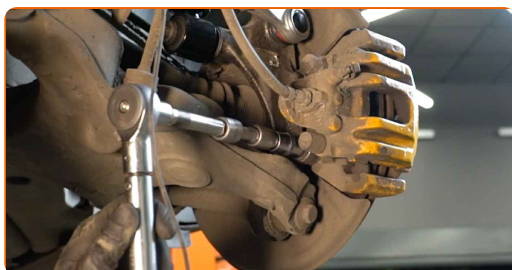
- 27 Tighten the brake caliper bracket. Use a drive socket #18. Use a torque wrench. Tighten it to 110 Nm torque.

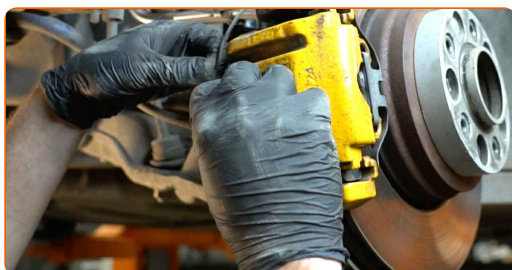
- 28 Connect the brake pads wear sensor.

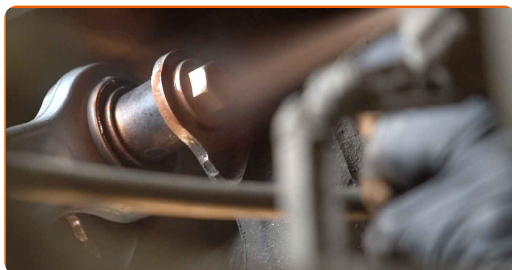
- 29 Treat all joints of the arm. Use copper grease.
