This tutorial was created based on the replacement procedure for a similar car part on: BMW 3 Saloon (E90) 318i 2.0

REPLACEMENT: ANTI ROLL BAR LINKS – BMW 3 TOURING (E91). AUTODOC EXPERTS RECOMMEND:

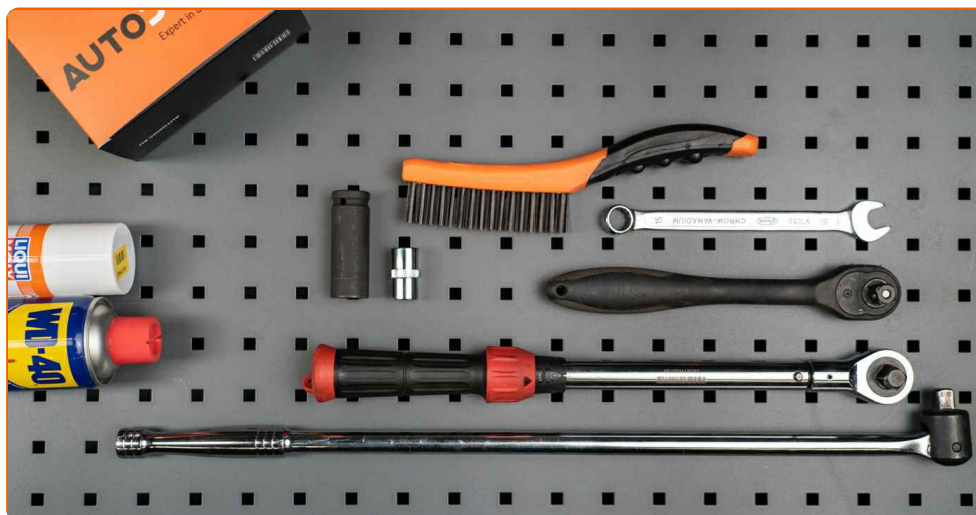
- Wire brush
- WD-40 spray
- Brake cleaner
- Copper grease
- Combination spanner #17
- Drive socket # 16
- Wheel impact socket #17
- Ratchet wrench
- Torque wrench
- Wheel chock

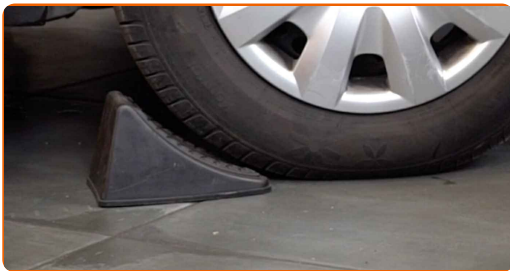
1

Secure the wheels with chocks.

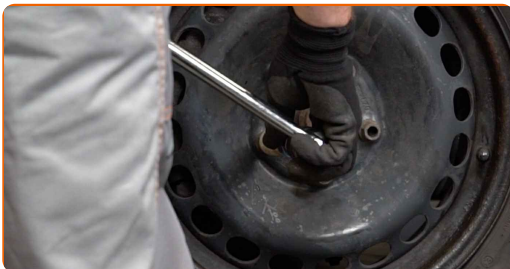
2

Loosen the wheel mounting bolts. Use wheel impact socket #17.

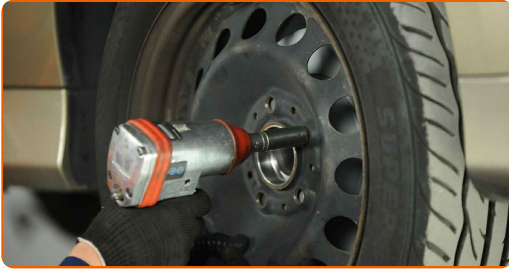
4

Unscrew the wheel bolts.

- Warning! To avoid injury, hold the wheel while unscrewing the fastening bolts.
BMW 3 Touring (E91)

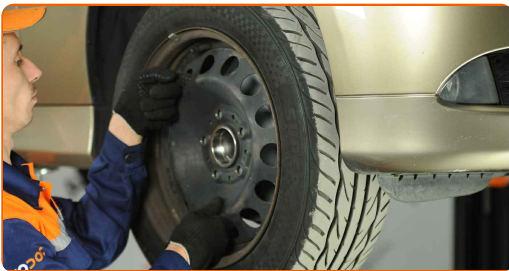
5

Remove the wheel.

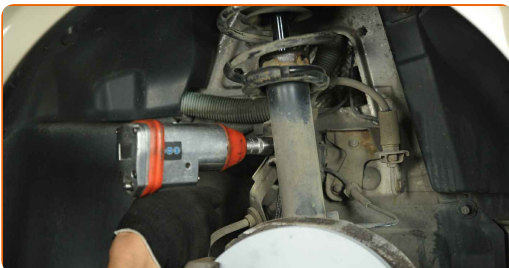
7

Unscrew the fastener connecting the stabilizer link to the shock strut. Use a combination spanner #17. Use a drive socket #16. Use a ratchet wrench.

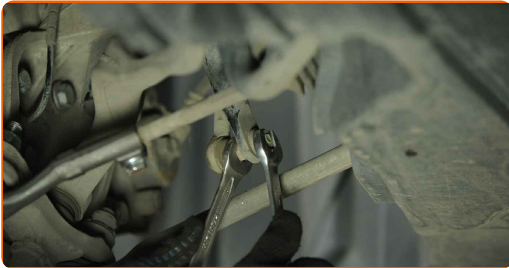
- 8 Unscrew the fastener connecting the stabilizer link to the stabilizer bar. Use a combination spanner #17 (2 pieces).

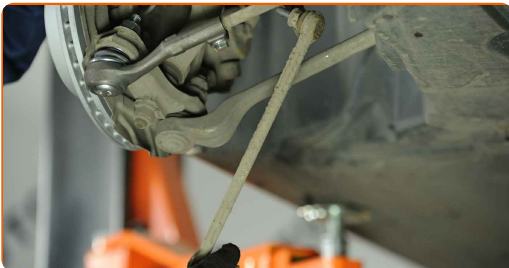
- 9 Remove the stabilizer rod.

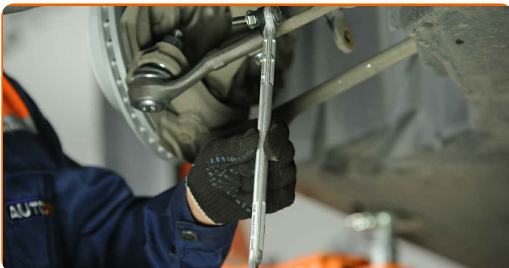
- 11 Install a new rod, tighten the fasteners.

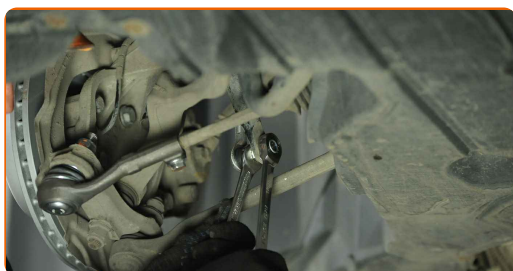
- 12** Tighten the fastener connecting the stabilizer link to the stabilizer bar. Use a combination spanner #17 (2 pieces). Use a torque wrench. Tighten it to 58 Nm torque.

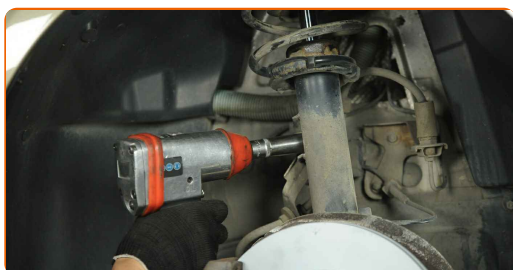
- 13** Tighten the fastener connecting the stabilizer link to the shock strut. Use a combination spanner #17. Use a drive socket #16. Use a torque wrench. Tighten it to 58 Nm torque.

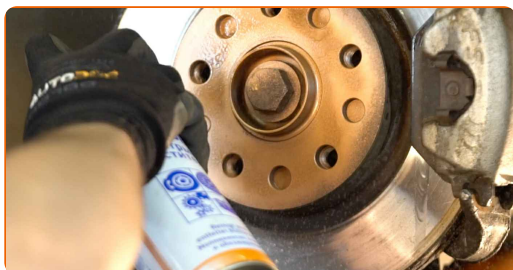
- 15** Treat the surface where the brake disc contacts the wheel rim. Use copper grease.

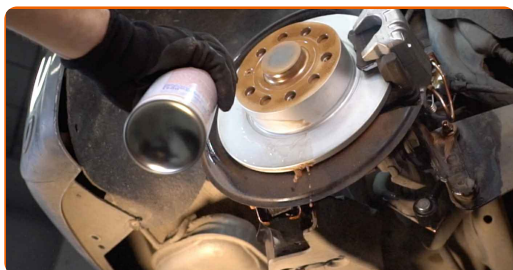
- 16** Clean the brake disk surface. Use a brake cleaner.

- Replacement: anti roll bar links – BMW 3 Touring (E91). After applying the spray, wait a few minutes.

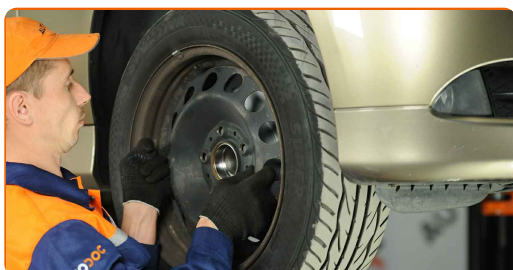
17

Install the wheel.

- Warning! To avoid injury, hold the wheel while screwing in the fastening bolts on the car. BMW 3 Touring (E91)

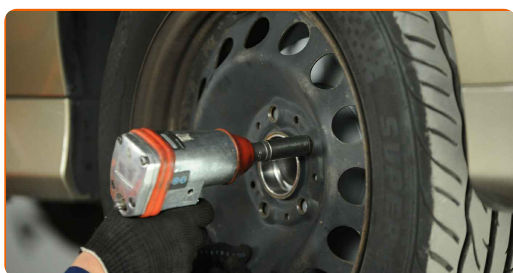
18

Screw in the wheel bolts. Use wheel impact socket #17.

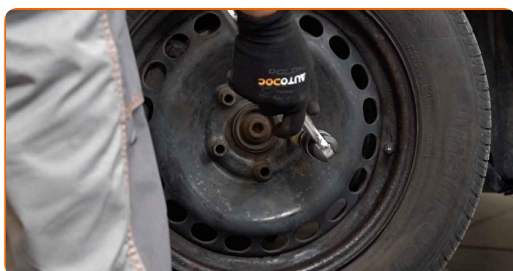
19

Lower the car and working in a cross order, tighten the wheel bolts. Use wheel impact socket #17. Use a torque wrench. Tighten it to 120 nm torque.

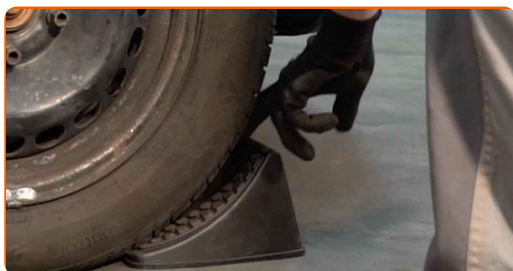
20

Remove the jacks and chocks.
