## REPLACEMENT: ANTI ROLL BAR LINKS – BMW 1 HATCHBACK (E81). AUTODOC EXPERTS RECOMMEND:

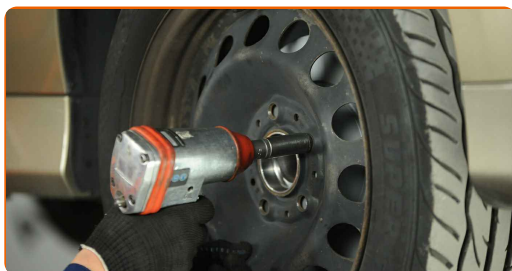
4

Unscrew the wheel bolts.

- Warning! To avoid injury, hold the wheel while unscrewing the fastening bolts.  
BMW 1 Hatchback (E81)

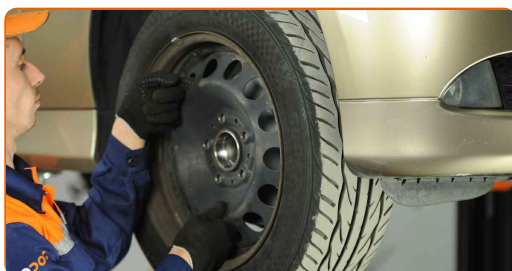
5

Remove the wheel.

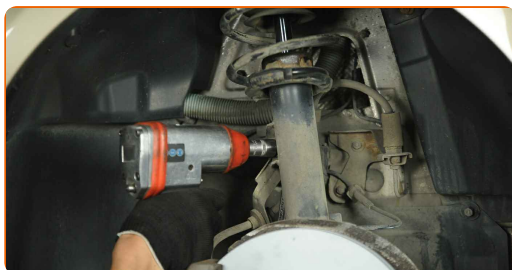
7

Unscrew the fastener connecting the stabilizer link to the shock strut. Use a combination spanner #17. Use a drive socket #16. Use a ratchet wrench.

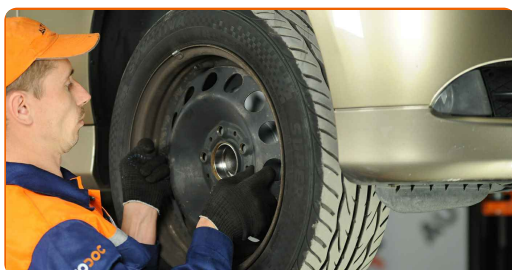
17

Install the wheel.

- Warning! To avoid injury, hold the wheel while screwing in the fastening bolts on the car. BMW 1 Hatchback (E81)

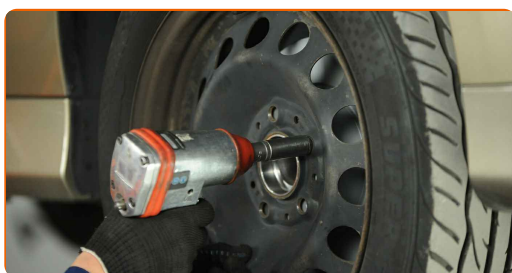
18

Screw in the wheel bolts. Use wheel impact socket #17.

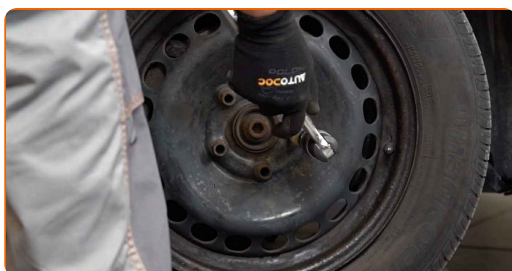
19

Lower the car and working in a cross order, tighten the wheel bolts. Use wheel impact socket #17. Use a torque wrench. Tighten it to 120 nm torque.
