PROPERTY INSPECTION REPORT FORM

INSPECTION DETAILS

Inspection Report Overview

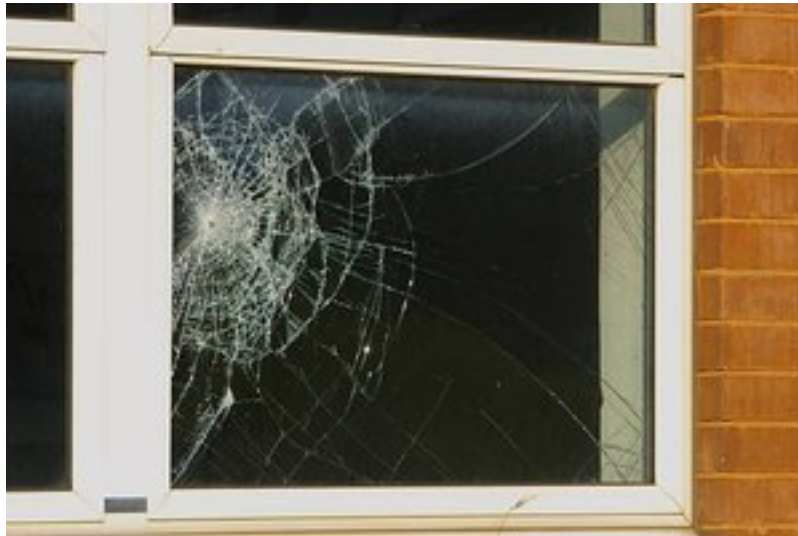
Ground-Level Exterior Structures: Window Systems and Sealing

- Decks and Stairways: Inspected
- Ground-Level Entry Structures: Not Inspected
The surface of the entryway was covered with an outdoor carpet material, which prevented a comprehen...
- Exterior Cladding and Trim: Not Inspected
The brick veneer lacked visible weep openings. Without these provisions, moisture may become trapped...
- Perimeter Fencing and Gates: Not Inspected
- Window Systems and Sealing: Deficient ·
A glass pane on one or more windows was broken. It is recommended to replace broken windows to resto...

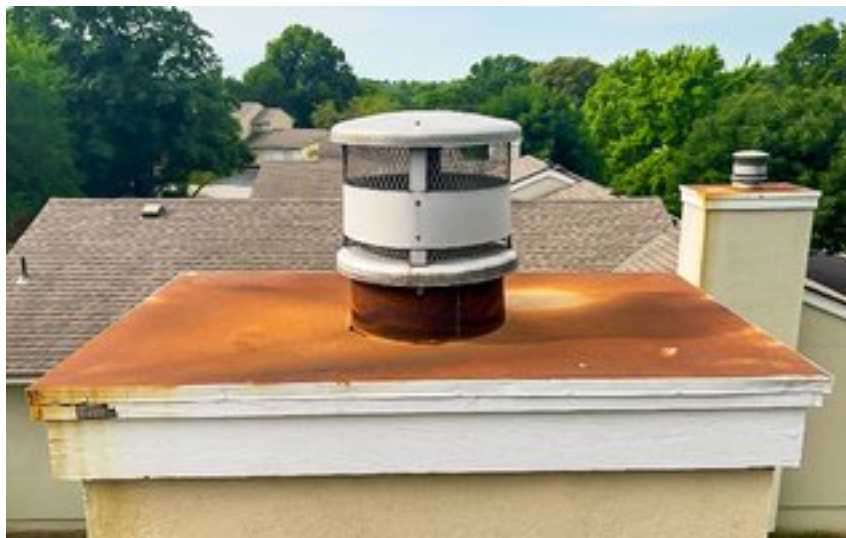
Ground-Level Exterior Structures: Chimney Structures

- Overall Roof Condition: Deficient ·
Several roof shingles were observed to be broken. This condition may lead to water intrusion and sho...
- Exterior Decks and Stairways: Inspected
- Flashing System Integrity: Not Present
The chimney flashing was identified as damaged, missing, or loose. This condition can result in wate...
- Outdoor Air Conditioning Unit: Not Present
Consider further evaluation by a qualified contractor to address the outdoor unit's excessive n...
- Rainwater Management Systems: Not Present
One of the gutters was observed to be improperly installed and hanging off the structure. This can l...
