CEDARS PARK

(Covenanted former site of James I's Theobalds Palace, Cheshunt, Hertfordshire, EN8 8RU)

Examples of 16/17 C. extant high brick walls, with bricks or part-bricks missing

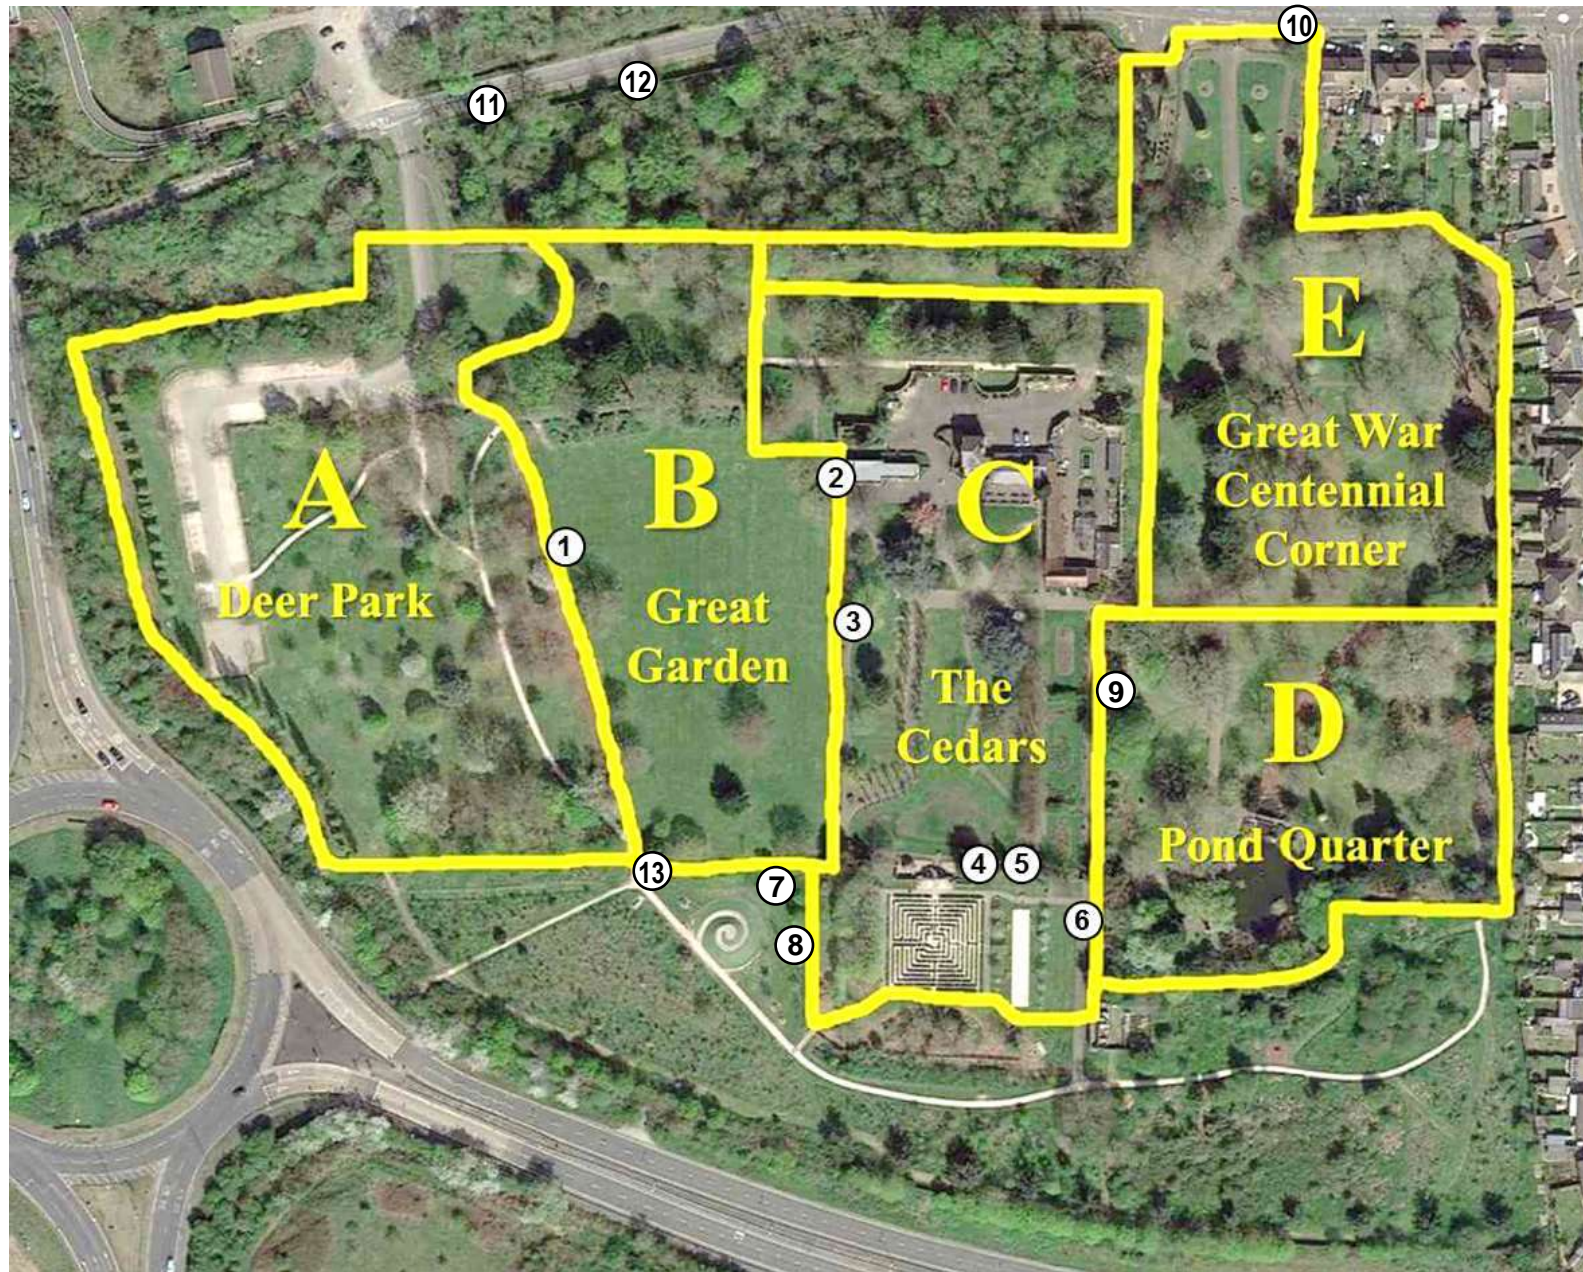
Missing bricks and holes in the walls – with photos

7. Wall north of Venusberg
8. Wall east of Venusberg
9. East-facing wall by the sensory garden
10. North-facing wall on Theobalds Lane, at East side of the pedestrian entrance
(No photo)
11. North-facing wall on Theobalds Lane, at East side of main car park entrance
(No photo)
12. North-facing wall on Theobalds Lane, further East – a new collapse at top of wall
(No photo)
13. South-facing wall by Venusberg – Since before Christmas 2021, new vandalism and continuing (May 2022) – imminent collapse of this section of the wall.
