Refined Load Rating Analysis and Load Testing (MP 28.9 over the Garden State Parkway)

10 July 2012

Introduction

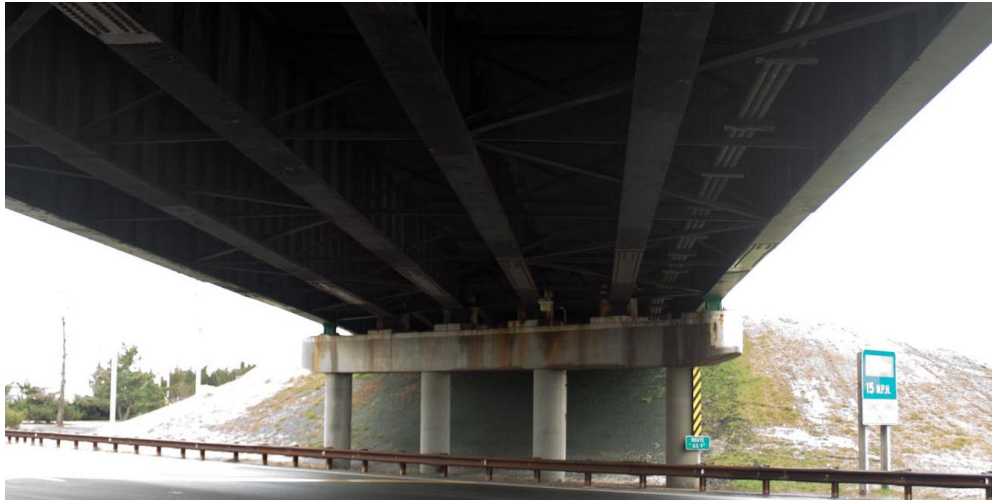
The MP 28.9 Bridge carries Route 9 over the Garden State Parkway in southern Atlantic County, NJ (Figure 2). The bridge is comprised of four simply-supported, multi-girder steel stringer spans that are constructed from welded plate girders. The bridge has two relatively short approach spans of 42 ft. and 53 ft. and two relatively long center spans of 147 ft. with all spans having a skew angle of 49 degrees. The six welded plate girders that support the longer spans were designed to act compositely with the deck. To save on material costs, the girders were designed with flange thickness transitions. The girders are connected transversely through X-type diaphragms. The bridge also includes wind bracing that spans from the exterior girders across two bays to the interior girder on each side of the bridge, as seen in Figure 3.

Figure 3 - Wind Bracing

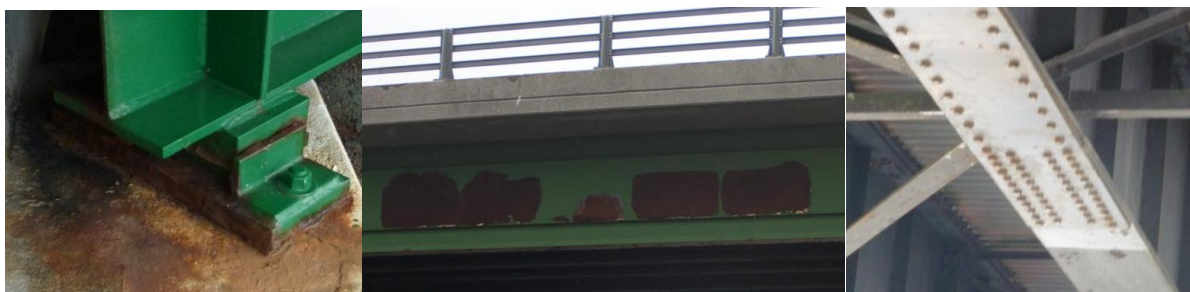
A site visit was conducted on Tuesday, December 20, 2011 to assess the condition of the structure as well as to evaluate the level of access in preparation for potential experimental testing (Figure 4). During the visit it was noted that the superstructure appeared to be in good condition with some minor surface rust and paint peeling on the girders. Some of the diaphragms did appear to exhibit a larger level of corrosion, though this was difficult to determine when viewing from ground level.

The majority of the bearings were clean and free of debris with the exception of a few locations where water was leaking through the joints or at exterior girder locations. The piers also appeared to be in good condition, with only very local and apparently superficial cracking in some portions of the pier cap that supported Spans 2 and 3. The deck and sidewalks appeared to be in fair condition, with some minor cracking and spalling in a few locations.

a. Bearing deterioration

b. Surface rust/paint peeling

c. Retrofit plate

Figure 4 – Condition of structure

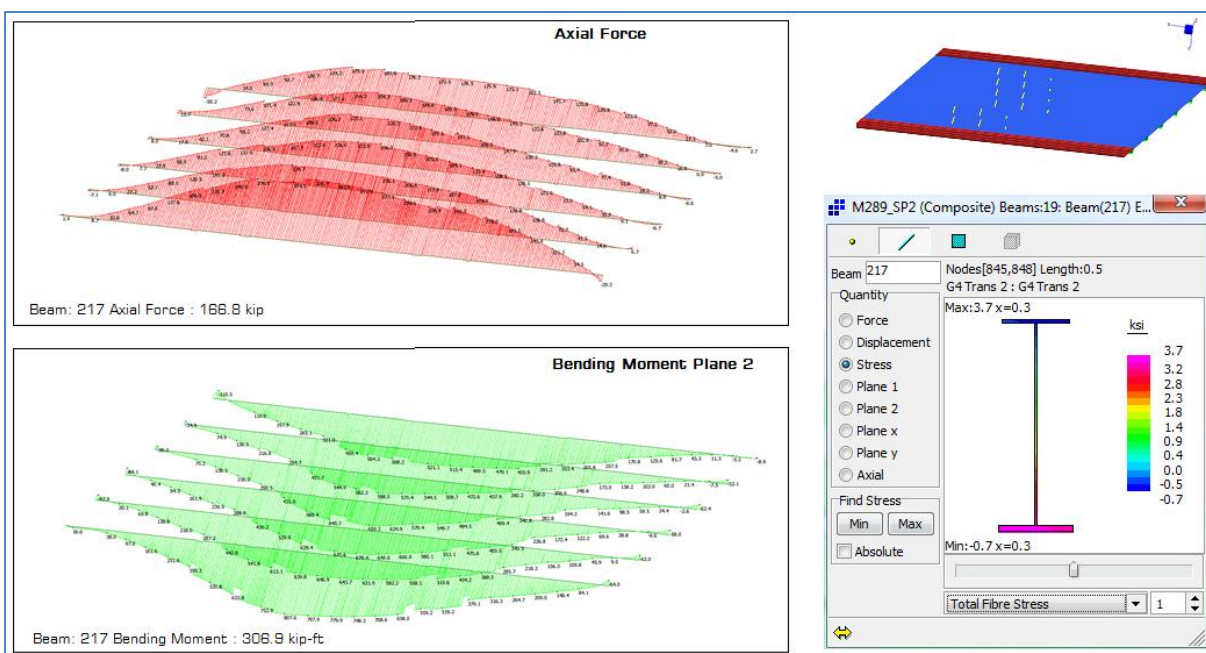
Once the model was error screened it was employed to estimate the dead load, superimposed dead load and live load effects for the Service II Limit State (which controlled using the conventional load rating approach). The analysis was carried out using an HL 93 live load model and considering moving truck loads in each lane, variable axle spacing, and multiple presence. For each location considered (associated with the ends of the transitions as defined previously) the maximum total fiber stresses were extracted from the model to compute the load rating factors. The total fiber stresses include the stresses caused by in-plane bending, axial forces, torsion, and out-of-plane bending. Figure 11 shows an example of typical axial force and bending moment diagrams along with a plot of the total fiber stress distribution within a cross-section at a girder transition.

Figure 11 – Sample results for the governing live load at the first transition of G1

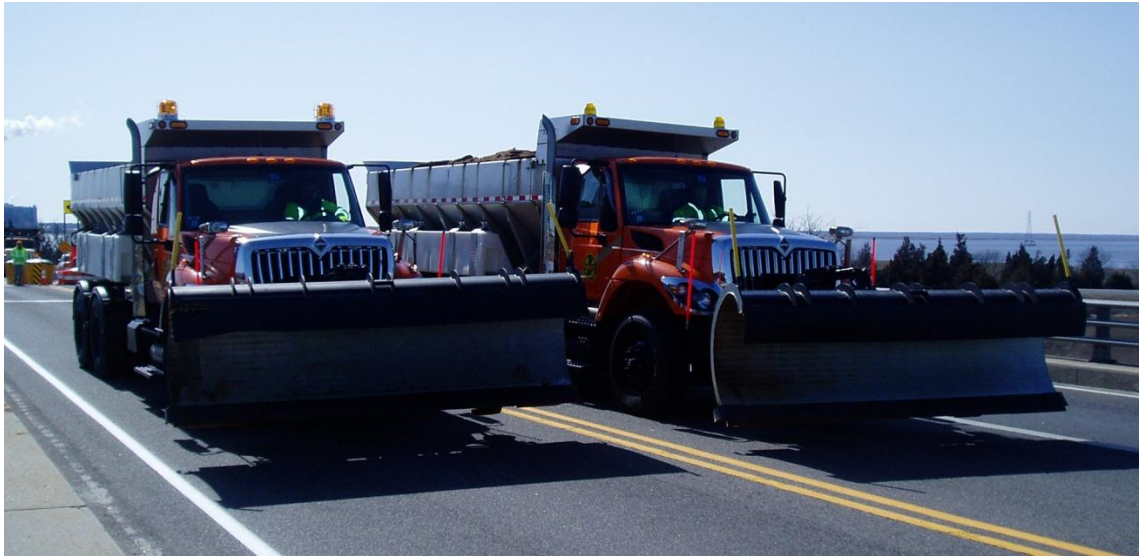
To compensate for the lack of truck traffic on the MP28.9 Bridge, two trucks were run across the bridge continuously to ensure that meaningful responses were captured during Phase 1, which lasted for approximately two hours. Phase 2 consisted of both crawl-speed and static testing of the span using two trucks loaded to approximately 65 kips (Figure 15), and lasted approximately three hours. All equipment and cabling was removed from the bridge by 5:30 pm.

Figure 15 - Static truck load positioning at mid-span

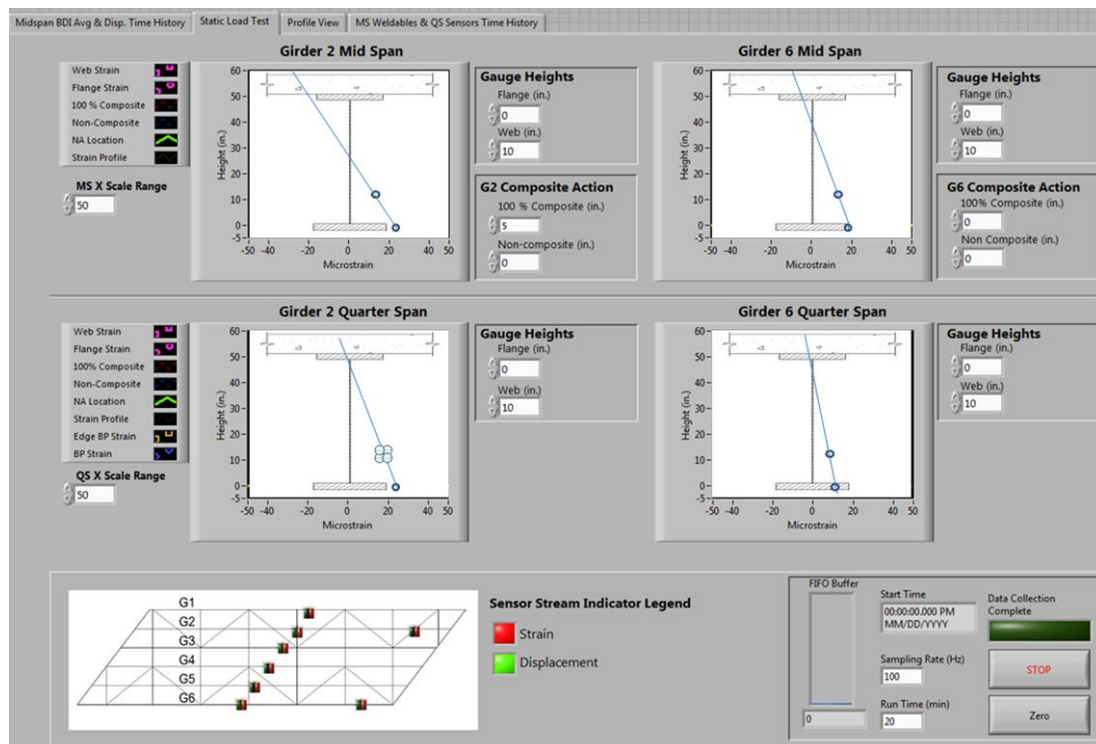
The next two panels were developed for the second phase. Using the measurements from the strain sensors installed on Girders 2 and 6, the neutral axis location is plotted at both the mid-span and the retrofit location (Figure 17). The level of composite action can be evaluated by comparing these values with the calculated neutral axis locations for the conventional load rating analysis. Mid-span displacement and strain profiles are also plotted spatially to allow on-site data interpretation and comparison with expected responses from the model (Figure 18). Finally an additional panel was developed to show the raw data from all of the weldable strain sensors for quality control, quality assurance.

Figure 17 - On-site data visualization - neutral axis plots

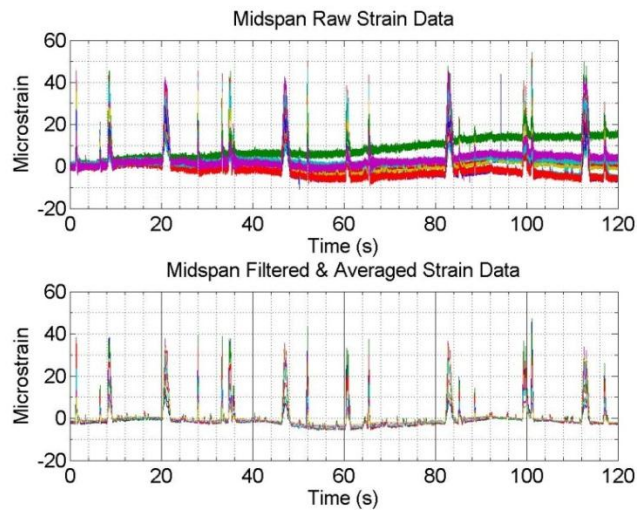
An automated data processing program was developed in order to quickly process each data set and extract pertinent information about the performance of the bridge. Sensors are grouped into families based on the type of response, and sensor location. The raw time histories of these families are plotted to check for any blatant anomalies. The data was subjected to a low-pass filter to reduce any effects from high frequency noise. If there was appreciable drift present in the response for any sensor, the trend was removed and any offsets were subtracted. For comparison purposes, plots of both raw and cleaned data streams are shown in (Figure 19).

Figure 19 - Example of raw and processed mid-span strain data

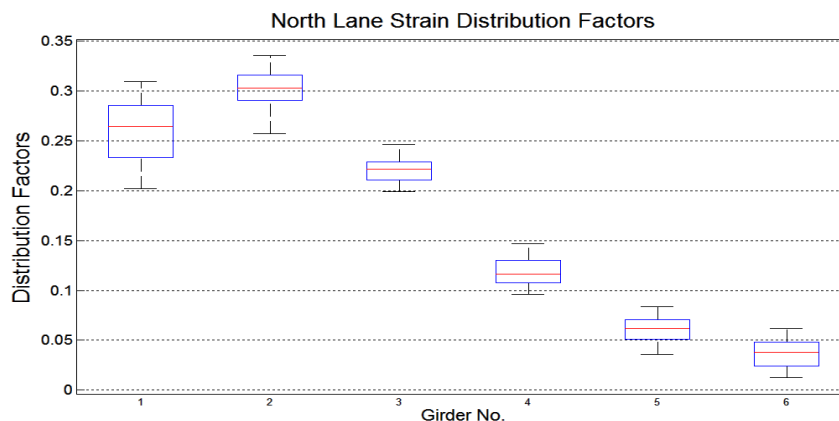
For each truck event, operational distribution factors were calculated. Box plots were developed showing the distribution factors based on strains and displacements as well as lane position (Figure 21). The red center line signifies the median distribution factor for that girder for all the truck events. The lower and upper limits of the box signify the 25th and 75th percentile, and the lower and upper bars indicate the lowest and highest experimentally observed distribution factors. Using conventional load rating procedures, the exterior girders have a distribution factor of 0.67 and the interior girders have a distribution factor of 0.56. Experimentally, the highest distribution factor measured was 0.33.

Figure 21 - Distribution Factors for trucks in north lane and south lane

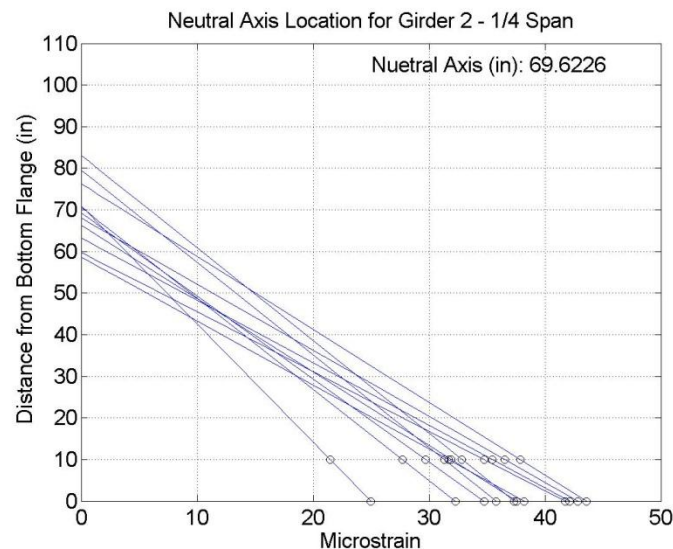
The composite and non-composite neutral axis locations were calculated previously for the conventional load rating analysis (assuming a standard effective width of the deck). For full composite action, the neutral axis should be located approximately 52 in. above the bottom flange at quarter-span. The results for Girders 2 and 6 indicate that the bridge is in fact fully composite with the quarter-span neutral axis locations being 69 in. and 62 in. respectively (Figure 22). The reasons that the measured neutral axes were higher than the fully-composite calculated ones include (1) the use of a conservative estimate for effective width, (2) the use of a conservative estimate of the elastic modulus of concrete, and (3) the

Figure 22 - 1/4 span neutral axis locations for Girder 2

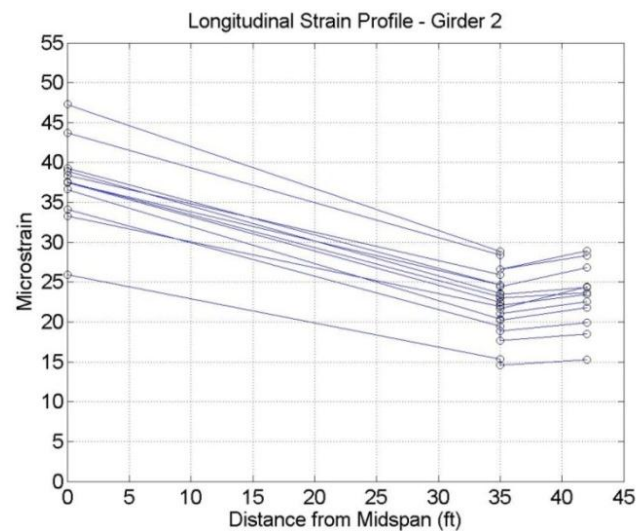
The strains measured on the retrofit plates were approximately equal to the strains measured on the parent girder indicating that the retrofit plates were actively resisting live load. Figure 23 below shows the mid-span strain (located at 0 ft. on the plot), the strain value from the sensor installed on the bottom flange 10 in. from the first transition (located at 35 ft. on the plot), the sensor installed on the underside of the retrofit plate 10 in. from the first transition (also located at 35 ft. on the plot) and the additional sensor located on the retrofit plate 7 ft. from the first transition (located at 42 ft. on the plot). The two sensors located on the bottom flange and the underside of the retrofit fit plate (located at 35 ft. on the plot), have a small difference in magnitude showing that the retrofit plate is indeed active. The additional sensor located further down the retrofit plate (located at 42 ft.) shows the retrofit plate is also developed over that length.

Figure 23 - Longitudinal strain profiles for Girder 2

- The retrofit plate was found to actively resist live load, with measured stresses of the same magnitude as the parent girder. It was also found to be active over the length in which measurements were taken (approximately 7 ft closer to the support than the transition).

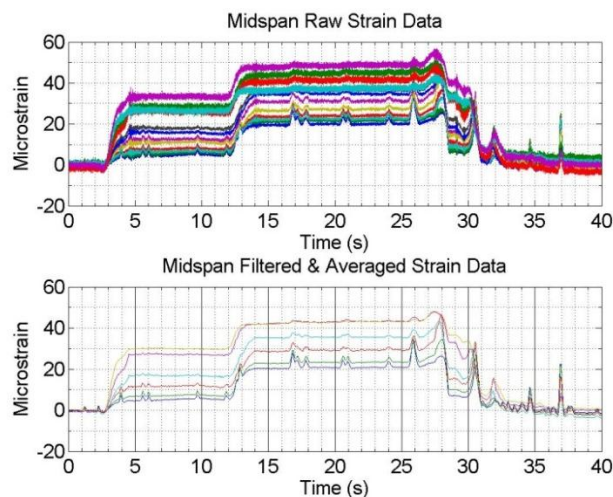
The static truck load test consisted of four different vehicle configurations within the traffic control area. The three single truck positions used were in the south lane at $\frac{1}{4}$ -span, mid-span, and at $\frac{3}{4}$ -span. The fourth configuration was two trucks located in the south and middle lanes at mid-span. The maximum mid-span responses for both strain and displacement occurred during the two truck loading configuration (Figures 24 and 25). Both the maximum strain and displacement occurred on Girder 5 with magnitudes of 43 $\mu\epsilon$ and -0.31 in., respectively. In all cases the bridge returned to its original position following the removal of the load, which indicates all responses measured were elastic in nature.

Figure 24 – Static Truck Load Test – 2 trucks – mid-span raw & processed strains

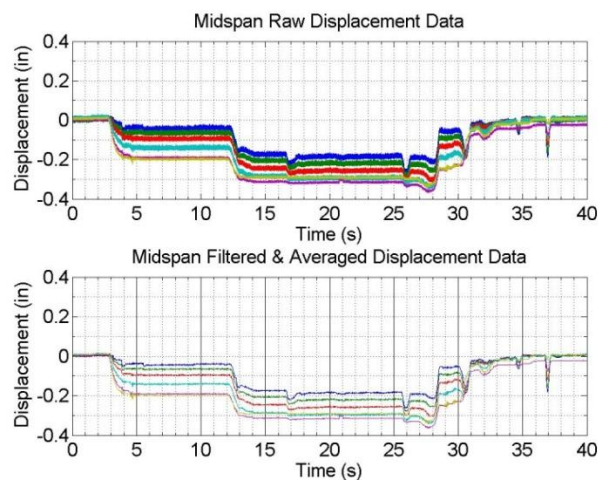
Figure 25 – Static Truck Load Test – 2 trucks – mid-span raw & processed displacements
