Concrete Encased Steel Girder Case Study

Bridge Introduction

The structure presented in this case study is a simply supported, two span bridge with a skew of 60 deg. It has concrete encased steel I-Beams with a cast-in-place deck. It had a posted weight limit of 20 tons. NBI listed it as having an ADT of 200. With a sufficiency rating of 46.0, the bridge was evaluated as "Not Deficient."

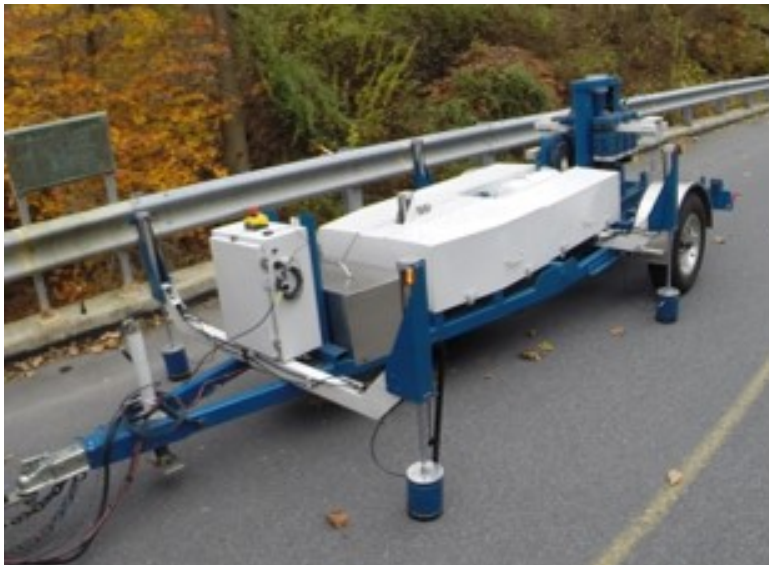
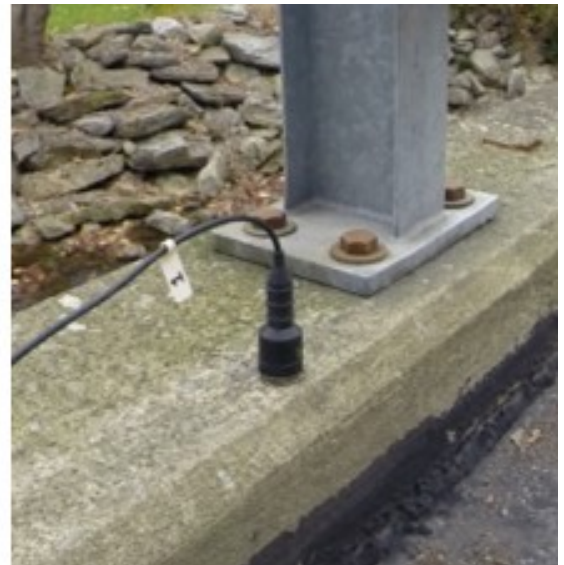
The THMPR(TM) system was used to perform MIMO (multi-input, multi-output) impact testing.

A total of six stationary reference accelerometers were used for each of the two spans. The references were temporarily attached to the bridge curbs using adhesive at the quarter span, mid span, and three-quarter span locations along each side. The reference accelerometers remained at the same locations on the deck throughout the vibration testing and were used to link together the vibrations measured by THMPR(TM)'s local sensor array of six accelerometers. The reference accelerometers were cabled to GPS synchronized data acquisition systems along each shoulder and out of the way of traffic.

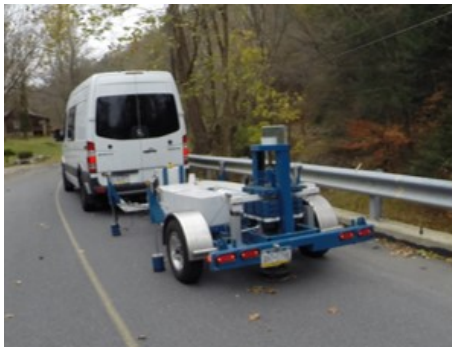
A total of six impact locations per span were selected for the test: (1) at quarter span in the right lane, (2) at mid span in the right lane, (3) at three-quarter span in the right lane, (4) at quarter span in the left lane, (5) at mid span in the left lane, and (6) at three-quarter span in the left lane. The impact locations were chosen so that the measured vibration responses would have a dense spatial resolution and to vary the spatial characteristics of the input excitation. The former consideration is important for resolving different mode shapes from the vibration measurements, while the latter is important for exciting different vibration modes. Note, only three of the six local output sensors were required for data analysis.
