## End-of-Life Performance Case Study

### Bridge Introduction

The structure consists of 57 spans with a 98 foot double leaf bascule span over the navigable channel. For 16 of the spans, the structure is comprised of two haunched steel plate girders which serve as the major load path of each span, while floor beams as well as tertiary members carry the load presented by the cast-in-place deck to the main girders. Another 40 spans are supported by reinforced concrete t-beams.

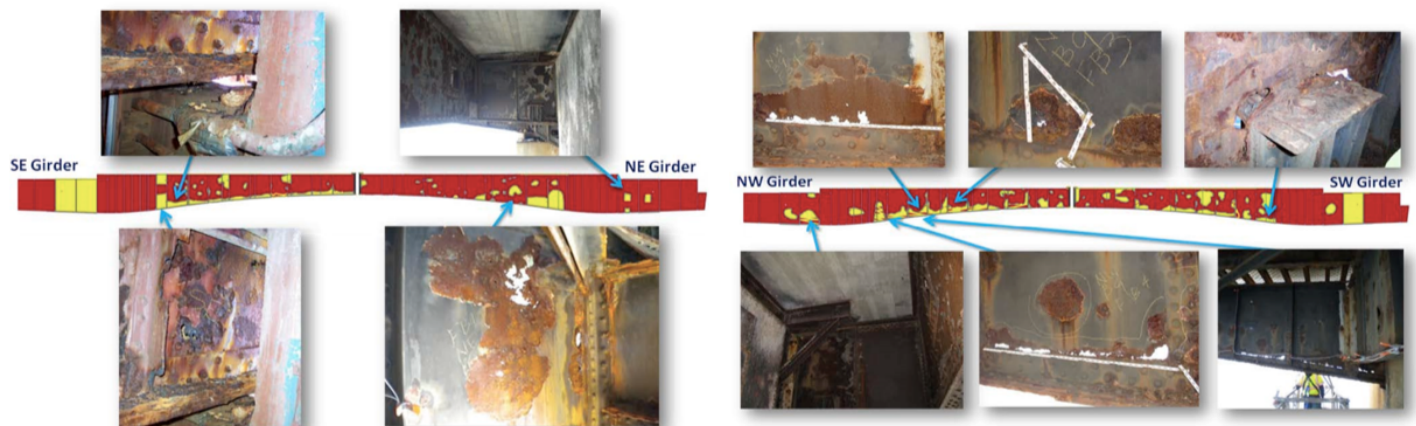
Inspection of the structure revealed extensive corrosion of many of the steel members and spalling of the concrete tee-beams leaving rusted re-bars exposed. There was severe section loss of the floor beam bottom flanges and in several locations the corrosion had left large holes in the steel web plates.

The bridge was listed as structurally deficient and functionally obsolete.

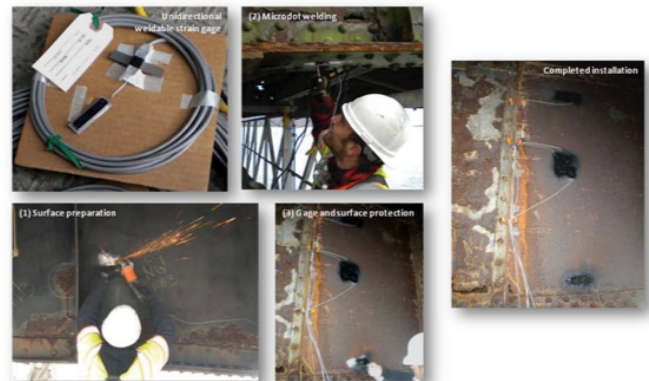
Visual inspection reports indicated that the north leaf of the bascule span exhibited more significant deterioration and was therefore selected to receive a denser instrumentation distribution. The general goal of the instrumentation was twofold: (1) identify and quantify the load sharing of the four bascule girders to inform the performance of both the live load bearings and the magnitude of shear transfer between the spans, and (2) quantify the strain distributions within the most deteriorated elements to identify whether strain compatibility exists. Given the objectives and the budget constraints, the north leaf was instrumented with 22 strain gages, while the south leaf was instrumented using 10 strain gages.

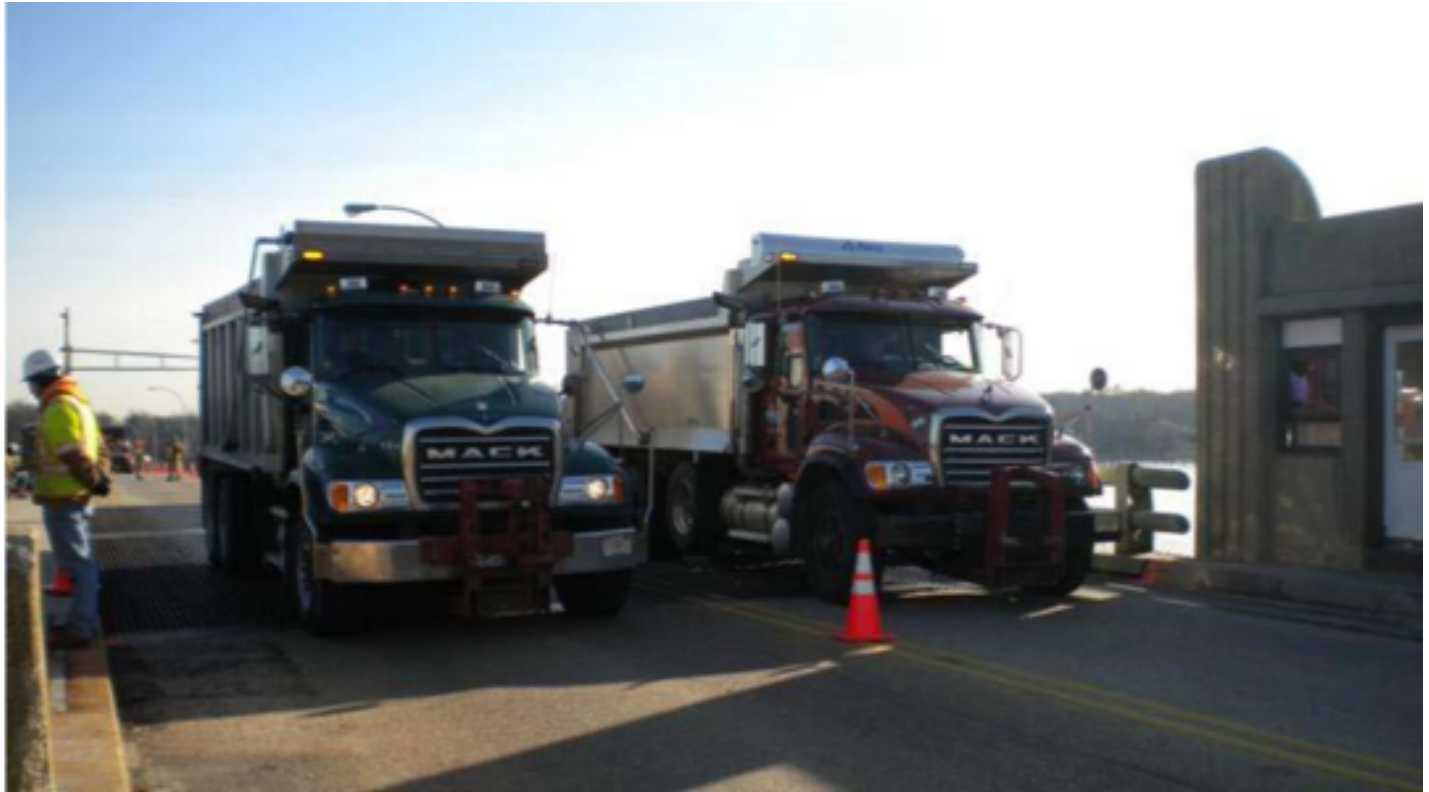
The load test was carried out with two tri-axle dump trucks. They were placed on the bridge with different fill levels and at several locations to provide incremental load levels from 18 tons (single truck) to 72 tons (two trucks). Before the static cases were started, the trucks were run back and forth over the bridge with traffic to gather benchmark data of operational response under moving loads and to 'loosen' up the bridge in case any appreciable stick-slip conditions existed. Next, traffic was stopped for 15 minute intervals and the static load

cases were carried out. Throughout the experimental program, strain levels were monitored to ensure the bridge remained safe and undamaged. The responses were well within the expected bounds and at levels consistent with the predictions of the refined FE model.
