## Case Study: Steel Multi-Girder

### Bridge Introduction

This steel multi-girder bridge was constructed in the 1980s.

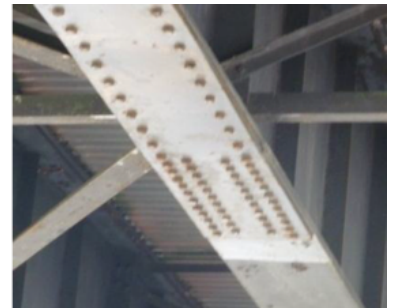
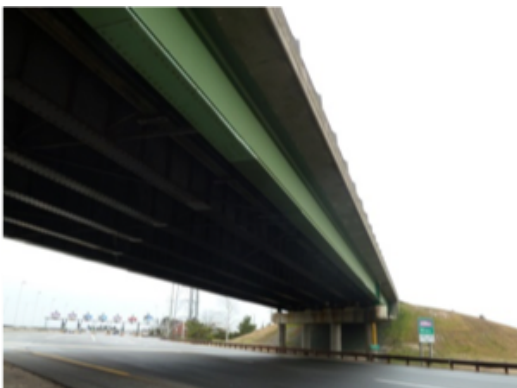
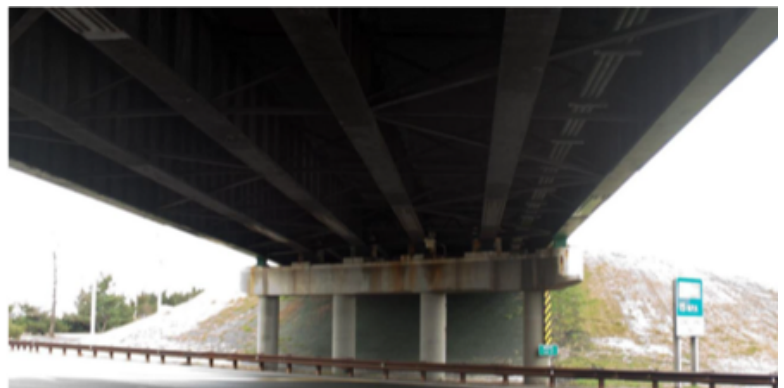
The bridge presented in this case study is comprised of four simply-supported spans, all with a skew angle of 49 degrees. It was the two longest spans, which each have a length of 147 feet, that failed to rate and thus were the focus of this study. Each span is composed of six (6) welded plate-girders and a cast-in-place deck.

Due to capacity issues, in 1997, steel retrofit plates were bolted to the bottom flange of the girders within Spans 2 and 3 at the first bottom flange transitions. Since these plates were installed without shoring, they are only active in resisting live load effects. Furthermore, these cover-plates were installed with too few bolts to achieve full development and failed to rate using conventional methods.
