Case Study: RC T-Beam

Bridge Introduction

This bridge features three simply-supported spans with a skew of approximately 18° and carries three lanes. Each span has a length of 48 feet, and an overall width of 48 feet when measured parallel to the skew. The structure is composed of six reinforced concrete T-beams with a cast-in-place deck. The first span is over dry ground, the second is over the Smithers Creek, and the third is over a small side street.

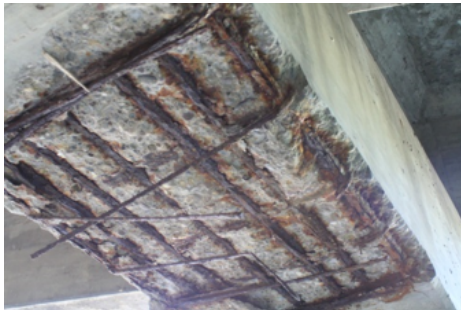
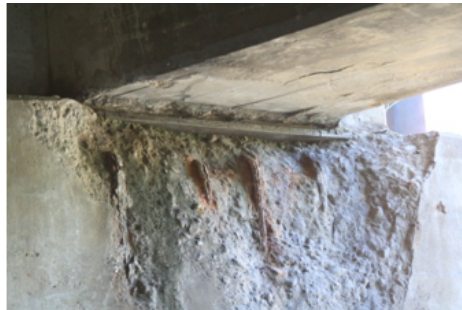
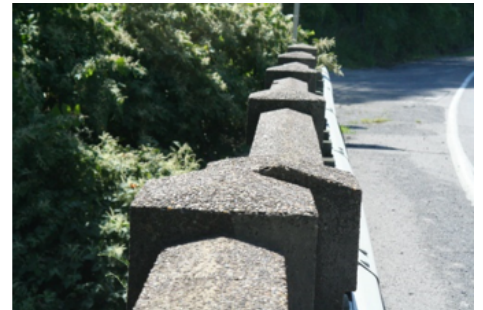
This bridge exhibited substantial deterioration, typically concentrated around the two central piers. There was spalling along the height of the pier, on the underside of the pier cap, and at the beam seat locations, with exposed and corroded rebar. The middle span appeared to have shifted laterally, possibly from lateral loads due experienced during a flood. However, no physical damage of the span was observed. Numerous cracks were observed in the beams and at the beam-diaphragm interfaces. However, these cracks were small and for its age the bridge was appraised to be in excellent condition. Inspections indicated no signs of scour or other foundation-related problems.

The uncertainty associated with this bridge's performance due to the observed deterioration necessitates a thorough understanding of the bridge's behavior for an accurate assessment.

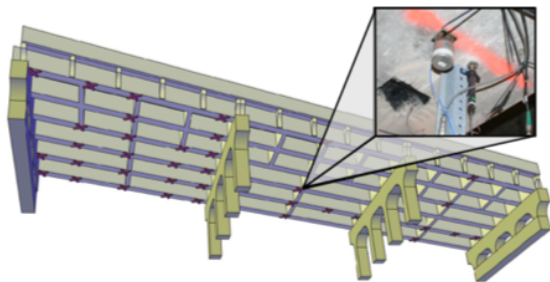
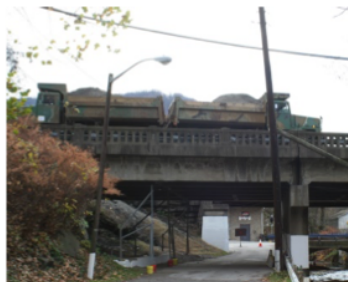
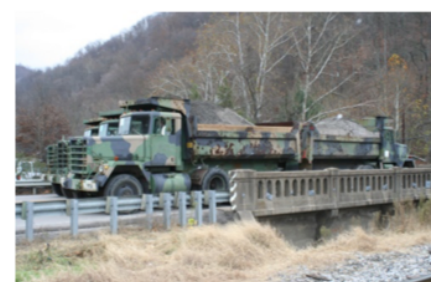
The NCHRP Manual for Bridge Rating Through Load Testing indicated that for this structure and the state legal truck of 40 tons, a proof load of 200 kips per lane, or 600 kips total would be required. The test therefore required positioning 6 special tri-axle dump trucks capable of being loaded to 100 kips each on the bridge. The bridge was loaded incrementally with loads increasing incrementally from 100 kips to 604 kips. Strain was recorded at 30 locations and displacement at 18 locations.

The bridge was evaluated using static load testing methods as well as with dynamic testing. The static load test consisted of placing loaded dump trucks on the bridge while recording the bridge response (strain and displacement). These responses can be directly compared with FE model predictions and used to calibrate the model.

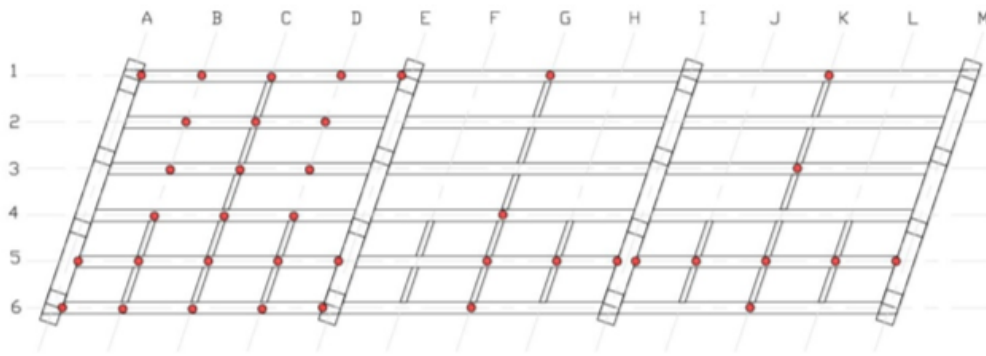
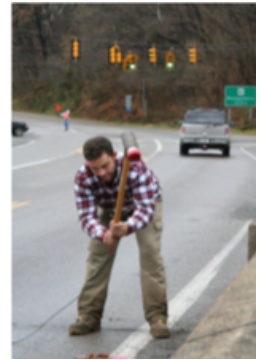
The dynamic test was performed by impacting the deck with a 25 pound instrumented sledge (load cell) at 37 locations. Impacts generally induced forces between 4 and 5 kips with broadband frequency input. Acceleration was recorded by accelerometers installed on the bottom of the girders at 38 different locations.

The dynamic test consisted of a multiple input – multiple output impact test whereby the deck was impacted with an instrumented sledgehammer, and acceleration was recorded at many distributed locations. The measurements obtained from the dynamic test were subsequently analyzed to extract the dynamic properties of the structure (shapes and frequencies of natural modes of vibration) which can be used to calibrate a finite element model of the bridge.

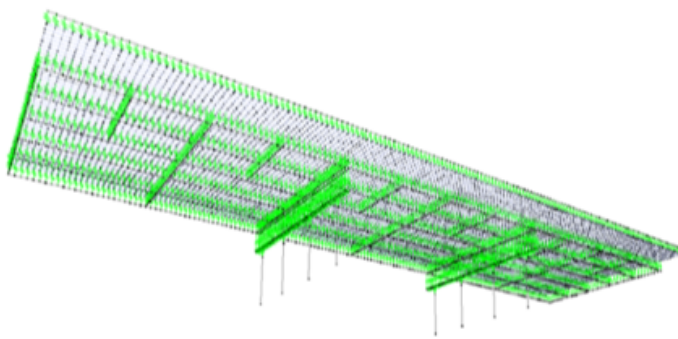
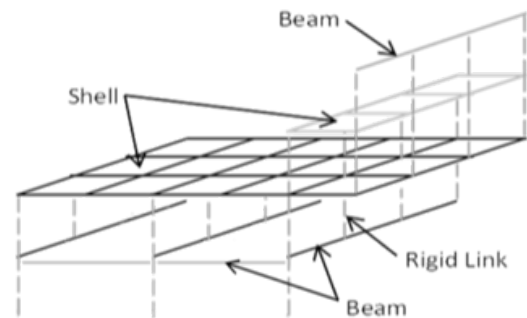
The impact locations were chosen so that the measured vibration responses would have a dense spatial resolution and to vary the spatial characteristics of the input excitation. The former consideration is important for resolving different mode shapes from the vibration measurements, while the latter is important for exciting different vibration modes. Modal processing of the resulting data was used to identify the bridge's natural modes of vibration.

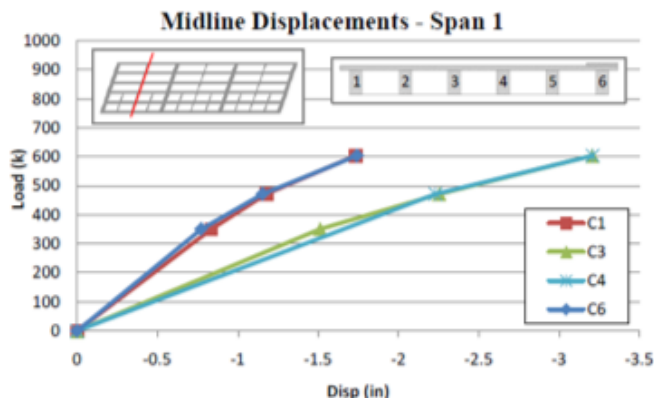
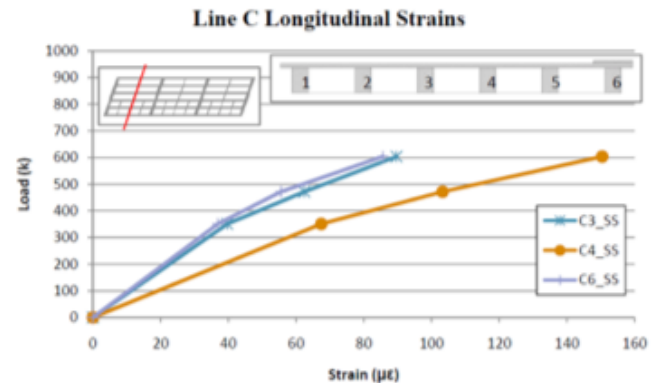
The measurements gathered during the static load test showed that the bridge behaved linearly thereby indicating that the bridge did not experience appreciable yielding or damage at loads up to proof-level.

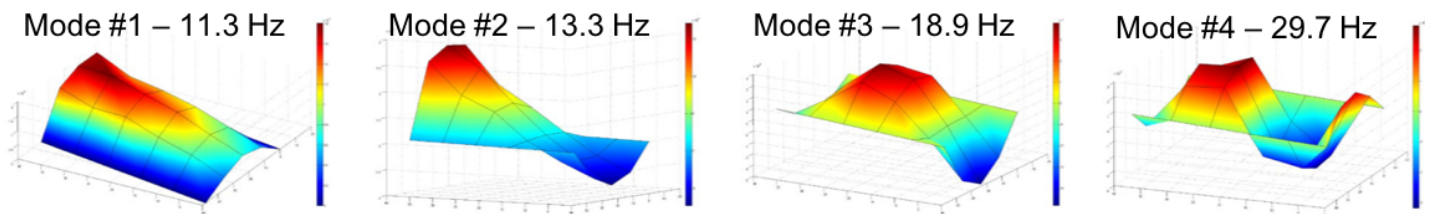
The data gathered during the dynamic test was used to identify the bridge's natural modes of vibration.

The displacements measured during the load test were compared to those predicted by the FE model. The initial model only required small changes in the moments of inertia of the beam elements to bring it into agreement with the experimental data. This natural modes of vibration predicted by the calibrated model were compared to those obtained from the experimental data and found to already be in close agreement. Therefore, no further calibration of the FE model was required.
