Monitoring ephemeral headwater streams: a paired-sensor approach

Abstract:

KEY WORDS ephemeral streams; sensor network; instrumentation; headwater; hydrology; hydrological connectivity

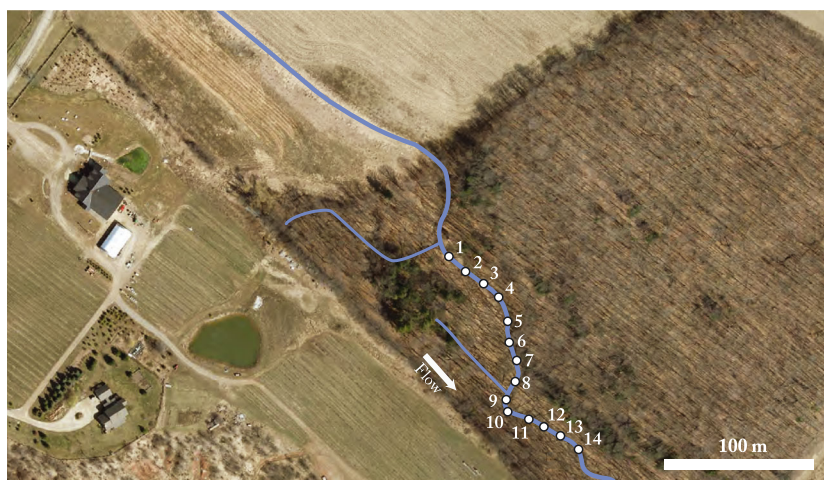
Figure 3. Site 1 study area including the positioning of the sensor pairs

Field-based sensor performance and evaluation were undertaken at two field sites in southern Ontario. Each site contained at least one ephemeral channel. Site 1 (43.7580N, 79.9392W) was located in a predominantly agricultural area in southern Ontario, west of the town of Cheltenham (Figure 3). The study reach of ephemeral channel was located in a forest adjacent to active corn fields and an apple orchard. The stream originates in the surrounding fields and is bounded by a riparian buffer where it bisects the field. In the forested section, the active stream is greatly incised in the banks and has a mix of bed-surface sediment conditions. At the head of the study reach, there were large cobbles and boulders across the width of the channel; however, the bed surface exhibited noticeable sediment fining downstream. The lower reaches of the channel had few rocks on the bed surface and appeared sandier. Grain-size analysis showed that in the 30 cm below the bed, there was more longitudinal consistency along the study reach. The channel was on average 53.7% sand, 12.1% silt and clay, with the remainder being grains larger than sand. The site had an average organic matter content of about 5.1% with a standard deviation of 1.3% along the entire study reach. The channel flattens and widens towards the mouth, with

an approximate average channel width of 2.5 m; however, flow tends to be concentrated in a far narrower area. The forest is composed of large, mainly deciduous, trees with minimal understory. This lack of understory resulted in leaf litter accumulation in the autumn months and increased the debris load in the channel. The channel empties into the Credit River near Cheltenham, Ontario.

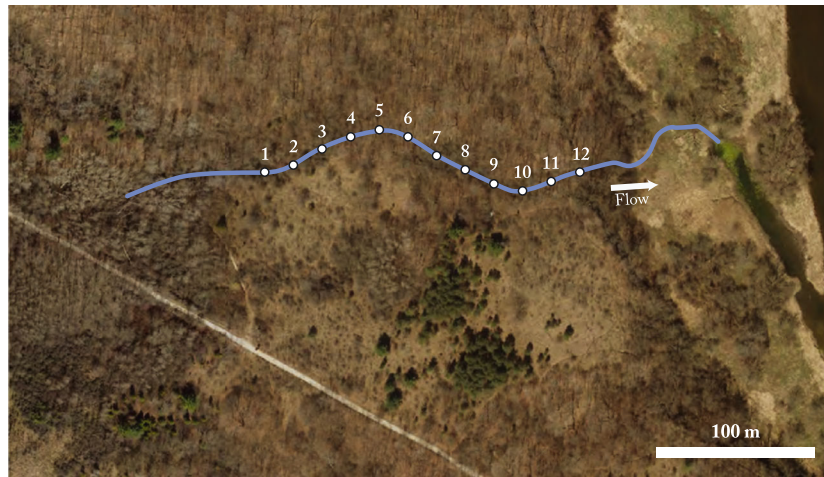
Figure 4. Site 2 study area including the positioning of the sensor pairs

Site 2 (43.3798N, 80.3433W) was located in a conservation area with a wet (Figure 4). The catchment is long and narrow in the study reaches, and the stream is bounded by rock cliffs approximately 15 m away from each bank. The channel has an average width of 1.5 m. Similar to Site 1, Site 2 has marked changes with regard to substrate on the channel surface (Figure 5). The channel surface was less rocky near the head of the study reach than closer to the mouth. Based on grain-size analysis, the upper 30 cm section of the bed averaged 64.7% sand, 19.4% silt and clay and 15.9% pebbles. In terms of organic matter, Site 2 had an average of 8.6% and a standard deviation of 2.7%. The forest surrounding the study reach is composed of predominantly deciduous trees but has a dense understory, protecting the channel from leaf litter. The upper contributing hillslopes include forest, as well as active and fallow agricultural fields. The channel flows into the Grand River near the confluence with the Speed River, in Cambridge, Ontario.

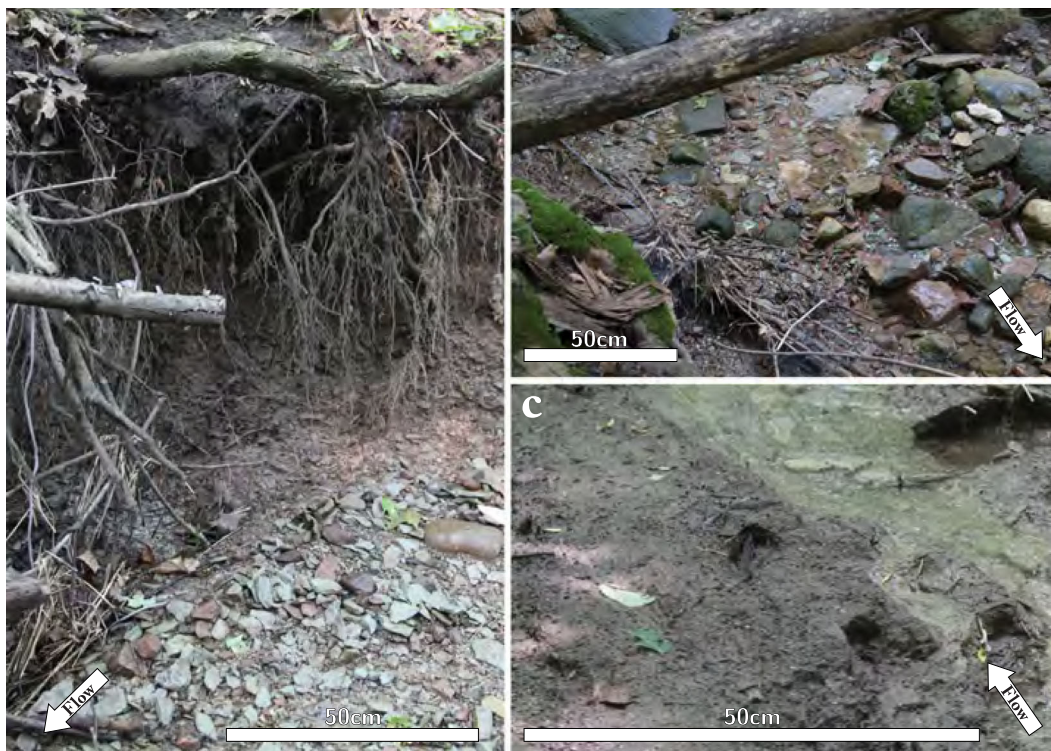
Figure 5. Photos of channel surface characteristics at Site 1. (a) The upper parts of the channel were deeply incised and contain lots of pebble-sized grains on the bed surface. (b) The lower reaches of the channel had a relative absence of larger grains on the surface. (c) In the mid-to-upper reaches, there was a mix of pebbles, cobbles and boulder-sized grains on the bed surface, which lead to potential siting issues. Site 2 exhibits similar channel surface characteristics, with the downstream area similar to (c) and the upstream area similar to (b). There were no channel surfaces similar to (a) at Site 2

was flatter, wider and sandier (Figure 5). At Site 2, the lower portion of the reach had larger rocks, while the upstream area had a sandier bed. The rockier areas generally resulted in better noise performance from the ER sensors than from the flow detection design. Because
