WORK INSTRUCTION
CLAMP ASSEMBLY PROCESS

| Document No.: | WI-ENG-PDE-891 | | |

| Model code/Part number: | 291B / 7L0036-7021 | Customer: | TRQSS |
| Car Model: | TOYOTA-SEQUOIA | | |

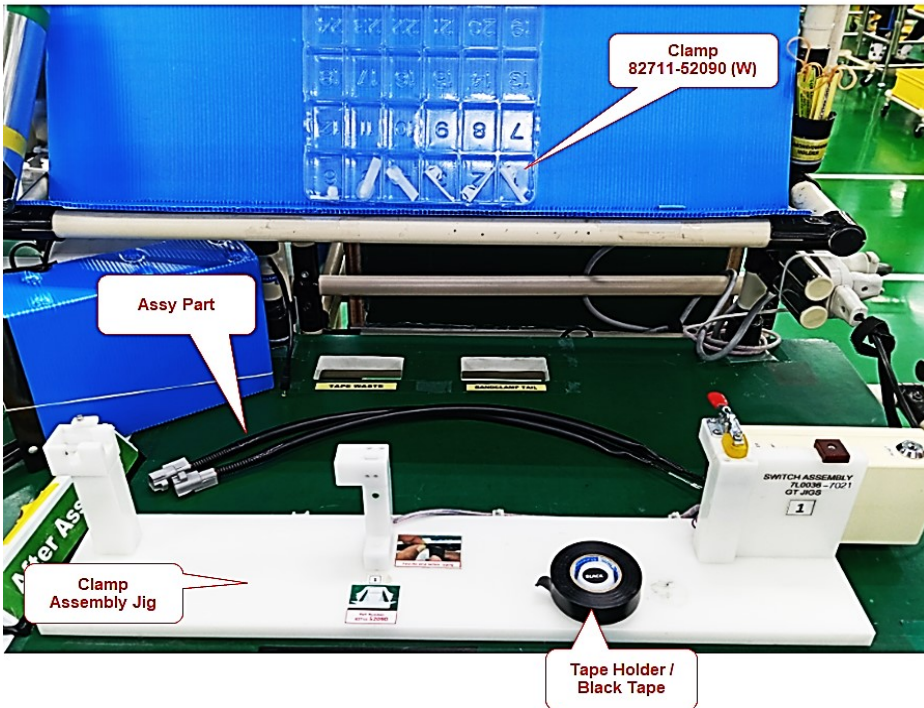
| 1 | Clamp | <p>TABLE LAY OUT</p> | | <p>Safety Instruction Be sure to wear required personal protective equipment during operation (gloves, finger cots, etc.)</p> <p>Housekeeping 1. Maintain and always practice 5's. 2. Personal things on the workplace is prohibited. Keep it in your locker.</p> <p>Alert level For any trouble, inform the Assembly Assistant Supervisor or Line Leader for immediate corrective action.</p> | <p>1. No wrong use of parts 2. No wrong use of clamp 3. No wrong use of tape</p> <p>Important reminders/Note/s: 1. Please check the Clamp first before start of assembly to avoid wrong use of clamp.</p> |

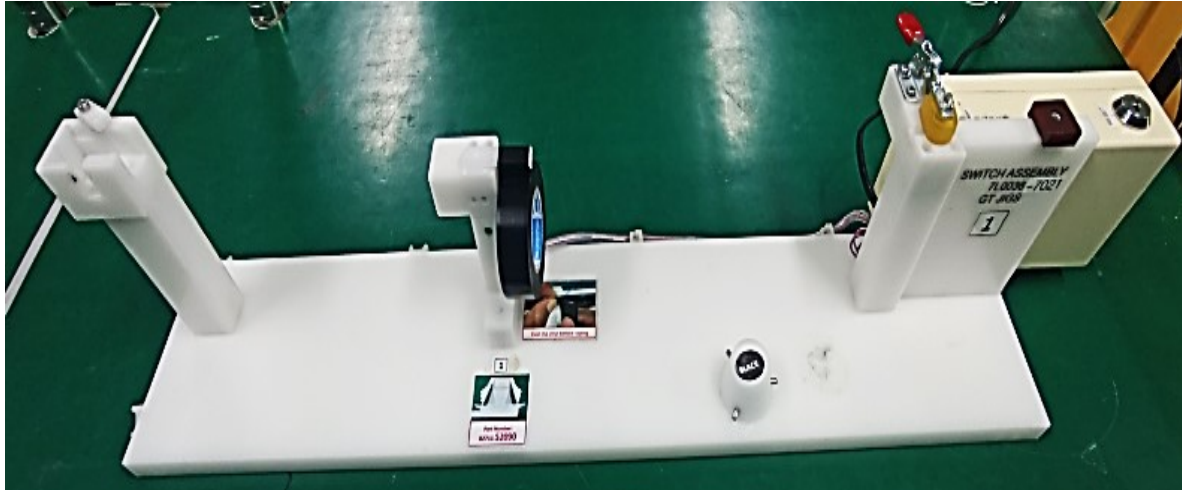
| 2 | Clamp | Clamp setting | | <div></div> <div>1. Get 1pc. of clamp 82711-52090 (W) using right hand and insert to location 1 using both hands.</div> <div>2. Initially attach Black tape on location 1 using both hands.</div> <div>Note: Please check the clamp before start of assembly to avoid wrong use of parts.</div> | | <div>1. No wrong use of parts 2. No wrong use of clamp 3. No wrong use of tape</div> <div>Important reminders/Note/s: 1. Please check the Clamp first before start of assembly to avoid wrong use of clamp.</div> <div><div>CLAMP ILLUSTRATION</div><div><div>GOOD</div><div></div><div>82711-52090 (W)</div></div><div><div>NG</div><div></div><div>82711-12A80 (W)</div></div></div> <div><div>STANDARD TAPING FOR CLAMP</div><div>One side tape under clamp</div><div></div></div> |

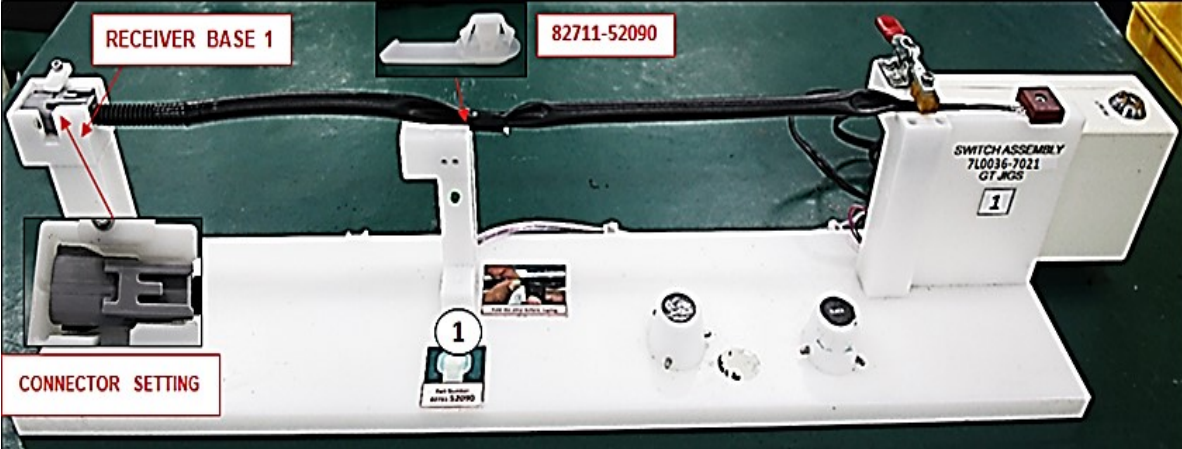
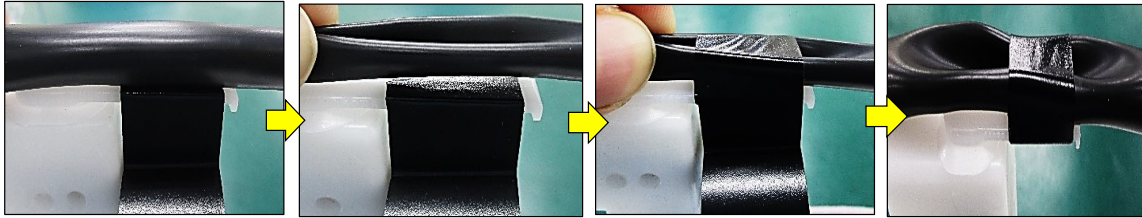
| 3 | Clamp Clamp assembly | <div></div> <div><p>1. Get the assy parts and set into jig. (See above picture for the correct setting). First, set the connector 6188-0294 (GR) to Receiver base 1 and then lock. Continue to set the harness in jig. Last, set the B/W-G wires together within the stopper then press by toggle clamp. Continue the process if sequence light in location 1 was ON.</p><p>2. Check if all LED light for POWER ON, WIRE1, WIRE2 and CLAMP ON was ON. If encountered abnormality, STOP and immediately CALL the attention of the leader. WAIT for further instruction and continue the process.</p></div> <div></div> <div><p>3. On clamp location 1, fold the vinyl tube. (See above picture as guide). Make 3 windings before cutting of tape. Press the SW button after taping. Go sound will be heard.</p><p>4. Conduct POINT CHECKING before removing the harness from jig.</p></div> | | <div></div> <div>Note: Make sure theres no clearance between terminal and stopper jig.</div> | <div>1. No flip-out tape 2. No peel-off tape 3. No loose tape 4. No wrong insertion of connector 5. Make sure no gap between terminal and stopper jig</div> |

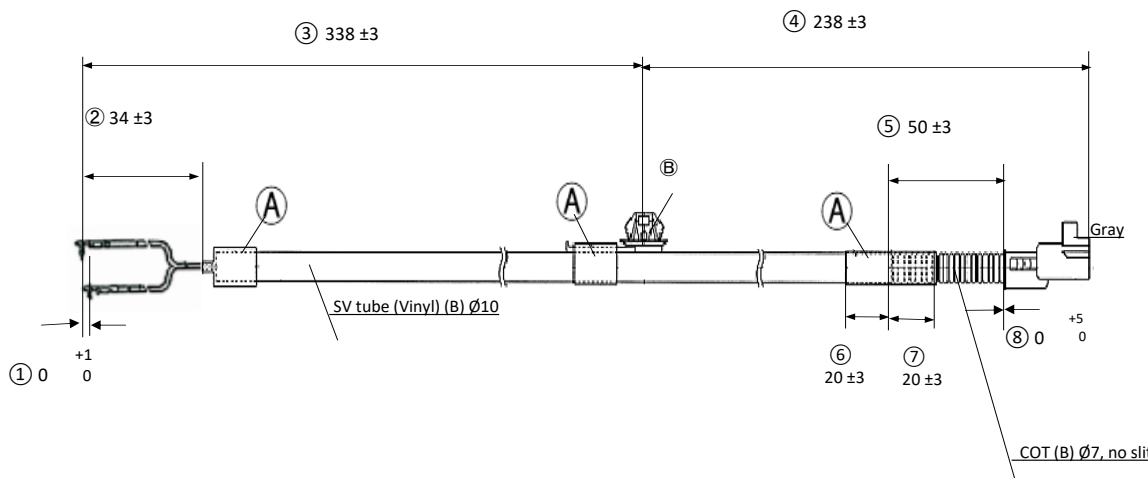
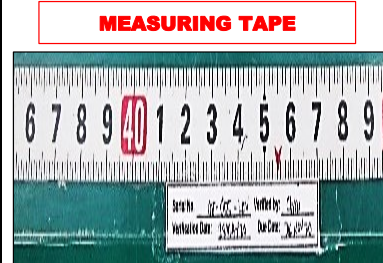
| 4 | Clamp | Measurement | <div></div> | <div> 0~1 mm</div> | <div>1. No wrong dimension</div> <div>MEASURING TAPE</div> <div>Wire alignment tolerance</div> <div>0~1 mm</div> <div>Important reminders/note/s: 1.Please use calibrated/verified measuring tape when getting the measurement.</div> |
