II. DESIGN PROCESS

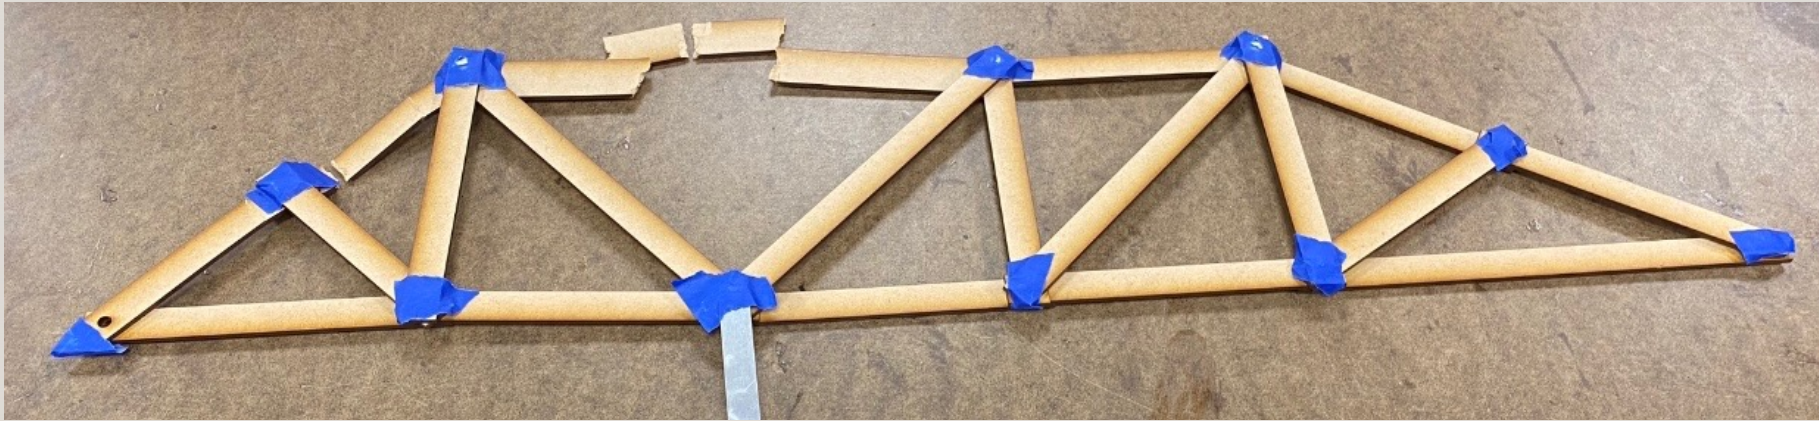
In our third and final design, we removed a few zero force members in order to improve our efficiency. In testing our third design we saw the impact of the widened member CD. We were able to hold nearly 113.5 lb in our preliminary testing, and the breaks did not always occur in CD either, which we were very happy about. In the tests of our final design failure occurred somewhere between 88.5 lb and 113.5 lb. The breaking point was mostly at CD, but sometimes at other members such as DE, EF, AB, or BC. Unfortunately, in our final test it failed at 88.5 lb at members CD, AB, and BC. Below is our broken truss from after the final test, a scale drawing of the truss is included on the next slide.
