# Electroluminescence Analysis of PV Module under Accelerated Lifecycle Testing

Teh Lai, B.G. Potter, Jr., and Kelly Simmons-Potter

Department of Electrical and Computer Engineering  
The University of Arizona, Tucson, AZ 85721

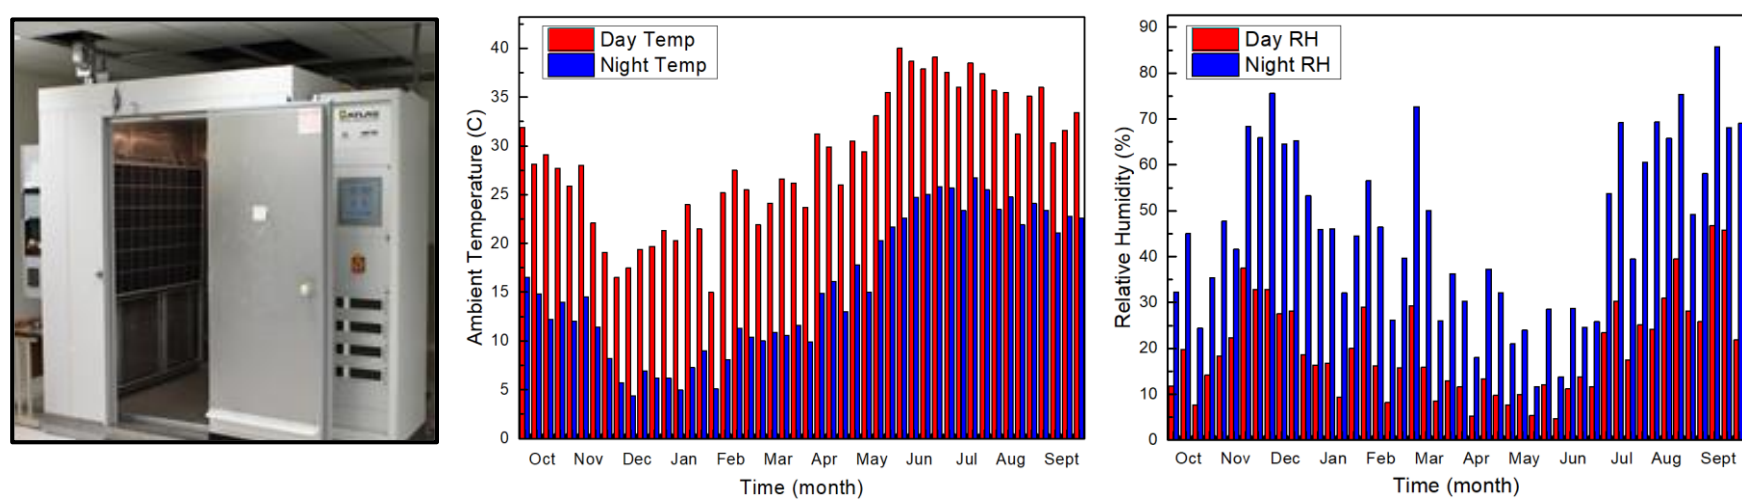
- Environmental chamber replicates accurate climate profile obtained by a weather station situated at the TEP test yard in Tucson, Arizona.<sup>1-2</sup>

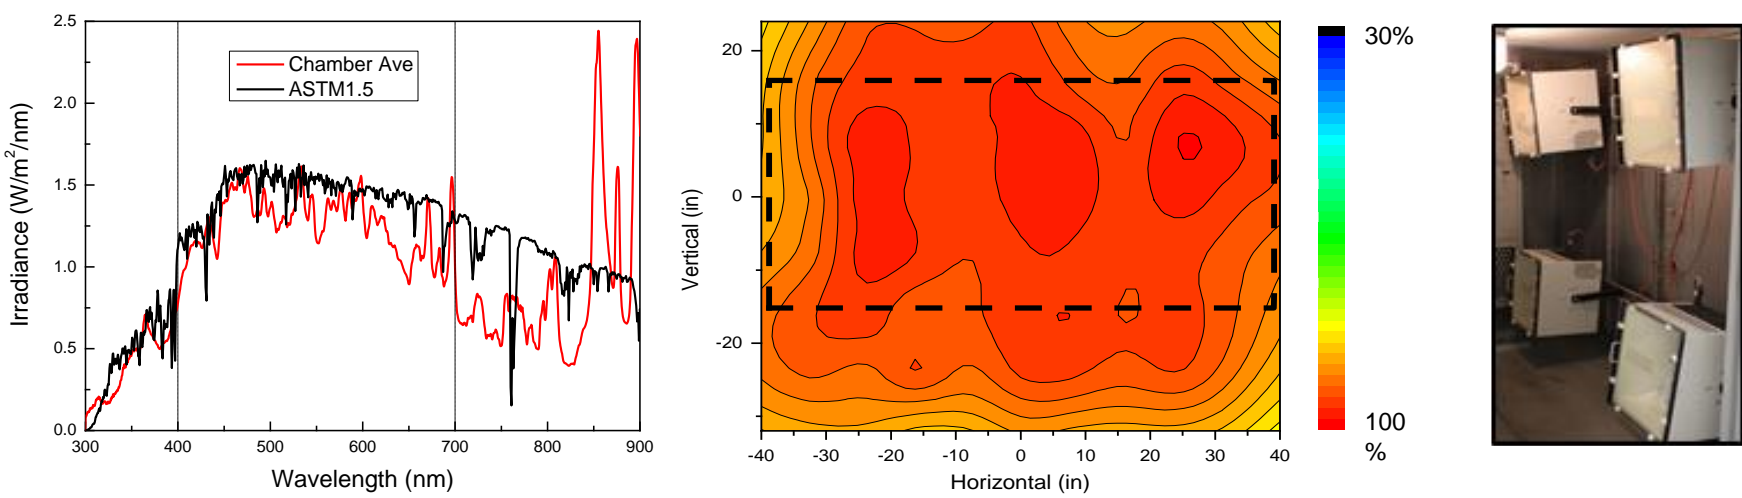
- UV-visible-IR metal-halide lamps enable accelerated lifecycle (ALC) testing: spectral distribution ~AM1.5; irradiance distribution ~95% uniformity; solar isolation of 1 full sun (1kW/m<sup>2</sup>).<sup>1-2</sup>

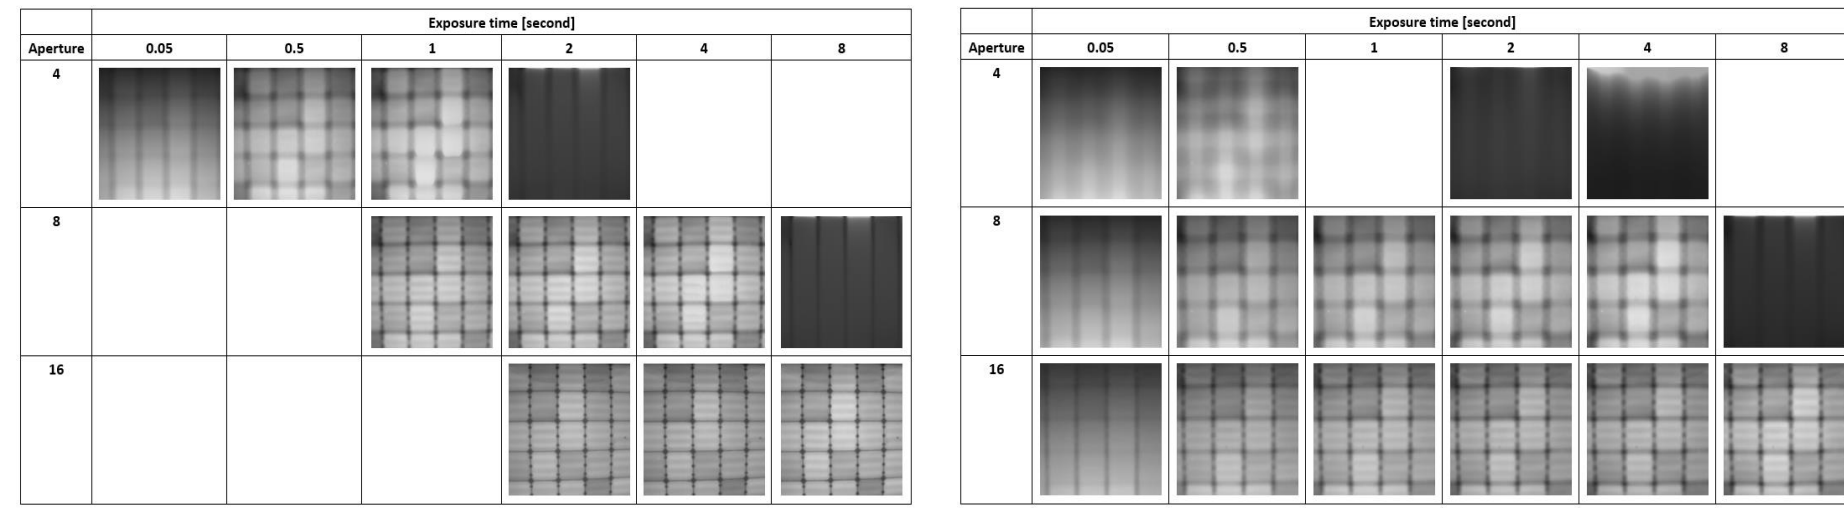
- EL images (Andor iKon-M) were obtained by applying a forward bias,  $I_{sc}$ , to the module. Optimized data acquisition conditions (5mm tube length, aperture size of 16, exposure time of 4-8 seconds) were determined via a series of image comparisons.

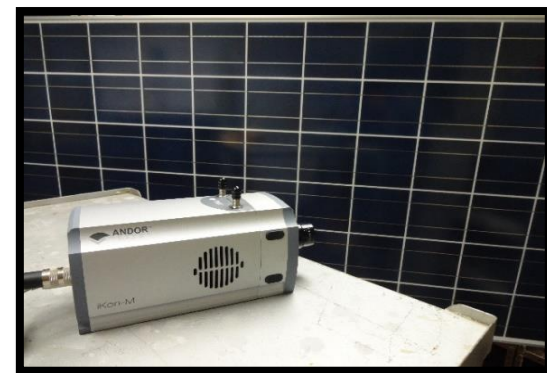
- EL images are captured during nighttime (dark soak) portions of the chamber test cycle in each simulated month for a simulated year.

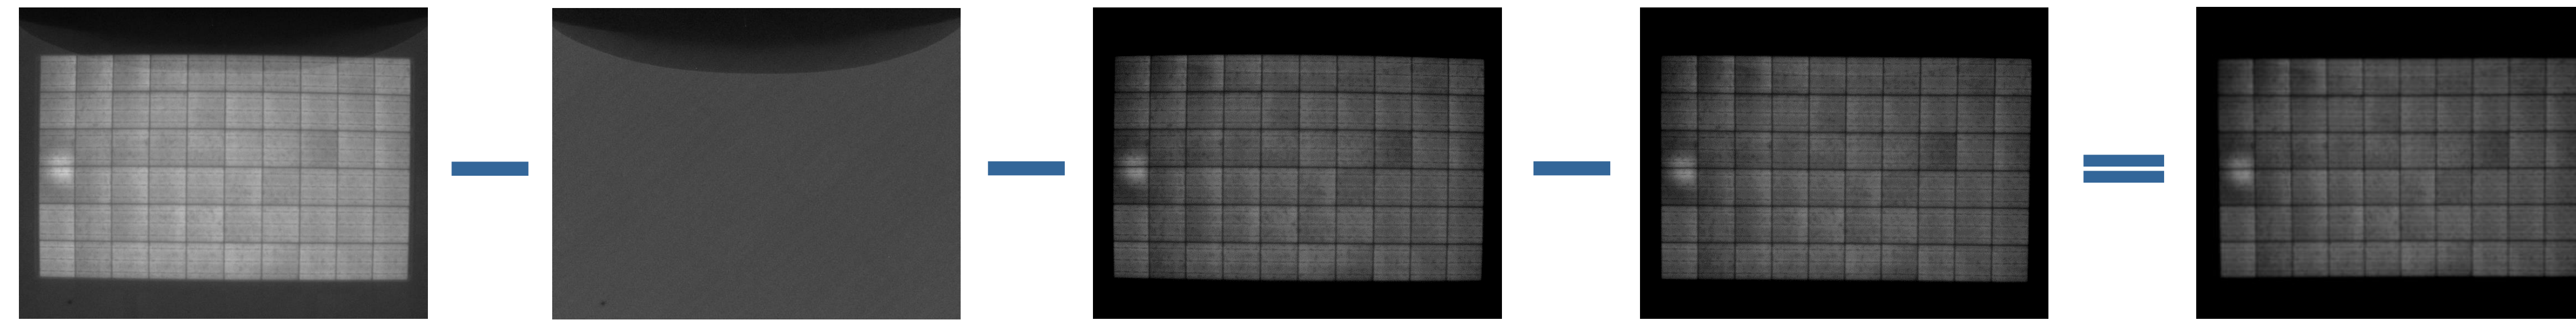
EL images exhibited background noise and image distortion. Image correction included:

- Initial noise removal through acquisition of background image with no energizing source.
- Optical barrel distortion (seen as bend towards each corner of the image) correction.
- Repositioning displacement (rotation) correction.

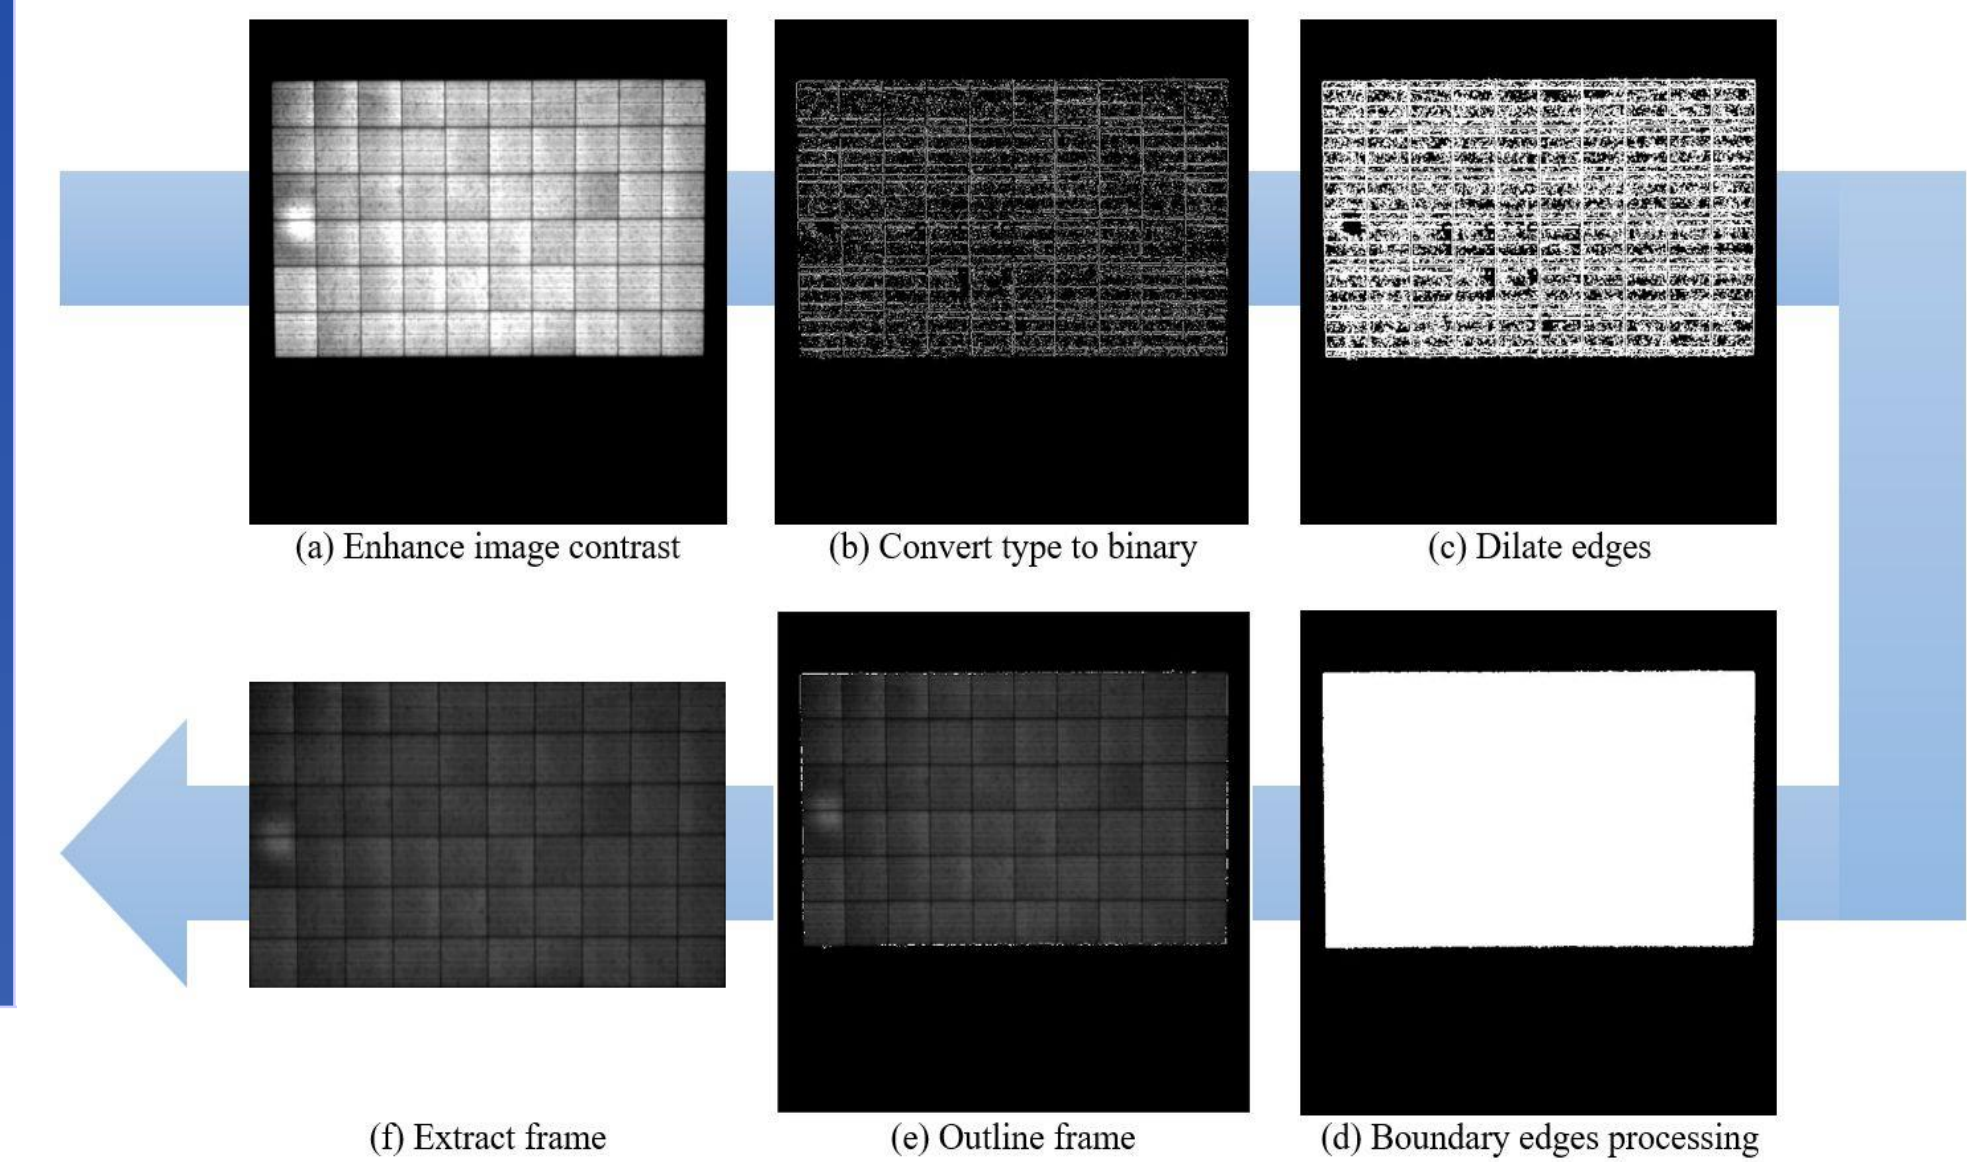
- Enhanced image allows frame edge detection so that the full module can be extracted from the full EL image.

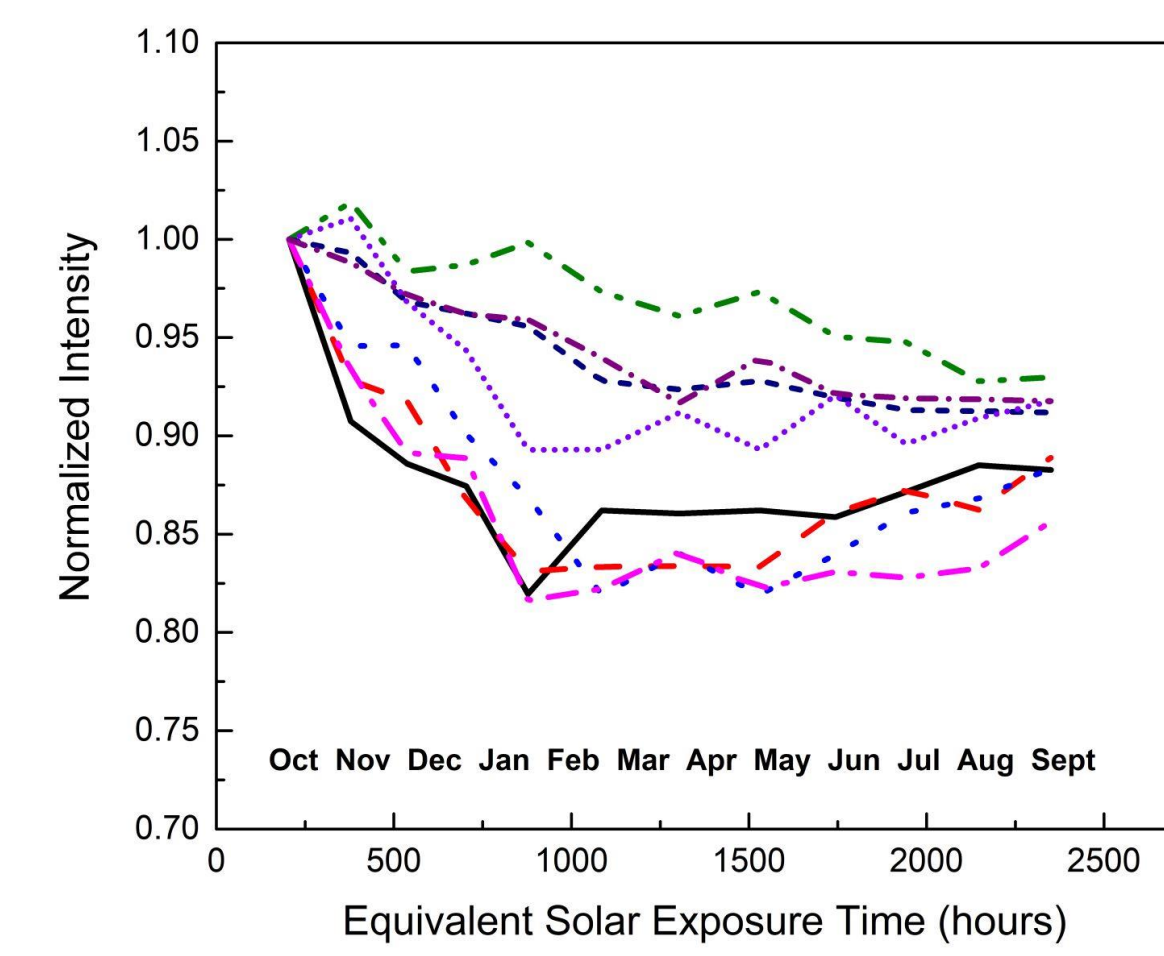
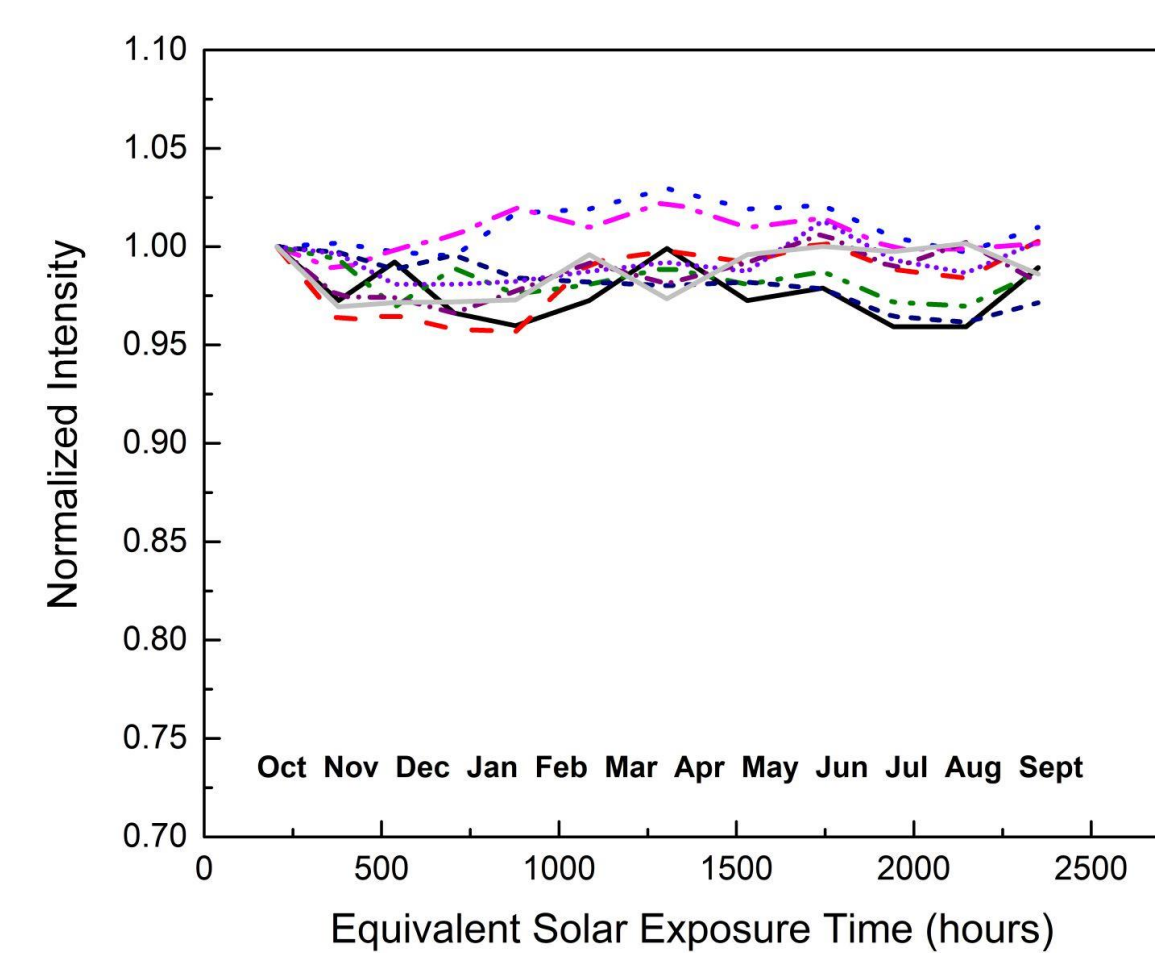
- Smoother decline in mean and unchanging standard deviation indicate a slowly degrading or undegraded cell.
- Sudden drop in pixel mean and rapid increase in standard deviation suggest potential cracks or significant defects.
- Two observed trends in mean variation of cell intensity over the course of a year-equivalent ALC test:
  - ❑ Relatively constant pixel distribution (left figures) for 2/3 of cells in module;
  - ❑ Significant decrease in normalized intensity (right figures) among 1/3 of 60 cells.

- Left representative figures show little variation in EL intensity histograms over the course of a twelve-month equivalent ALC test: pixel count of 810-816 at intensity level of 78 out of 255, and width (FWHM = 22, and  $1/e^2$  width = 38).
- By contrast, right representative figures show a clear decay in normalized EL intensity, with losses ranging from 5% to nearly 20%: decrease in pixel counts from 607 to 533, a shift in intensity level from 70 down to 68, and an increase in  $1/e^2$  width (37 increasing to 43 out of 255 with a notable asymmetry on the low intensity side of the distribution).
- In contrast to other studies using EL assessment of PV modules, no evidence for significant macroscale crack evolution was observed under these more field-relevant, early lifetime environmental test conditions.

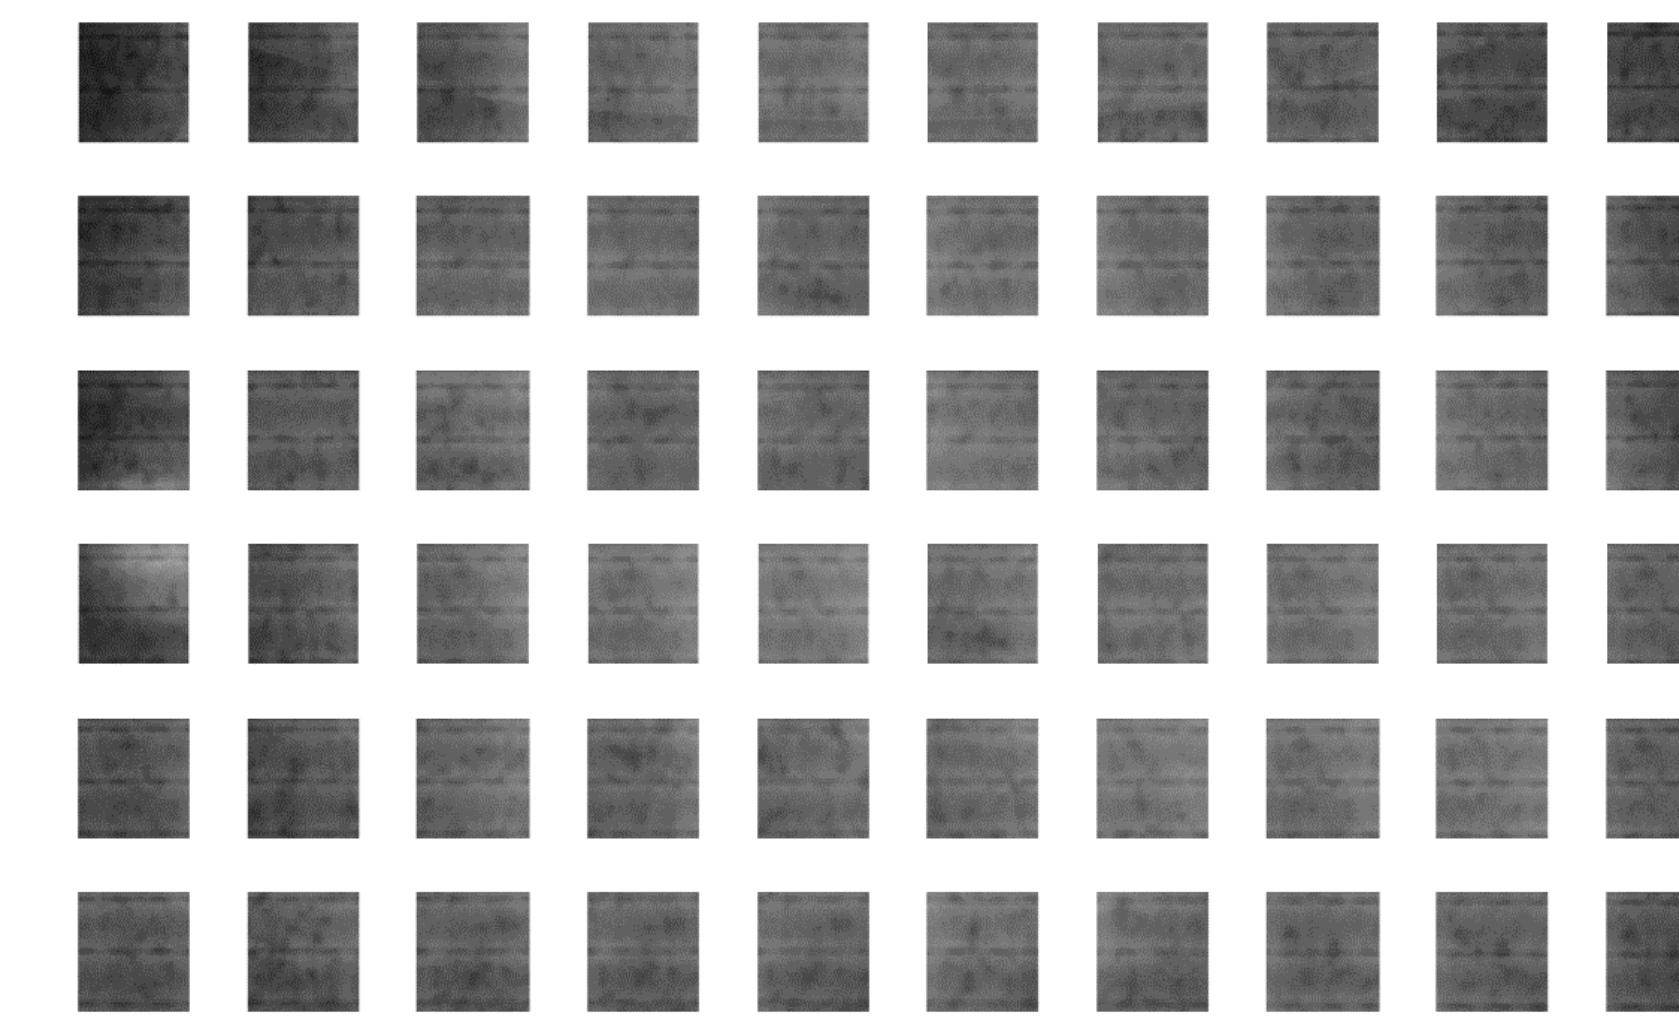
- Given numbers of columns and rows, individual cells are identified and extracted based on their positions in the full module image.

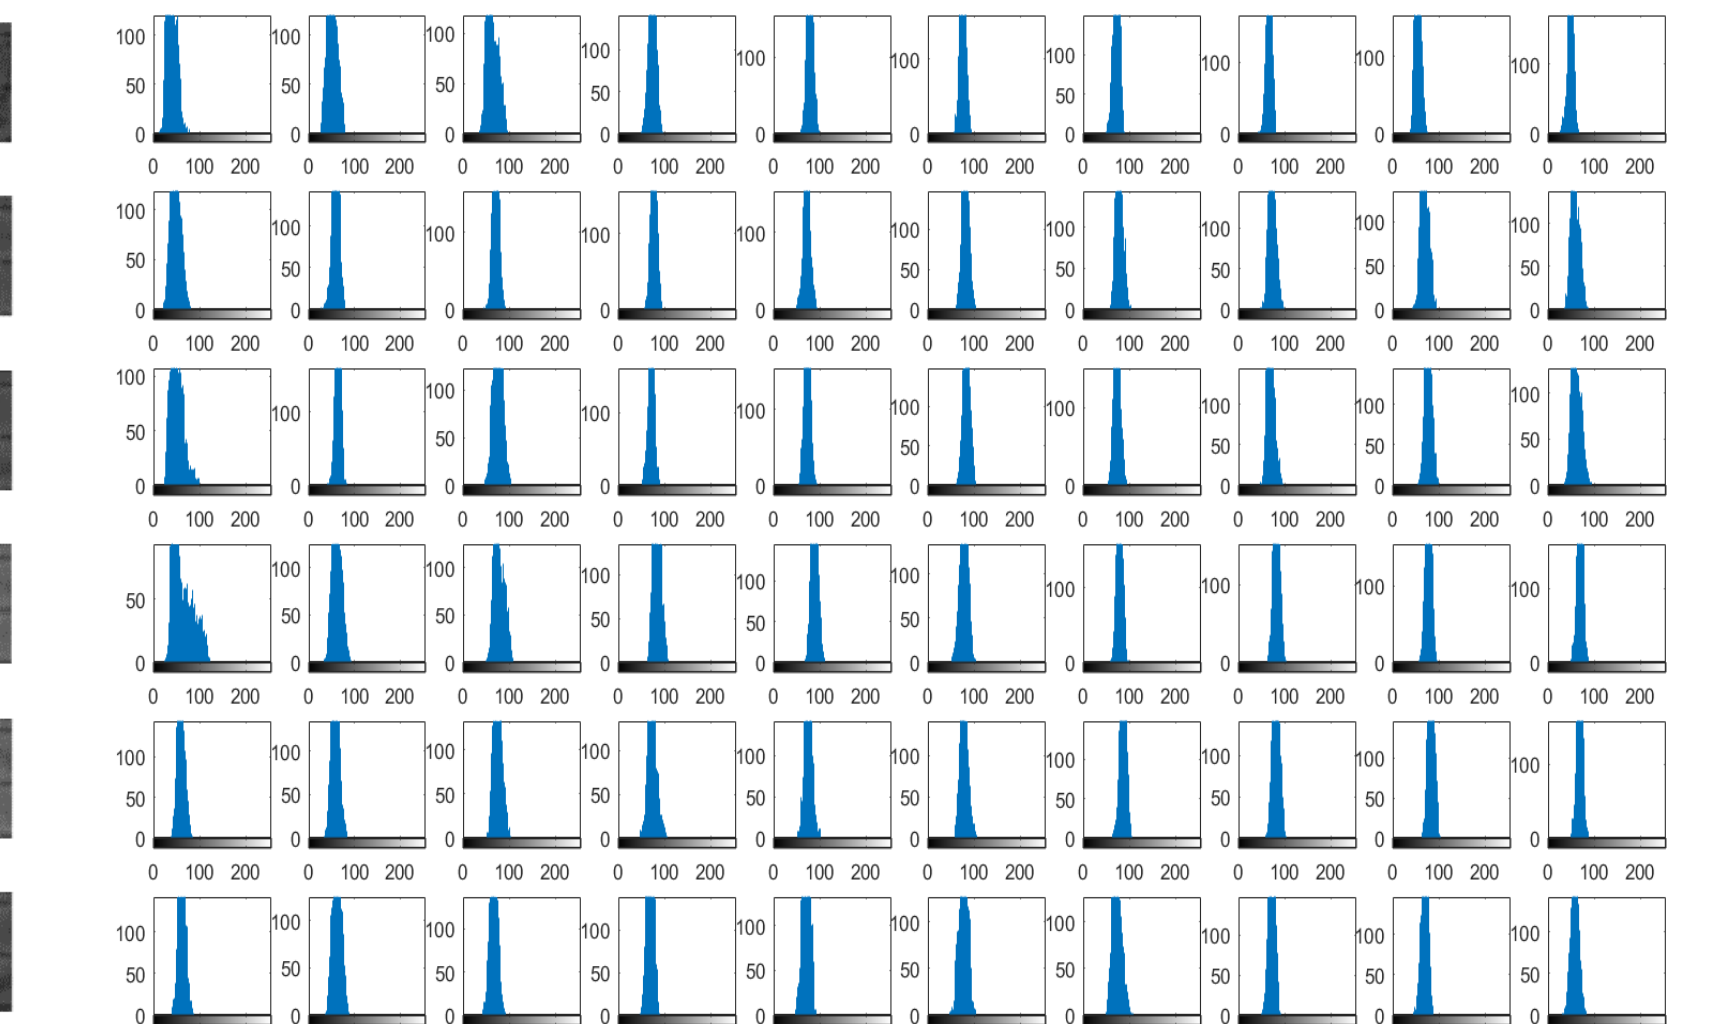
- Intensity histograms of individual cells are monitored monthly to enable degradation analysis using statistical parameters (mean, standard deviation).

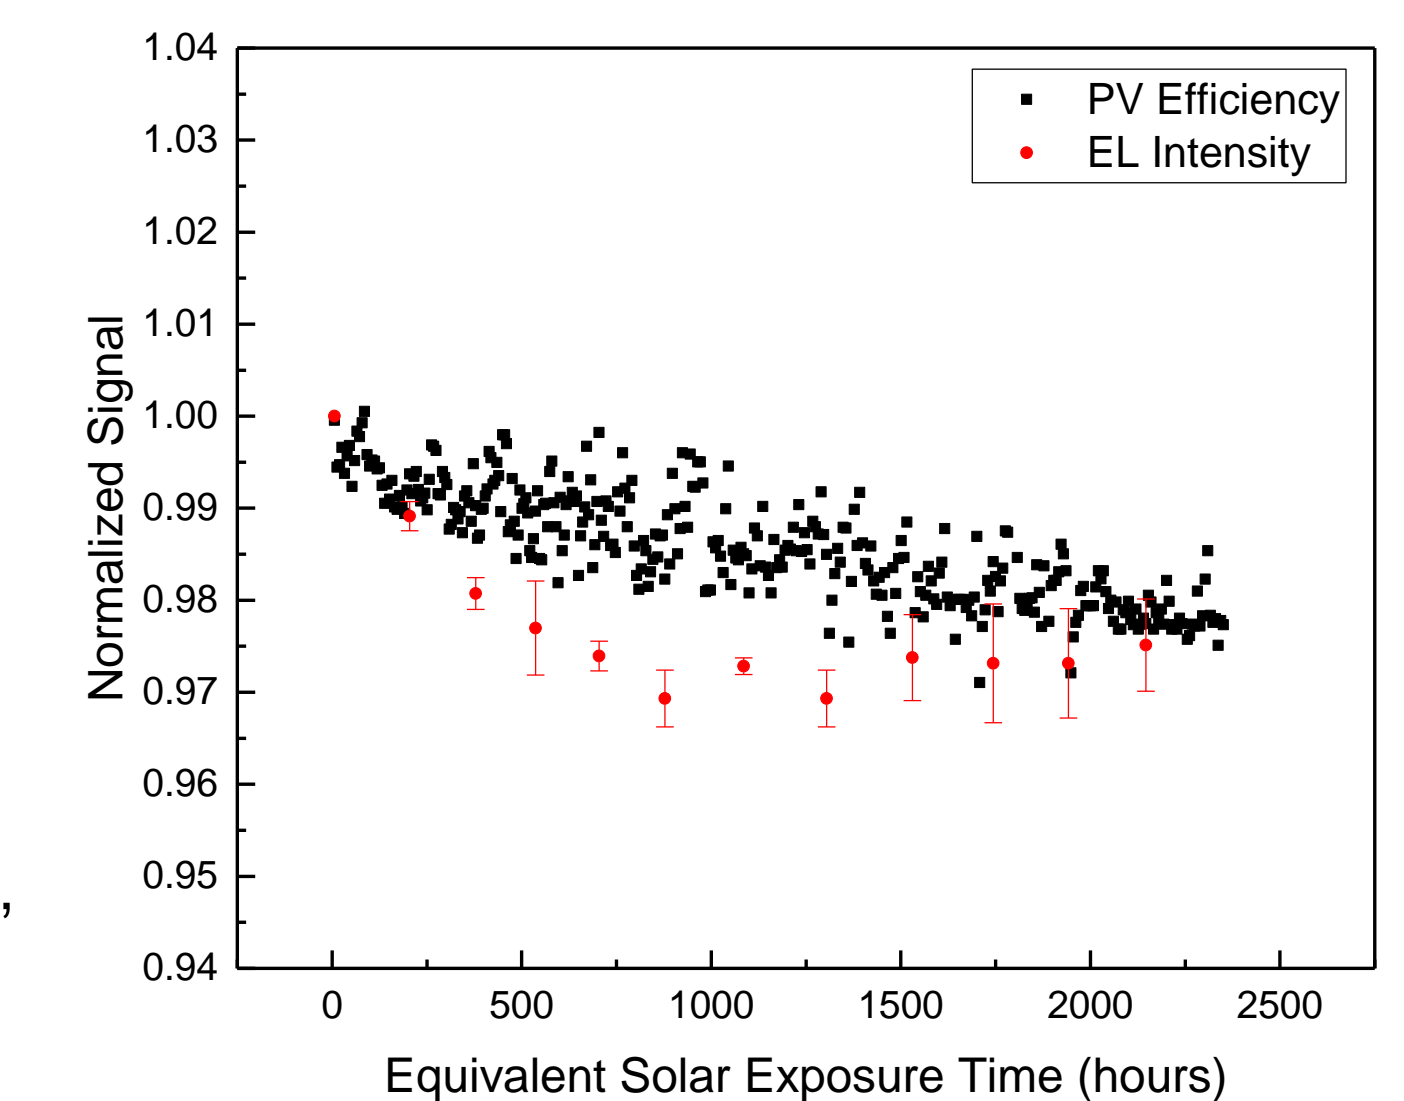
- Rapid degradation in EL intensity experienced by 1/3 of the cells in PV module contributed to full PV module degradation behavior.
- Examination of data shows a 0.35% reduction in actual power conversion efficiency (or 2.3% decrease in relative efficiency as plotted in the figure) during the 1-year accelerated lifecycle test.
- A normalized decrease of approximately 2.5% in normalized EL intensity across the module exhibits good agreement with the measured normalized PV efficiency decrease of 2.3%.
- While the form of the normalized efficiency degradation and the normalized EL intensity decay are not identical, within the error bars, the similarity in the behaviors of the two curves is unmistakable and confirms a correlation between these two measurement trends.

- Comparison of panel efficiency degradation behavior with the observed EL intensity degradation suggests good correlation between the overall module performance with a loss of electrical connectivity, possibly due to the formation of microcracks or other small-scale defects in the cell structure.
- Calibration source has been introduced to the environmental chamber to supply a repeatable calibrated peak intensity for image normalization.
- Finer pixel-to-pixel line scan image analysis will be pursued in future research.
