Pacific Gas and Electric Company

Application Assessment Report # 0716

LED Low-Bay Garage Lighting San Francisco, California

Issued: July 22, 2008

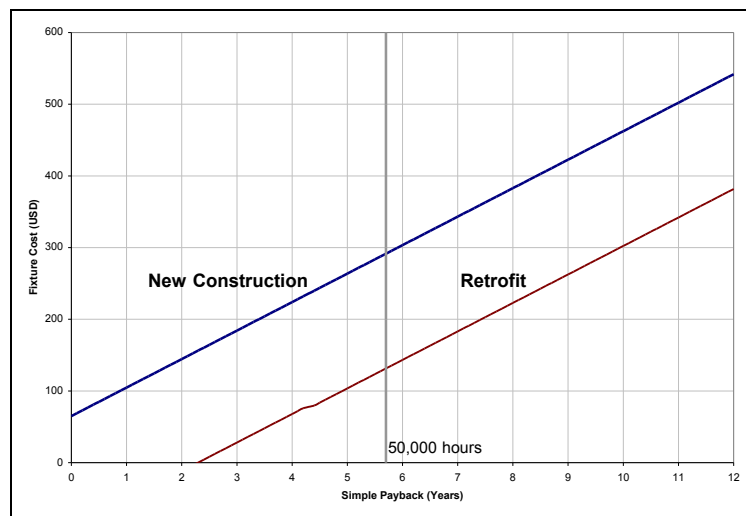
FIGURE ES -1: ESTIMATED LED FIXTURE PAYBACK

For this particular case-study, these payback periods are longer than the 50,000-hour expected useful life of the LED fixtures. To achieve a simple payback of less than 5.7 years under current conditions, the cost of the LED fixture needs to decline to less than \$135 in a retrofit scenario or approximately \$292 in a new construction scenario.

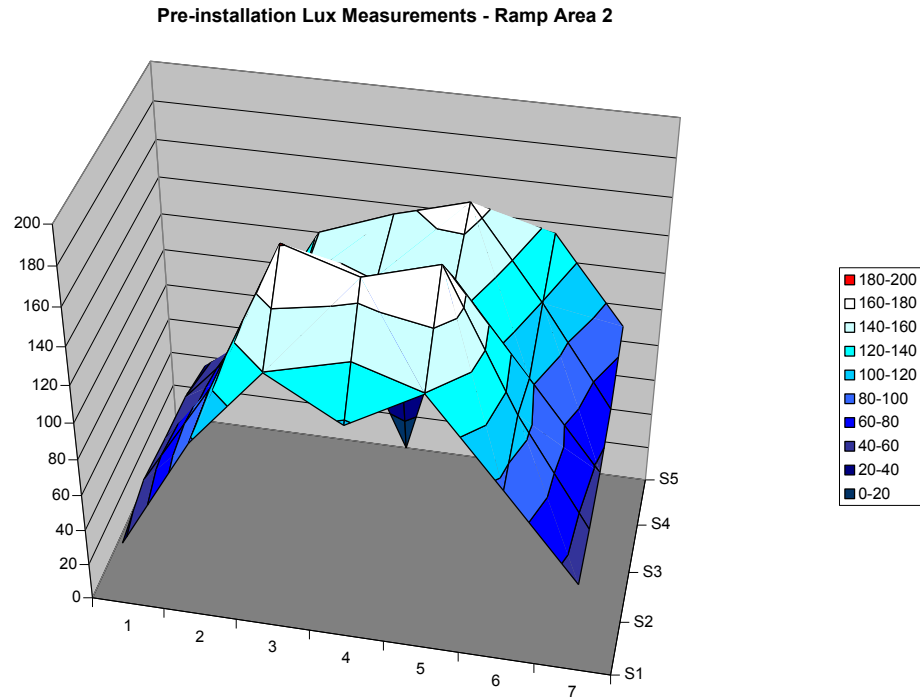
FIGURE 3: AREA 2 PRE -INSTALLATION LIGHTING MEASUREMENTS (LUX)

Illuminance levels were measured on a 4'6" x 5'4" grid for Demonstration Area 2, and on a 2-foot grid for a detailed test area. The average measured illuminance for the linear fluorescent fixtures was 9.7 foot-candles, with the LED fixtures decreasing this value to 5.7 foot-candles. The maximum and minimum levels measured for the linear fluorescents in were 16.8 and 3.2 foot-candles, respectively. The uniformity ratio in this case is 21:4. For the LED fixtures, these values were 11.6 and 2.1 foot-candles, with a slightly worse uniformity ratio of approximately 11:2. A fixture-to-wall ratio was not calculated for Demonstration Area 2, due to interference from surrounding light at the edge of the demonstration area.

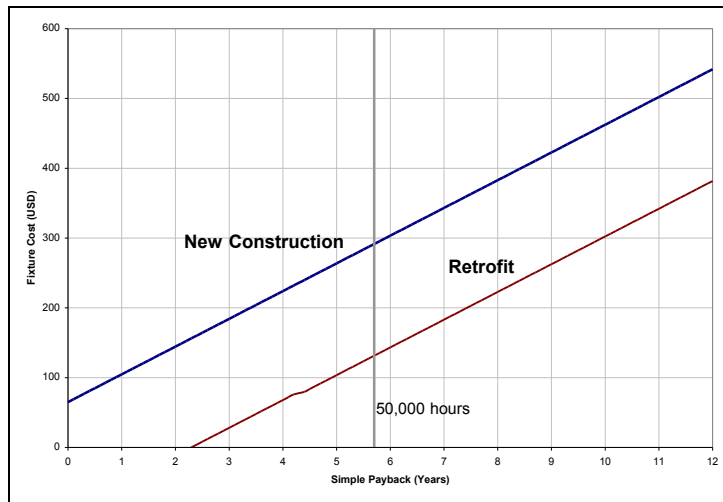
FIGURE 4: ESTIMATED FIXTURE PAYBACK (ASSUMING NO MAINTENANCE)

Cost curves were generated showing requisite LED fixture costs for simple paybacks under 10 years with the existing replacement factor of one LED fixture for two linear fluorescent lamps.
