# Precise Aerial Measurement Report

8002 Kilpatrick Parkway, Bennington, NE 68007

Report: 59103561

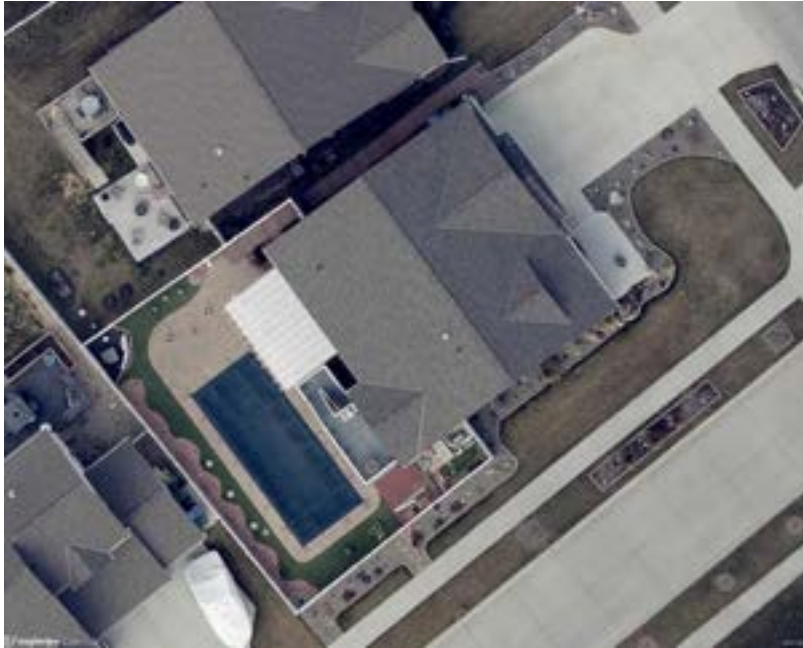
In this 3D model, facets appear as semi-transparent to reveal overhangs.
