Precise Aerial Measurement Report

3808 Gertrude St., Bellevue, NE 68147

Report: 59970300

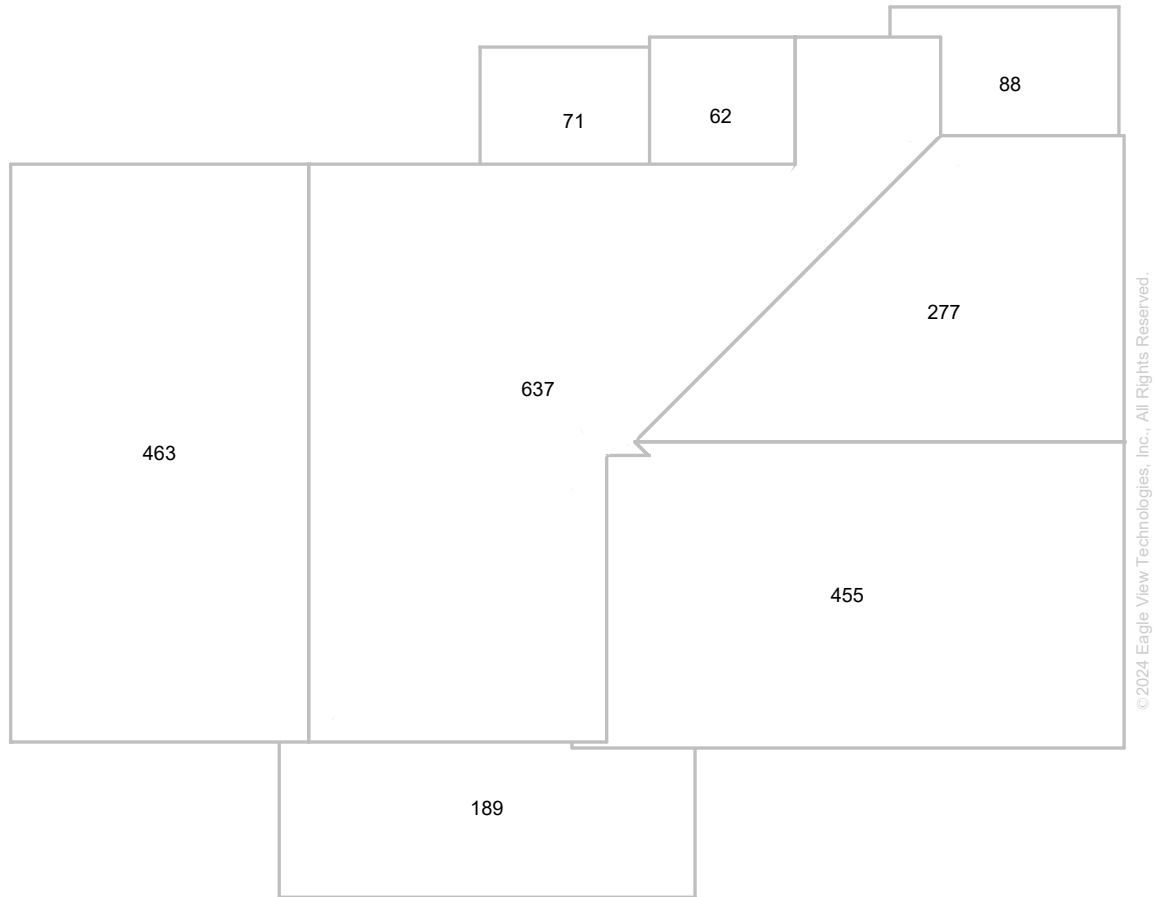
AREA DIAGRAM

Total Area = 2,241 sq ft, with 8 facets.

Note: This diagram shows the square feet of each roof facet (rounded to the nearest Foot). The total area in square feet, at the top of this page, is based on the non-rounded values of each roof facet (rounded to the nearest square foot after being totaled).
