Fred J. Anderson

A highlight of environmental and engineering geology in Fargo, North Dakota, USA

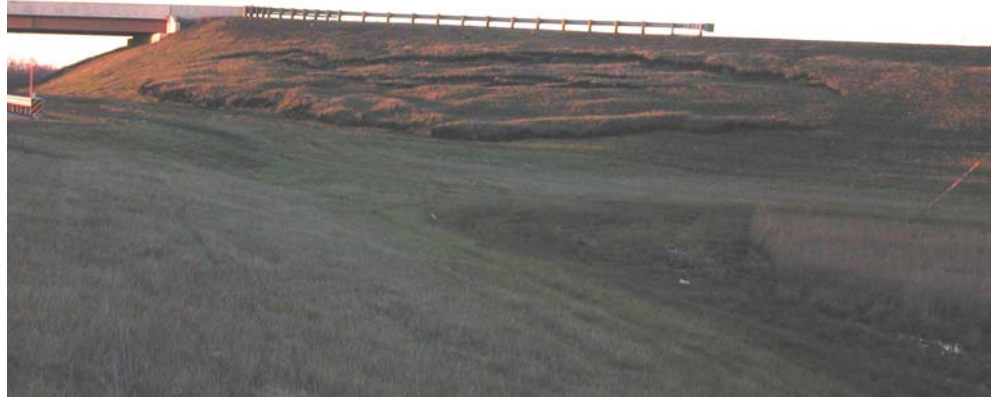
Fig. 1 Failure of engineered fill soils on the eastern ramp of the Business HWY94 overpass just west of the City of West Fargo after recent heavy precipitation in the area during the Fall of 2004

water resource identification, development, and protection. Environmental geology issues, both historical and recent, in Fargo, North Dakota must be dealt with and a brief discussion follows (Fig. 1).

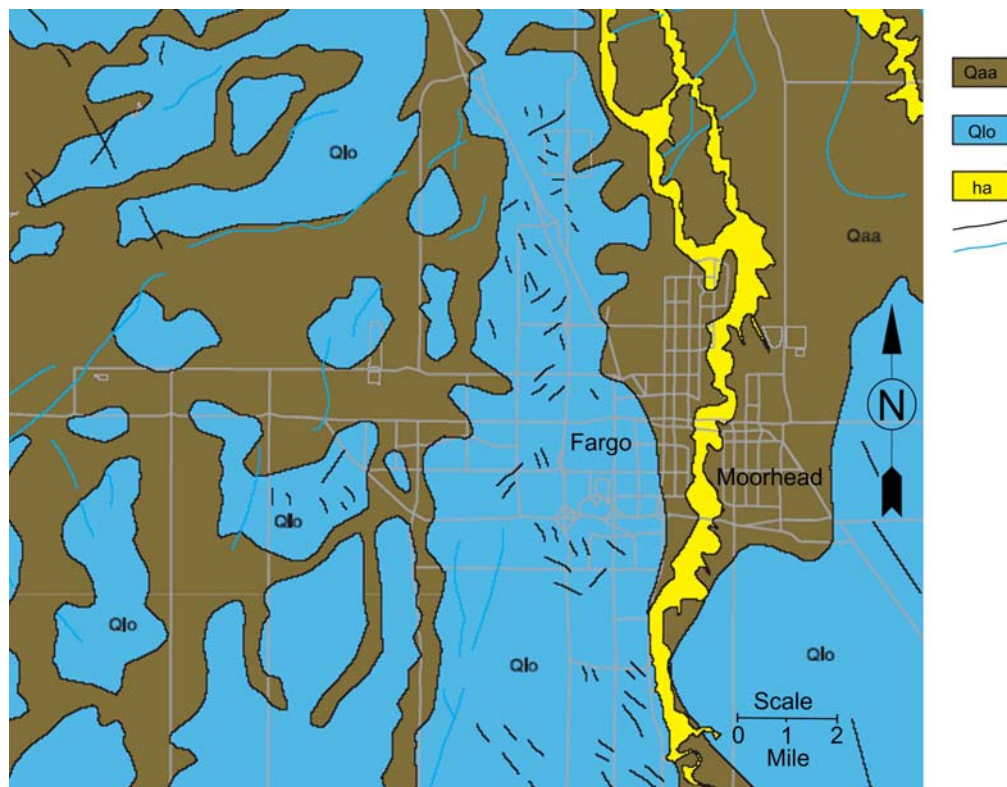
Fig. 3 Generalized lithostratigraphic geologic map of the Fargo area depicting the distribution of surficial sediments in the southern Red River Valley. Unit Qaa consists of overbank sediments associated with ancient river systems draining the Lake Agassiz floodplain. Unit Qlo consists of offshore glaciolacustrine silts and clays of the Sherack and Brenna Formations (Harris et al.

1974). Unit Ha consists of Holocene age alluvium and channel sediments deposited within the Red River floodplain and along tributary drainages. Ice drag marks (*linear black lines*) and compaction ridges (*linear blue-gray lines*) are also shown. Modified from Harris et al. (2005)

a relatively uniform blanket of glacial lake sediments deposited during the onset of Glacial Lake Agassiz around 11,000 years before present (bp) (Fig. 3) and alluvial sediments that mantle the lake silts and clays throughout the southern Red River Valley.

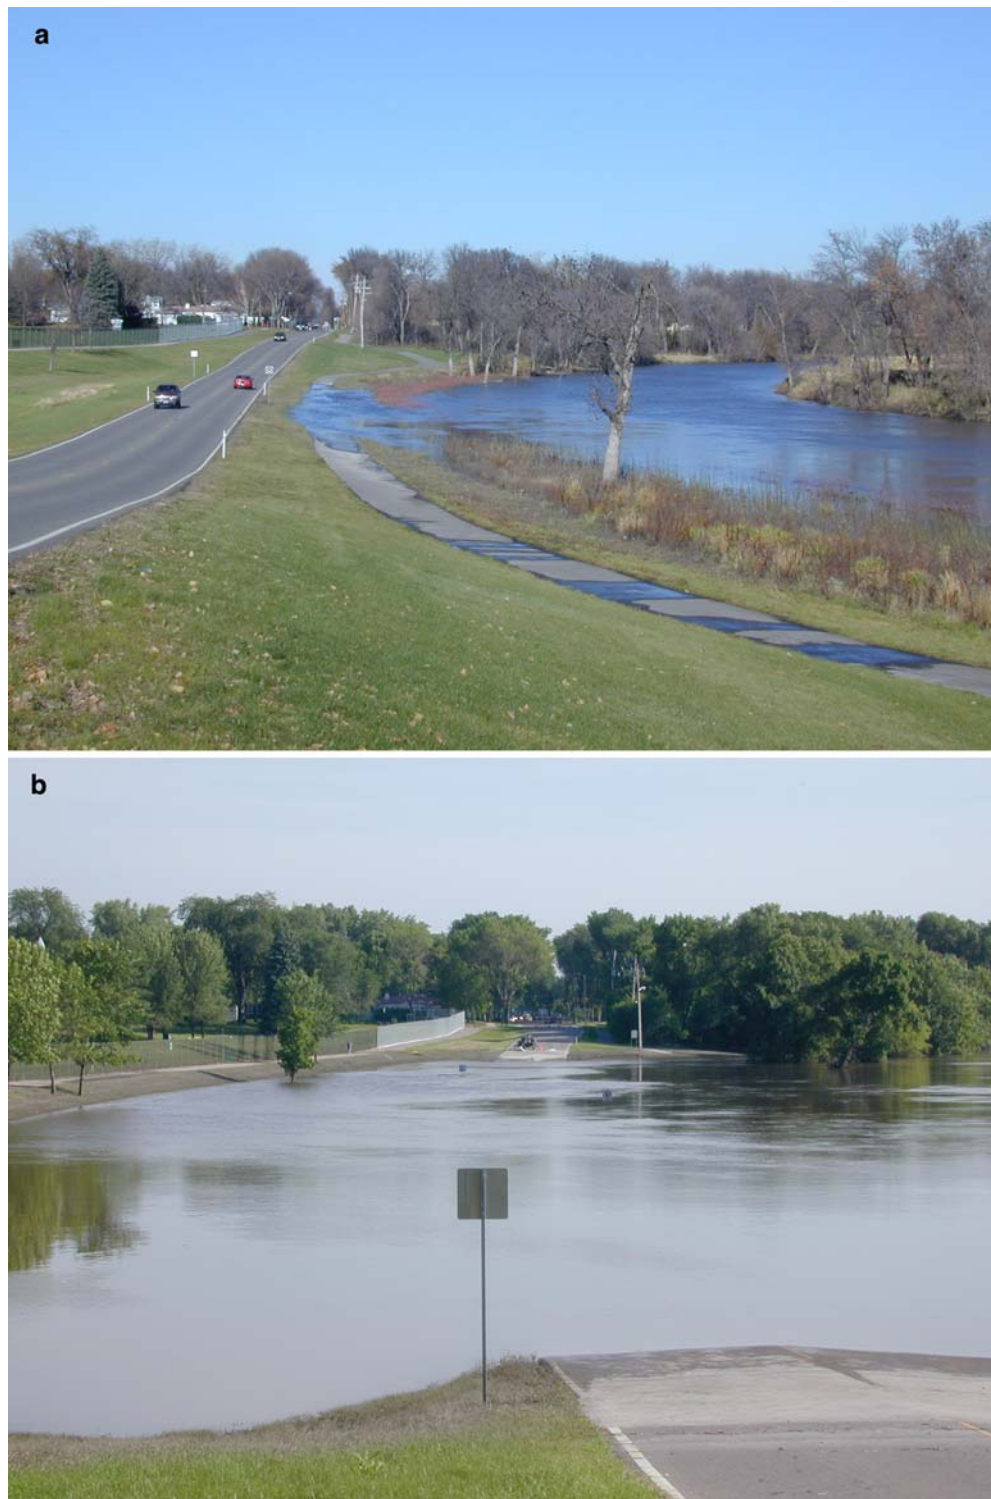
Fig. 4 a View to the north along North Elm Street in Fargo. High water levels in the Red River encroaching upon and in many cases shutting down convenient local transportation routes and providing for increased cutbank meander instability and erosion through

seasonal saturation of the entire cutbank meander as shown Fig. 4b in this southern view of North Elm Street during recent flooding in the Summer of 2005

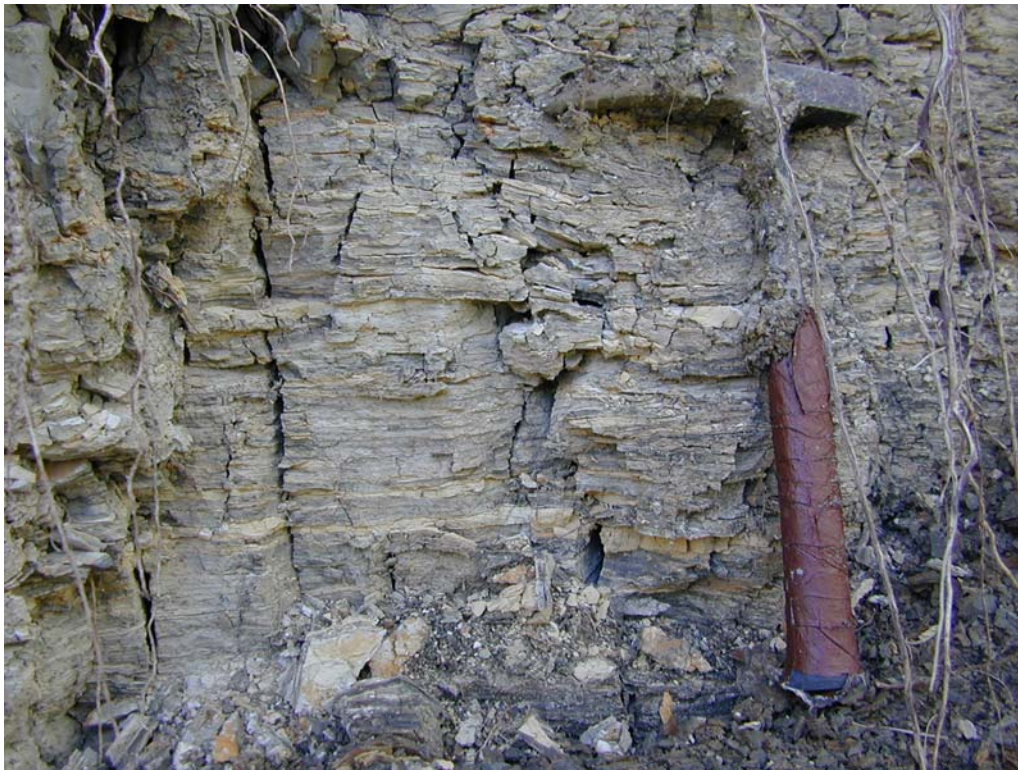
Fig. 6 Outcrop of Sherack Formation along a tributary drainage of the Red River of the North just north of the City of Fargo showing the well developed laminae of silts and clays deposited in

the offshore depositional environment of Glacial Lake Agassiz and subvertical fracturing developed within this unit at the outcrop

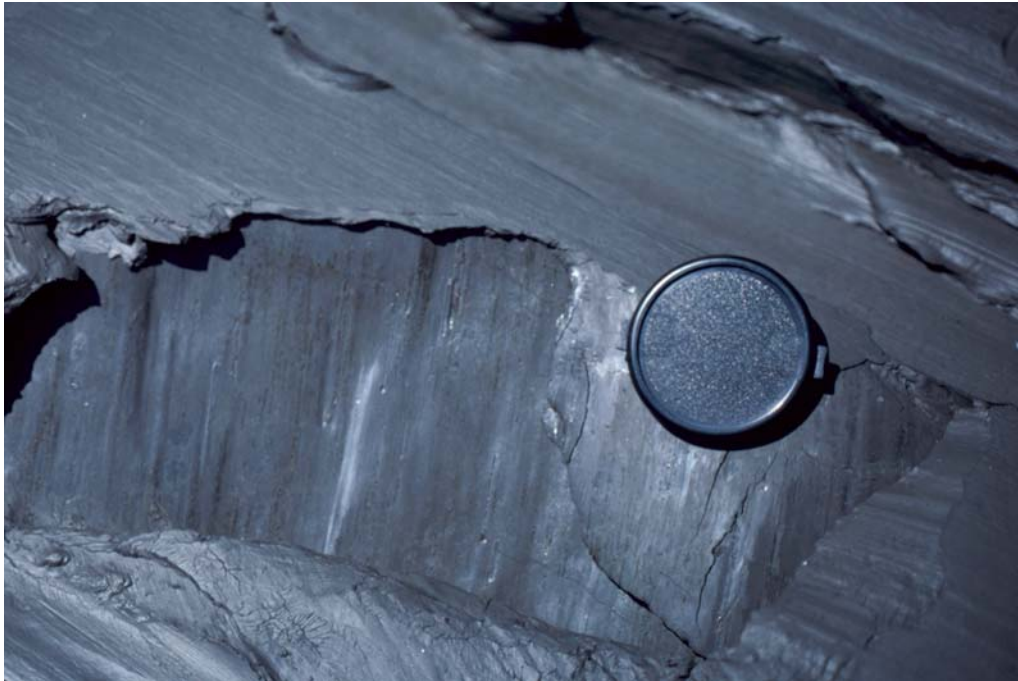
Fig. 7 Brenna Formation slickensided clay uncovered at the City of Fargo, North Dakota landfill during excavations for new waste cell construction. The Brenna Formation was formally named and described by Harris et al. (1974) and is recognized at depth

throughout the near surface throughout the Red River Valley and has been well discussed by Schwert (1997, 2003) (Image by Schwert)

The sediments that underlie the Fargo area consist dominantly of glacial lake silts, sands, and clays (and gradational combinations of each) that reach depths of up to 46 m below the land surface (bls). The Red River of the North incises this relatively featureless plain and periodically delivers a healthy amount of overbank fines to the area during seasonal flooding events (Fig. 4a, b). Sediments underlying the Fargo area that are arguably of greatest concern consist of glaciolacustrine silts, clays, and silty clays of the Sherack and Brenna Formations (Harris et al. 1974). In the Fargo area these sediments are generally found to depths slightly greater than 31 m. The generalized stratigraphy of these units (Fig. 5) is somewhat regular with 6 m of yellow-brown laminated silty clays of the Sherack Formation (Fig. 6) underlain by approximately 24 m of gray, fat clays of the Brenna Formation (Fig. 7) (Schwert 2003). Sandwiched between

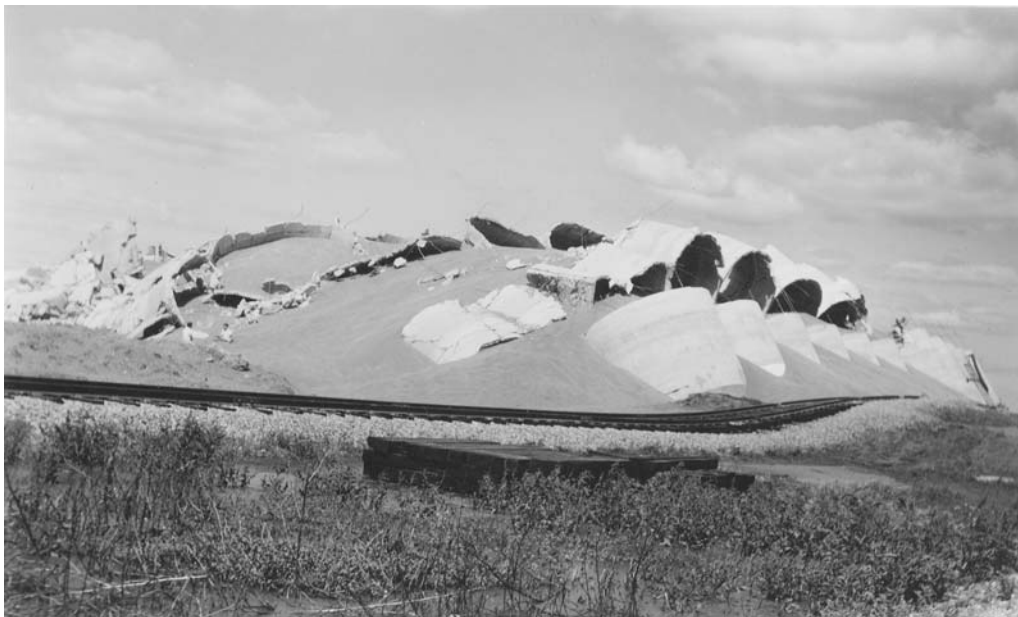
Fig. 8 View of the collapsed Fargo Grain Elevator after subsurface soil failure in 1955. (Image from the Institute for Regional Studies, North Dakota State University, Fargo, North Dakota)

struction, use, and subsequent failure of the Fargo grain elevator in 1955 (Fig. 8), soils beneath the structure deform in response to the increased load upon them, resulting in an adverse structural effect. Upon removal of the load, these materials restore to their previous condition.

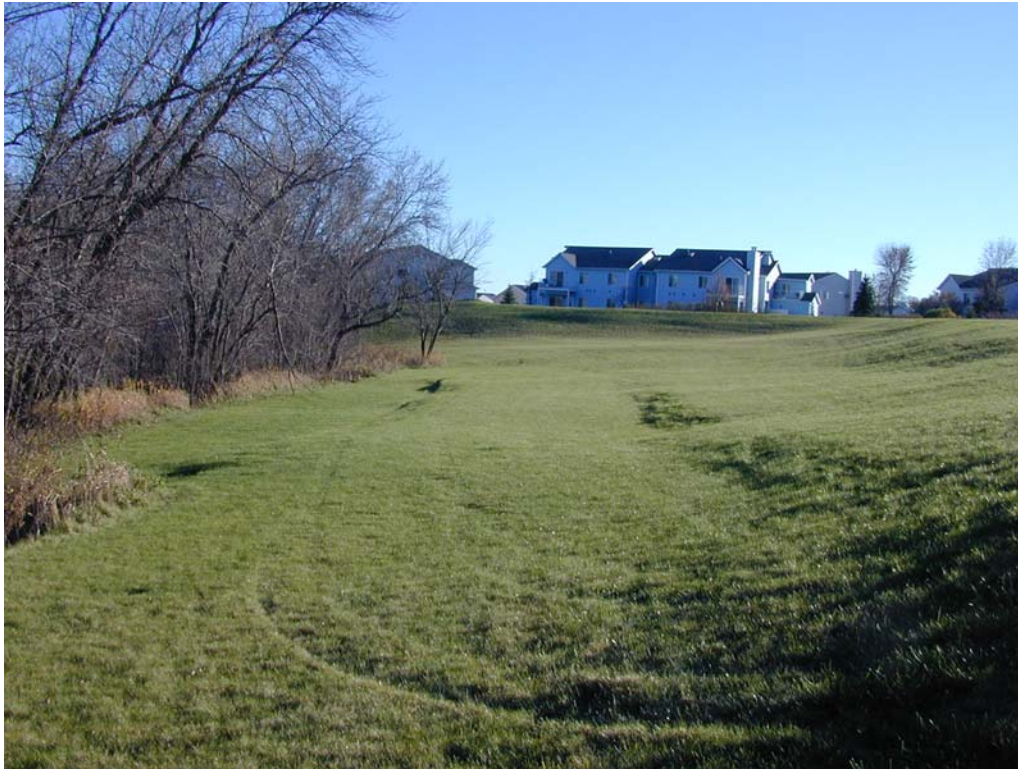
Fig. 9 View to the south along the eastern bank of the Red River depicting earthflow, soil slumping, and bank failure near residential developments in north Fargo. Note the subvertical orientation of trees and presence of developing scarps in the foreground

Failures of materials within cutbank meanders along the banks of the Red River are persistent and common and are related to the inherent instability of underlying Brenna Formation sediments which undergo plastic deformation in the subsurface with the resultant block failure of overlying Sherack and recent alluvial sediments and repeated seasonal flooding (Figs. 9, 10).

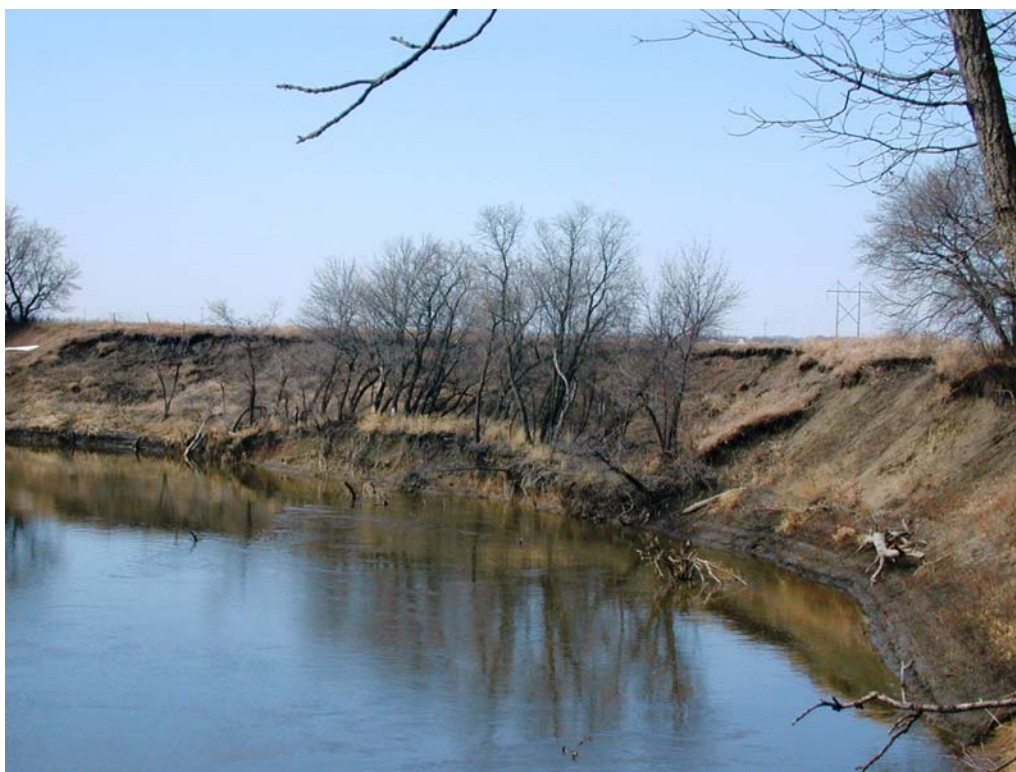
Fig. 10 View to the southwest of failed cutbank along a meander of the Red River north of Fargo, North Dakota. Note the presence of a well defined failure scarp and coherent vegetated slump block

with subvertically orientated trees. Portions of the upper Sherack Formation are visible along the cutbank
