## Keyer I/F & AK4951 v2.0.1 PCB Errata

17th Aug, 2017  
ji1udd

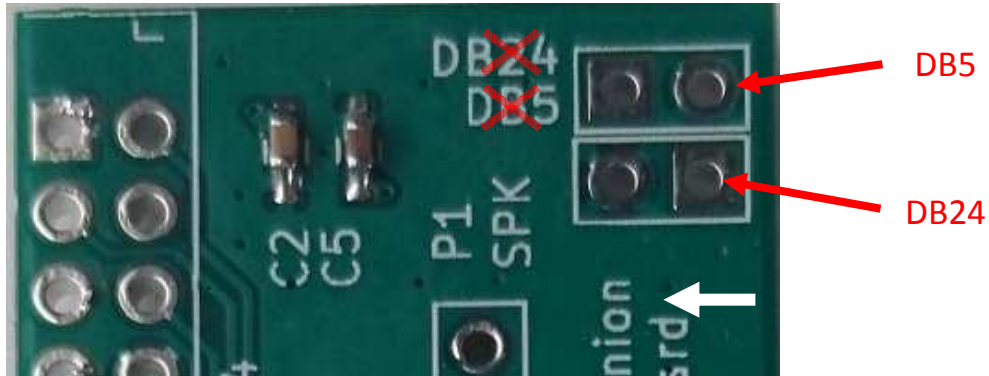
### 1) Wrong Silk

The silks of DB5 and DB24 are swapped

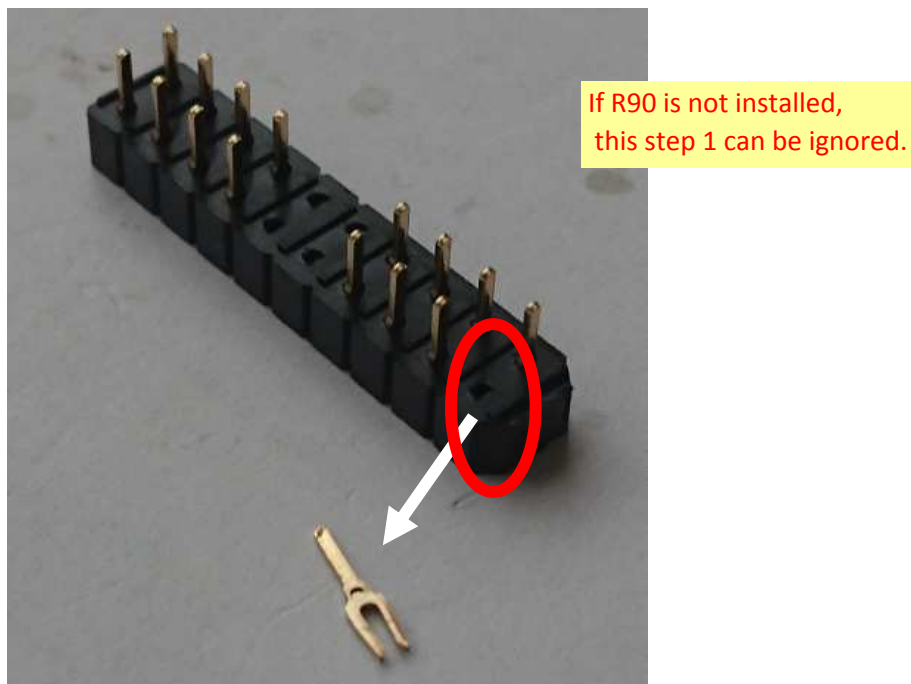
FPGA Pin89 (CN5-7) cannot be assigned as Output port.

FPGA Pin76 (DB24-1) is connected to AK4951 Pin11(SDTI) instead.

Step1. Pull CN5-7 contact pin out.
