Maintain a copy of this form and any documentation provided with the insurance policy

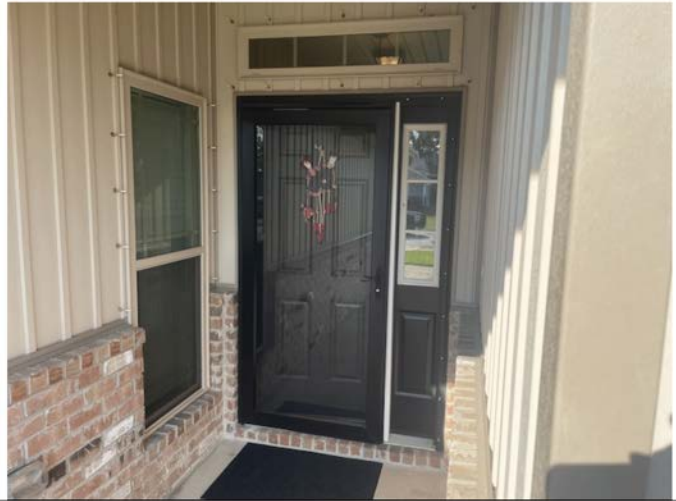
Opening Protection Level Chart		Glazed Openings				Non-Glazed Openings	
		Windows or Entry Doors	Garage Doors	Skylights	Glass Block	Entry Doors	Garage Doors
N/A	Not Applicable- there are no openings of this type on the structure		X	X	X	X	
A	Verified cyclic pressure & large missile (9-lb for windows doors/4.5 lb for skylights)	X					X
B	Verified cyclic pressure & large missile (4-8 lb for windows doors/2 lb for skylights)						
C	Verified plywood/OSB meeting Table 1609.1.2 of the FBC 2007						
D	Verified Non-Glazed Entry or Garage doors indicating compliance with ASTM E 330, ANSI/DASMA 108, or PA/TAS 202 for wind pressure resistance						
N	Opening Protection products that appear to be A or B but are not verified						
	Other protective coverings that cannot be identified as A, B, or C						
X	No Windborne Debris Protection

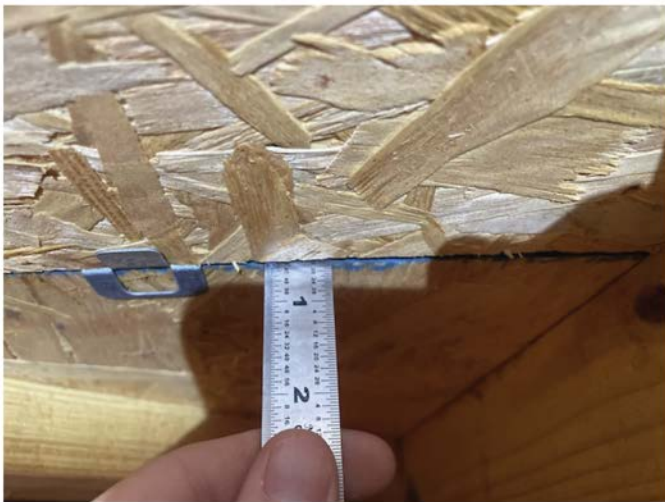
- ☐ B. Plywood/OSB roof sheathing with a minimum thickness of 7/16" inch attached to the roof truss/rafter (spaced a maximum of 24" inches o.c.) by 8d common nails spaced a maximum of 12" inches in the field. -OR- Any system of screws, nails, adhesives, other deck fastening system or truss/rafter spacing that is shown to have an equivalent or greater resistance 8d nails spaced a maximum of 12 inches in the field or has a mean uplift resistance of at least 103 psf.

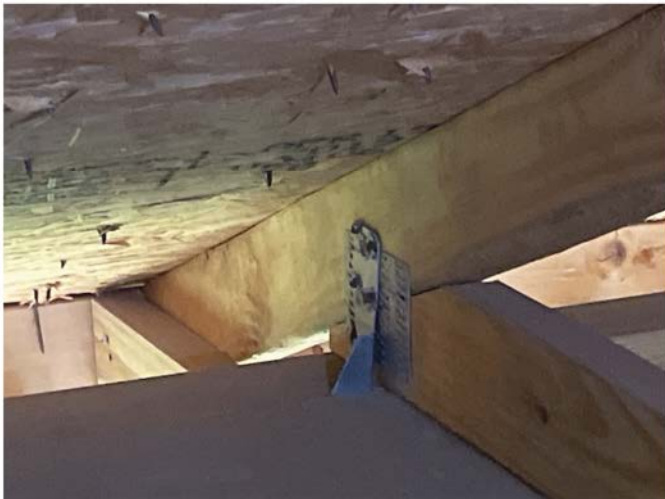
- ☒ Secured to truss/rafter with a minimum of three (3) nails, **and**
- ☒ Attached to the wall top plate of the wall framing, or embedded in the bond beam, with less than a 1/2" gap from the blocking or truss/rafter **and** blocked no more than 1.5" of the truss/rafter, and free of visible severe corrosion.

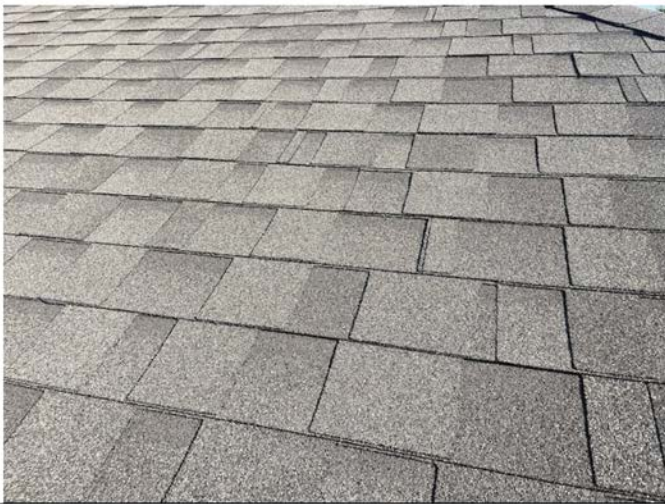
2. **Roof Covering:** Select all roof covering types in use. Provide the permit application date OR FBC/MDC Product Approval number OR Year of Original Installation/Replacement OR indicate that no information was available to verify compliance for each roof covering identified.
