TRA Trial Site Performance Report

Frauscher FAdC Axle Counters/RCS Level Crossing System

Dacun, Changhua

Version: 1.0
Date: 22 June 2018

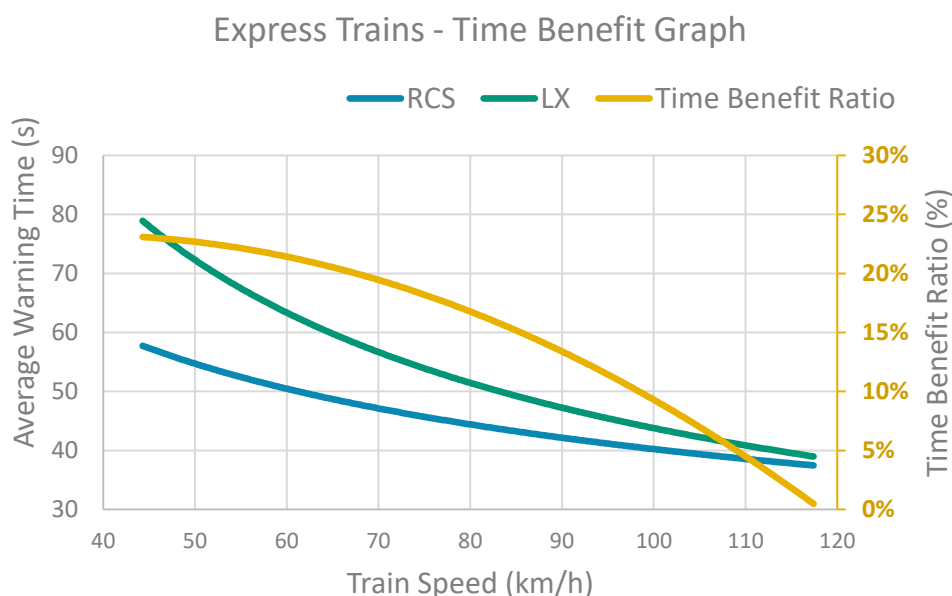
Figure 9 - Express Trains - Time Benefit Graph

Figure 9 shows the warning time and time benefit ratio of the RCS Level Crossing System when considered for express trains of various speeds. This shows that the RCS Level Crossing system performed better than the existing level crossing system for all express trains that travelled less than the line speed.

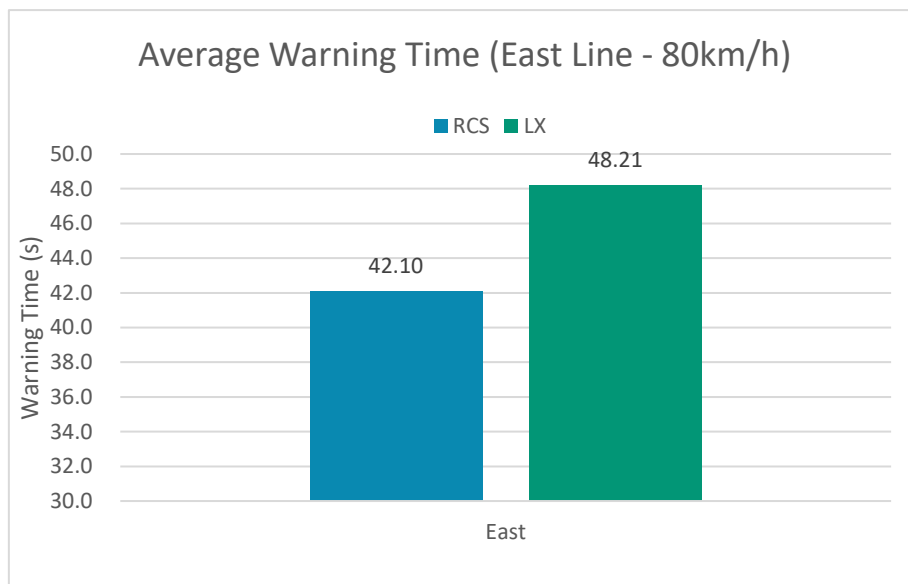
Figure 10 - Average Warning Time for The East Line Prior to the Speed Restriction Removal (i.e. 80km/h speed restriction)

Figure 10 and Figure 11 below show the performance on the East line prior to and after the 80km/h speed restriction on the down side of the crossing was increased to 100km/h, respectively. This shows that the RCS Level Crossing system was able to provide a consistent warning time for 80km/h and 100km/h speed trains, whereas the existing level crossing provided an undesirable increased warning time while the 80km/h speed restriction was active, and in all circumstances the RCS Level Crossing system performed significantly better than the existing level crossing system.

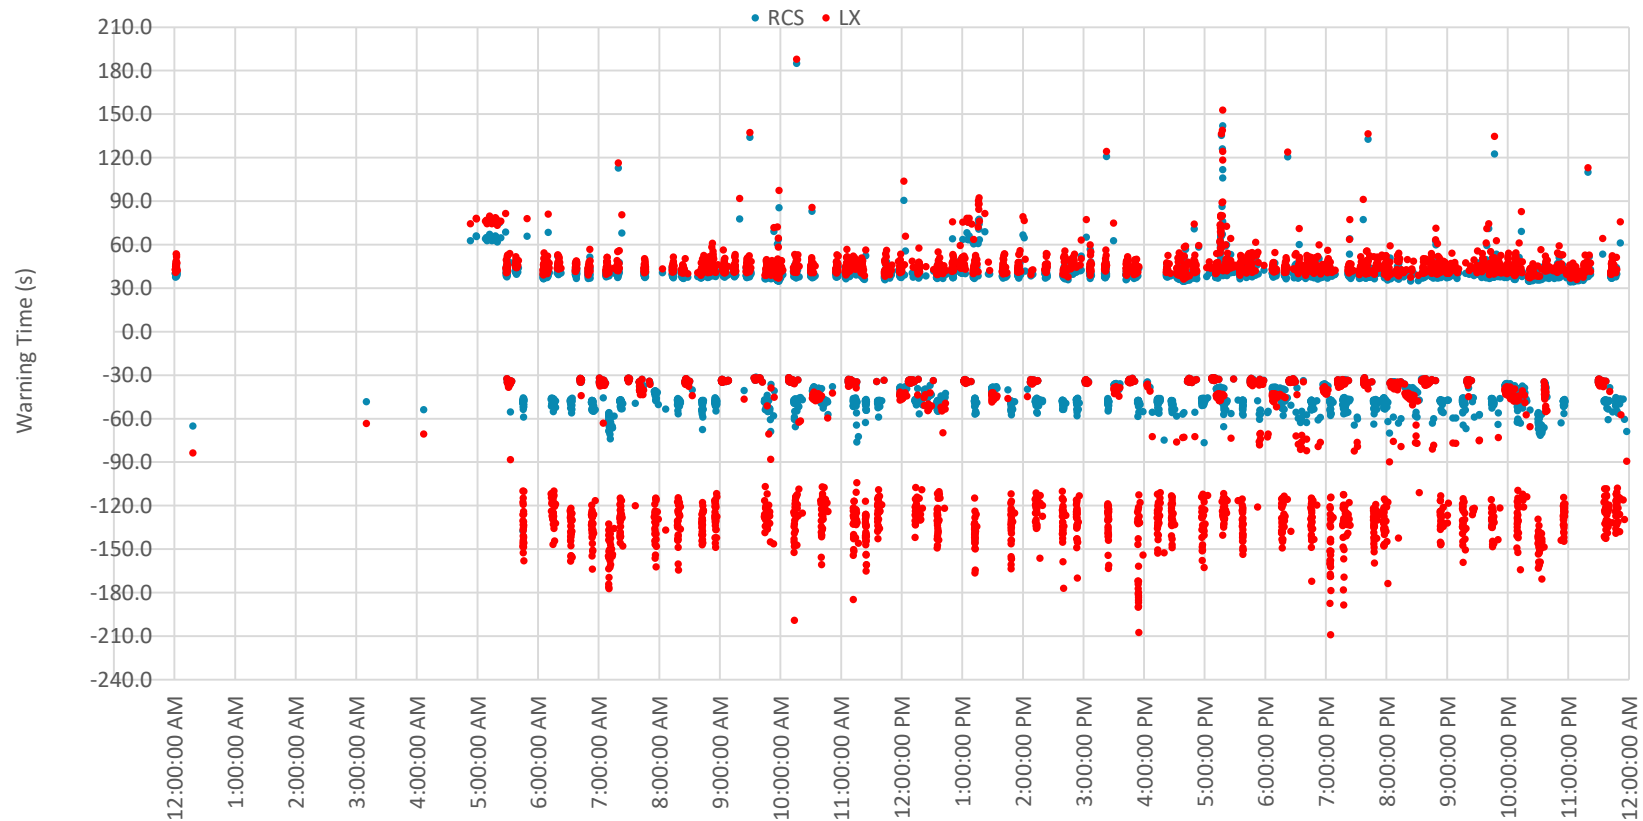
Figure 13 - Warning Times for Each Train

Figure 13 shows the Warning Times for each train during the trial period plotted against the time of day. This helps to show how same timetabled train services performed across different days, and how the speed proving of the Frauscher/RCS Level Crossing system performed against the existing level crossing. It shows East line trains warning times as positive values, and West line trains as negative values. This graph clearly shows the difference in performance between the Frauscher/RCS Level Crossing system and a non-speed proving level crossing system. The stopping trains on the West line showed the biggest performance increase - typically providing at least a 60 second reduction in warning time.

Warning Times for Time of Day (East times shown as +ve and West -ve)
