PRE-STRESSED CONCRETE CYLINDER PIPE

PCCP CASE STUDY

MIDDLESEX COUNTY UTILITIES AUTHORITY

FORCE MAIN RUPTURE

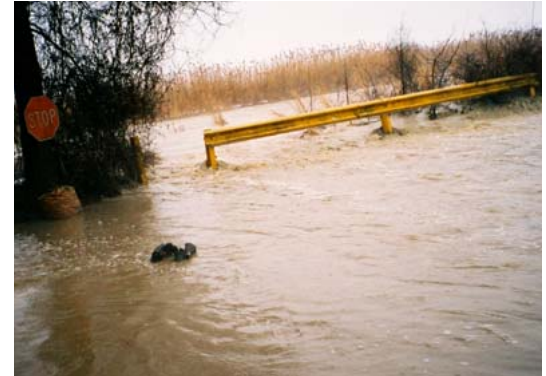
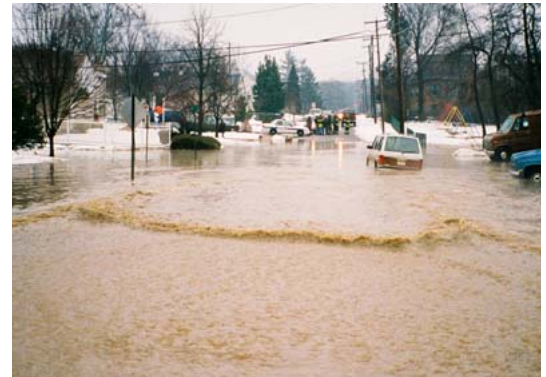
2

- Rupture occurs at 9:37 a.m.
- Sewage flows onto Boehmhurst and 6th Avenues.
- Site secured by Sayreville Police and Office of Emergency Service (OEM).
- MCUA and Borough of Sayreville respond with the County Board of Health and NJDEP by implementing remedial measures to assure the safety of residents and roadway. A berm is created by the Borough to divert water away from the residential areas.
- MCUA hires dewatering company to assist with sewage pumping at break site.
- Sayreville Fire Dept. washes down streets, driveways, and residents' homes affected by the sewage overflow.
- OEM informs residents of the Force Main Rupture.
- MCUA switches sewage flow to a backup line to stop the flow from the damaged pipe and to limit the amount of untreated sewage entering the Raritan River.
- Sewage plant loses an average of 4.5 million gallons/hour of sewage within the first 24 hours.

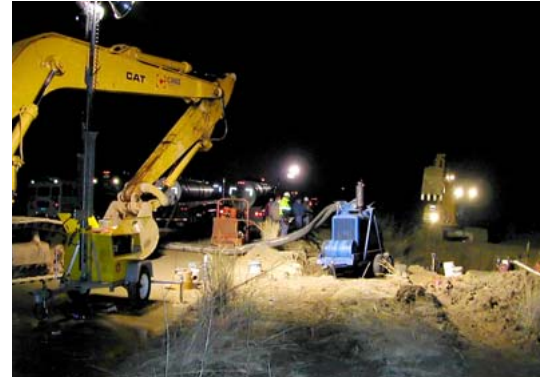
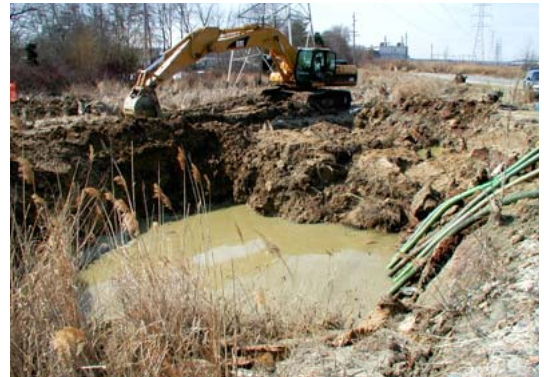
- 24-hour pumping begins at break site, using tanker trucks to transport 100,000 gallons/hour of sewage to the MCUA Central Treatment Plant in Sayreville, NJ.
- MCUA and County Health Dept. hand-delivered a letter to the residents impacted.
- MCUA spread lime pellets on lawns and a small public park affected by the overflow; neighbors are contacted and told who to contact with problems.
- MCUA contains sewage leak at break site; NJDEP orders shellfish beds in Raritan Bay closed until testing can be completed.
- Sewage bypass estimated at 3 million gallons/hr.
- Backup system working at full capacity due to melting snow and rainfall. Treats average of 100-110 million gallons/hour.
- Contracted Construction Company mobilized at the break site to assess ruptured pipe for repair.

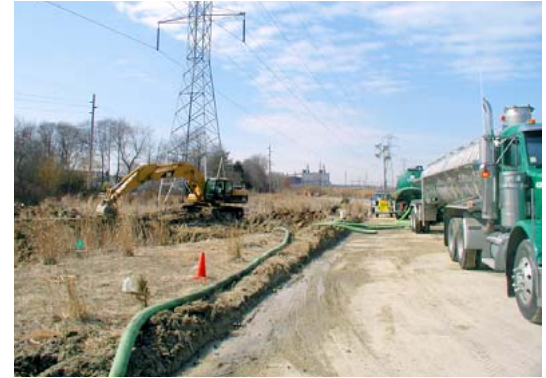
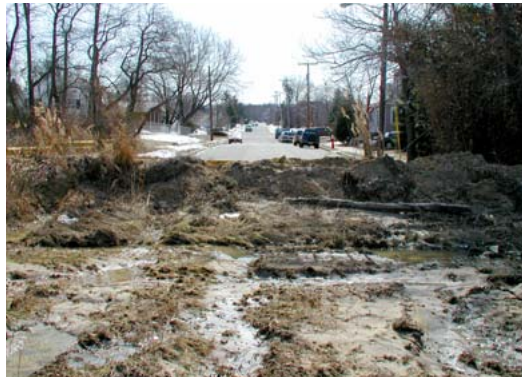
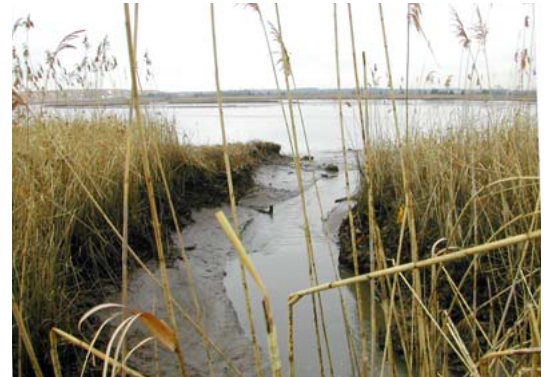
4

- Sewage between shutoff valves and break point continue to be trucked to treatment plant.
- MCUA and NJDEP call on residents and businesses within the service area to conserve water in order to reduce the strain on sewerage system.
- Engineering firm hired to sample various sites along the Raritan River to monitor impacts.
- Backup system continuing but still bypassed an average of 1.9 to 3.3 million gallons/hour.

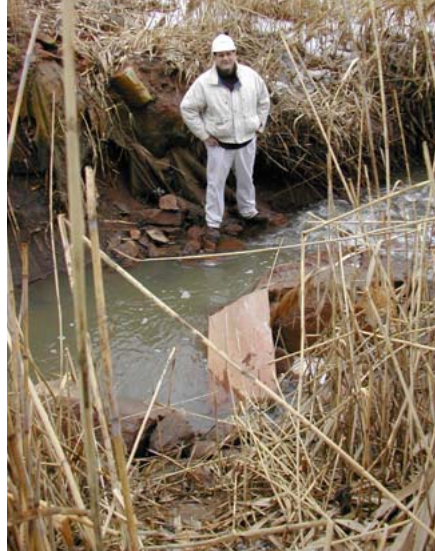
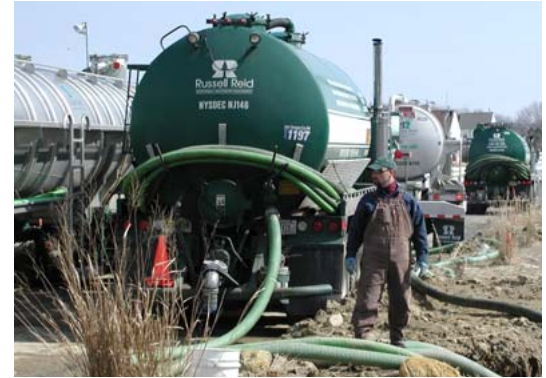
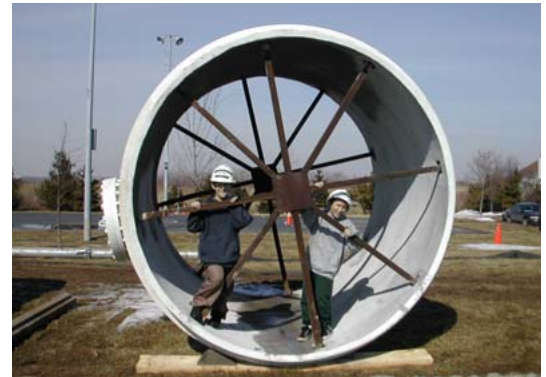
5

- MCUA Representatives met with NJDEP, County Board of Health and Borough Officials.
- Dewatering, truck transport and work by MCUA engineers continue in effort to reach pipeline break.
- Bypassing ceased briefly during the 6:00 a.m. hour.
- PCCP repair section delivered to site

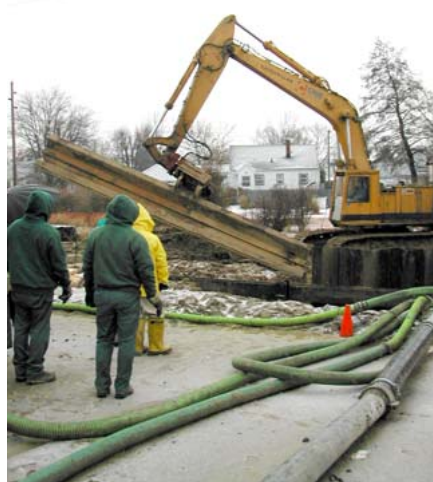
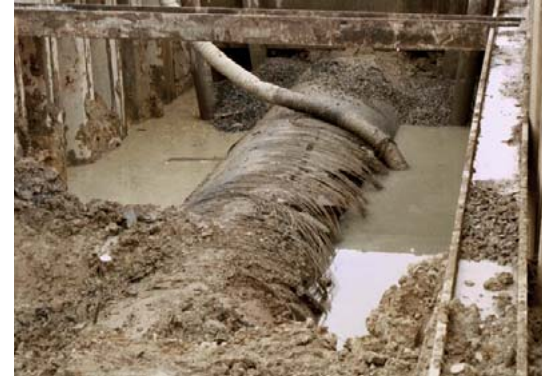
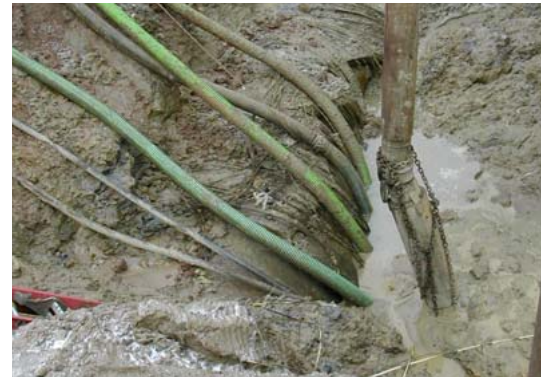
6

- Direct access to damage in pipe section is achieved, allowing repair planning to begin.
- Meeting with construction contractor to assess repair schedules depending on different damage scenarios.
- Contractor places steel sheeting around affected area of pipe.
- Raritan River and pump station sampling continue.
- Work continues on a 24-hour basis.
- Bypass sewage estimated at 335 million gallons.
- Average hourly bypass sewage rate varies between 2.7 to 5.7 million gallons/hr.

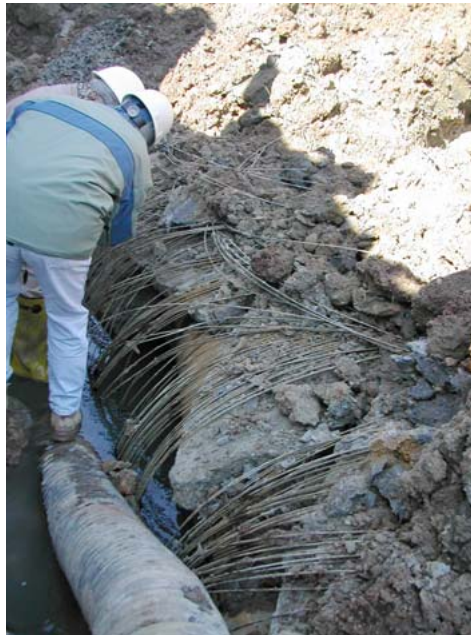
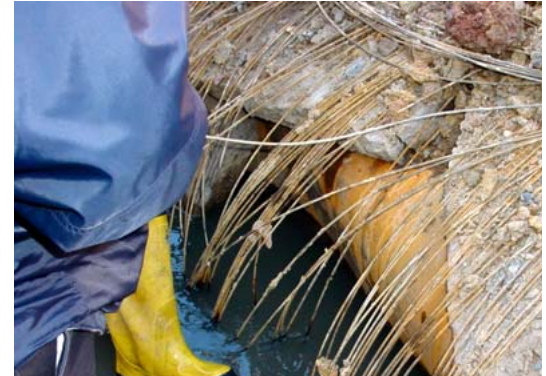
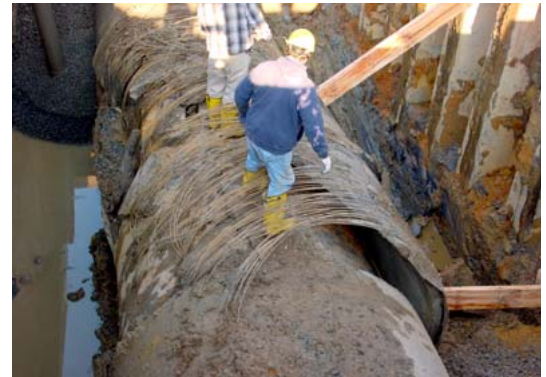
7

- Engineering firm hired to conduct soil samples of affected neighborhood.
- Work continues on a 24 hour basis.
- Bypass sewage estimate at 400 million gallons.
- Average hourly bypass sewage rate varies between 0.8 to 2.0 million gallons/hr.

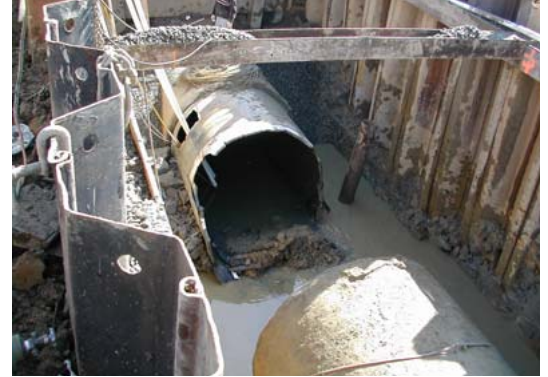
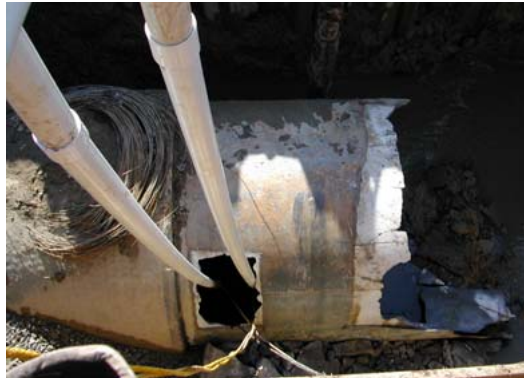
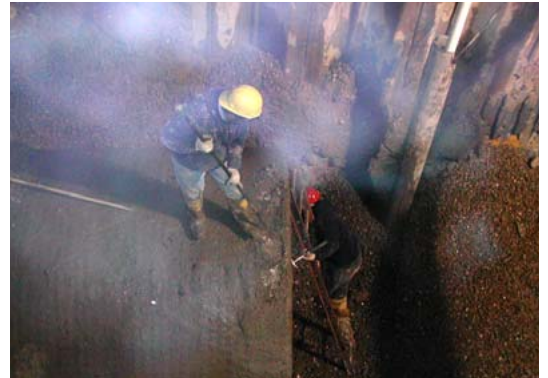
8

- Damaged pipe is removed and inspection process begins at break site.
- Sayreville pump station sampling continues throughout weekend.
- Bypass sewage at the Sayreville Pumping Station estimated at 440 million gallons.
- Average hourly bypass sewage rate varies between 1.6 to 3.0 million gallons/hr.

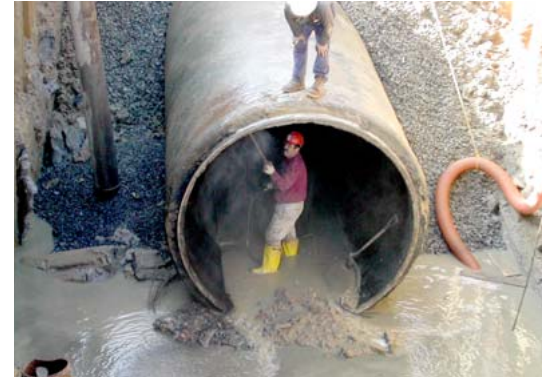
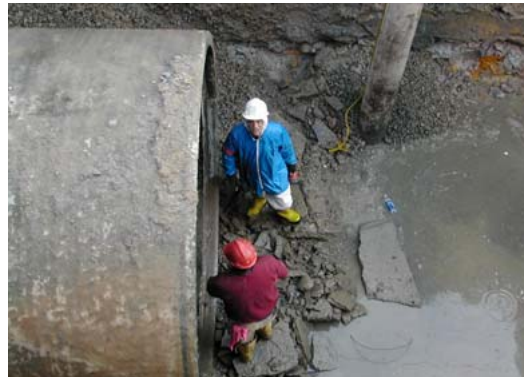
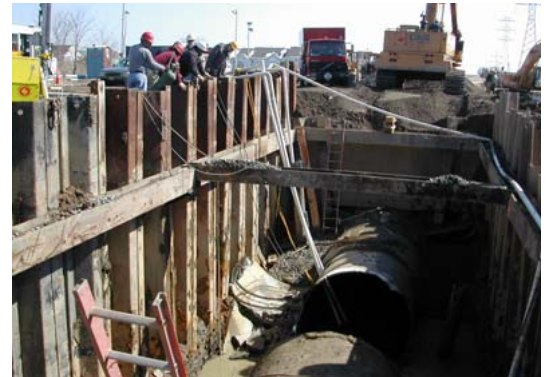
9

- Break at pipeline isolated to one section. Approval given to go forward with repair, replacement pipe section brought in and welding begins.
- Bypass sewage at the Sayreville Pumping Station estimated at 495 million gallons.
- Average hourly bypass sewage rate varies between 1.3 to 3.0 million gallons/hr.

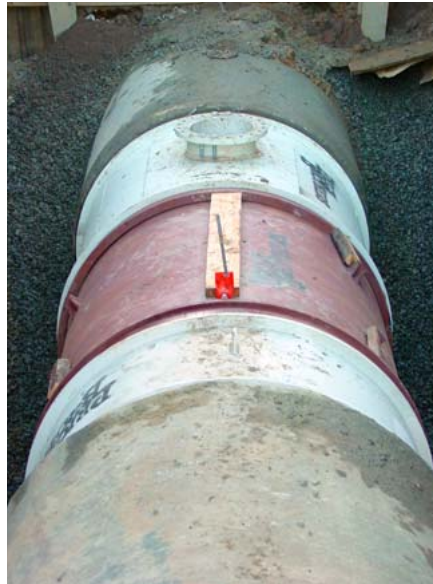
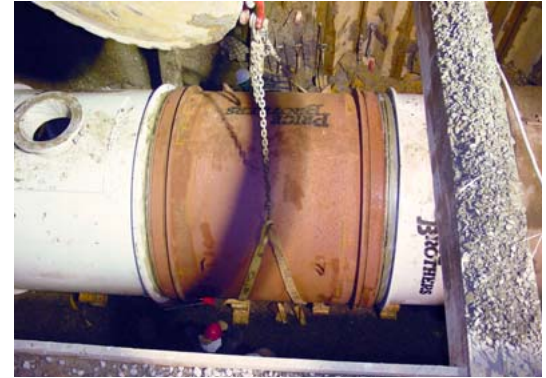
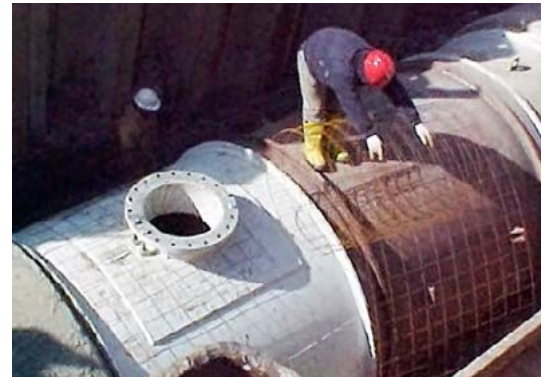
10

- Repair completed at break site.
- 102-inch pipe filling commences and backfilling of excavation begins.
- Sayreville 8" sewer line section replaced.
- Representatives of the MCUA attended the Sayreville Council Meeting and answered questions from residents and the governing body.
- Bypass sewage at the Sayreville Pumping Station estimated at 541 million gallons.
- Average hourly bypass sewage rate varies between 1.6 to 3.0 million gallons/hr.

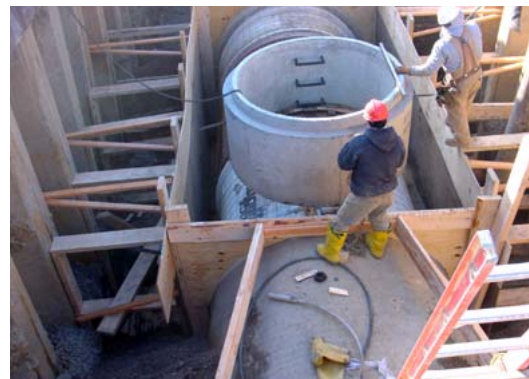
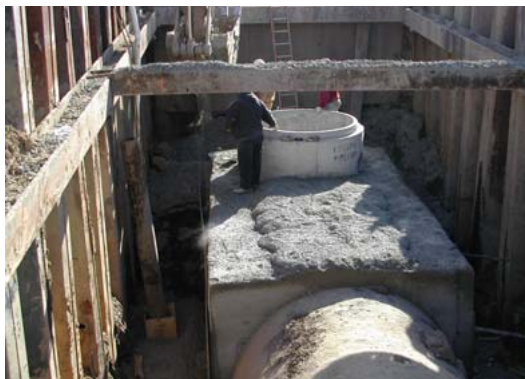
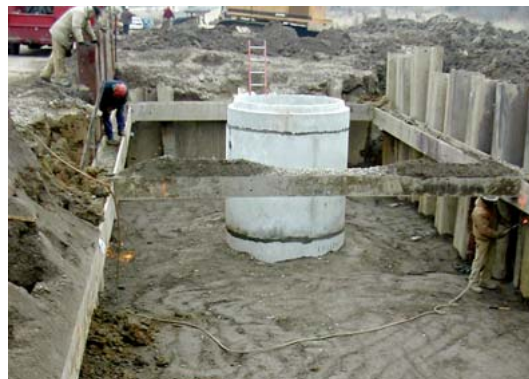
11

- At 2:18 p.m. the 102-inch Force Main was placed back into full service eliminating the bypass. All sewage is treated at the Sayreville MCUA Wastewater Treatment Plant.
- Backfilling and grading of site continues.
- From the beginning of the break to today, the total amount of bypass sewage at the Sayreville Pumping Station was estimated at 570 million gallons.

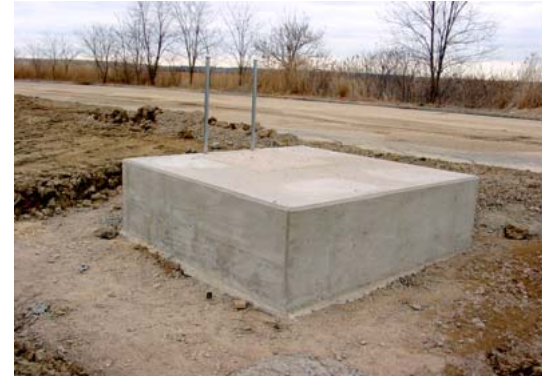
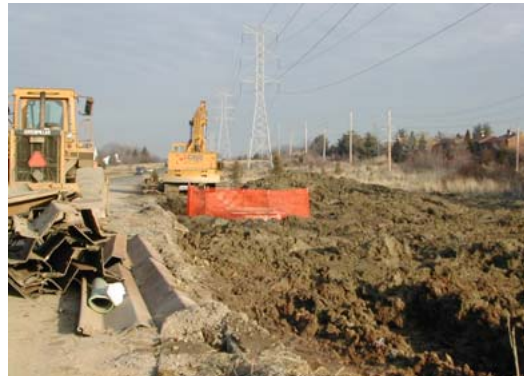
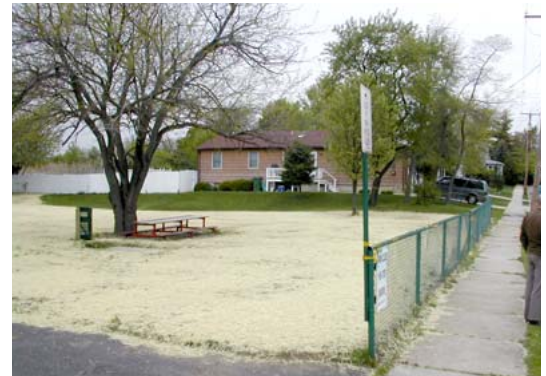
12-13

- Backfilling, excavation, and removal of sheeting continue.

- Backfilling completed. Site graded with seeding to be performed during the spring months.
- Utilization of both the 72" pipeline and the repaired 102" pipeline is required to contain sewage and only treated sewage from the wastewater treatment plant is discharged to the Raritan River/Bay.

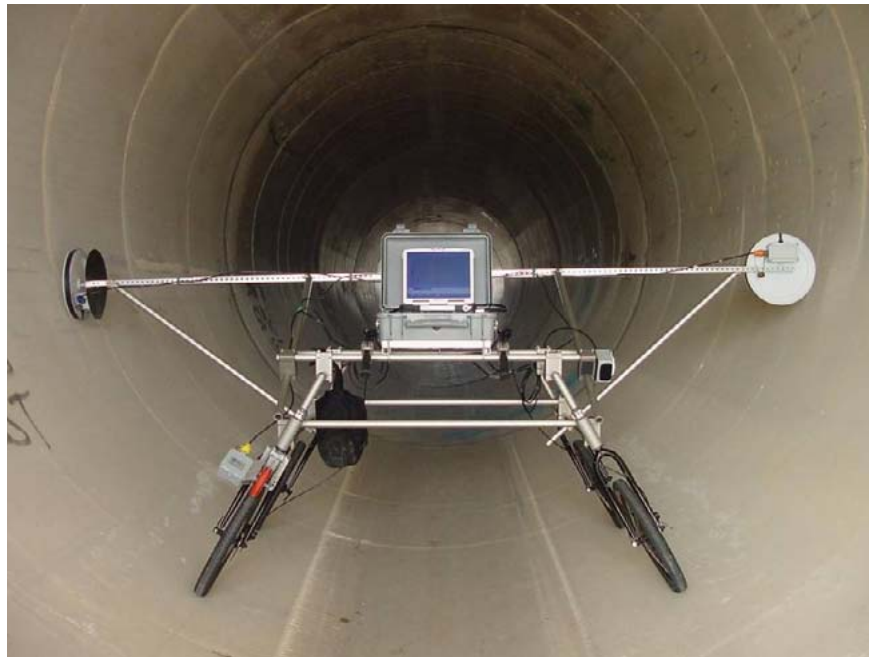
P-Wave™, an electromagnetic pipeline inspection technique that provides baseline information on the axial location and number of wire breaks on individual prestressed pipe sections.

- ▶ P-Wave results provided “baseline” of current condition of individual pipe lengths.
- ▶ 18,000 ft. of pipe surveyed in 2-day period.
- ▶ Indicative report issued within 10 days.
- ▶ Final report incorporated updated stationing information from visual inspection team.
- ▶ Electromagnetic information provided critical first “layer” of information for the ongoing management system employed on the line.
