Utah Water Research Laboratory
UtahStateUniversity

Water Main Break Rates in the USA and Canada: A Comprehensive Study

A Resource to Support Asset Management,
Pipeline Renewal, and Replacement

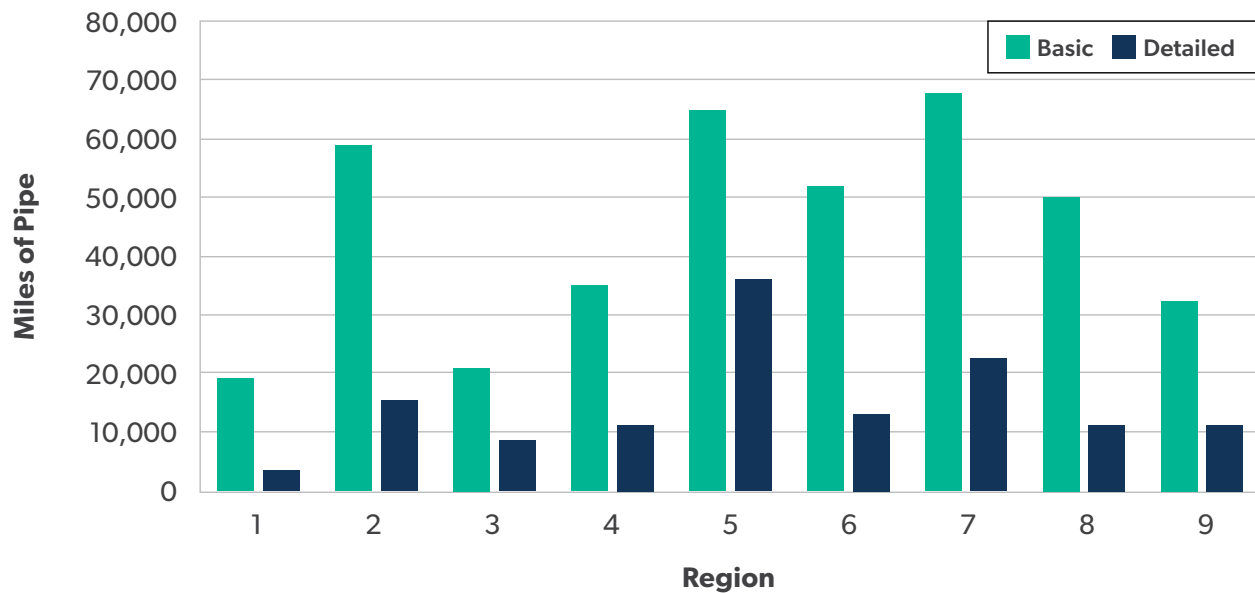
FIGURE 4: MILES OF PIPE FROM EACH REGION FOR THE BASIC AND DETAILED SURVEYS

As illustrated in Figure 4, Regions 5 and 7 reported the most miles of pipe from the basic survey. Figure 5 shows that the greatest number of respondents came from Region 6. Figure 6 shows the average miles of pipe per utility from the basic survey by region. Region 5 had the highest average pipe length at 783 miles and Region 3 had the lowest with 256 miles. The average miles of pipe represented per utility respondent is 505 miles (Figure 6) serving an average population of 146,432 (Figure 7). For comparison, the 2012 and 2018 surveys reported an average utility had 626 and 607 miles of pipe serving 164,325 and 186,752 people, respectively. The decrease in both average miles of pipe per utility and average population serviced seems to indicate a greater participation from smaller utilities for this study. The 2023 basic survey had 2.8 times more respondents and 2.34 times more miles of pipe than in 2018, increasing the statistical validity of this study.

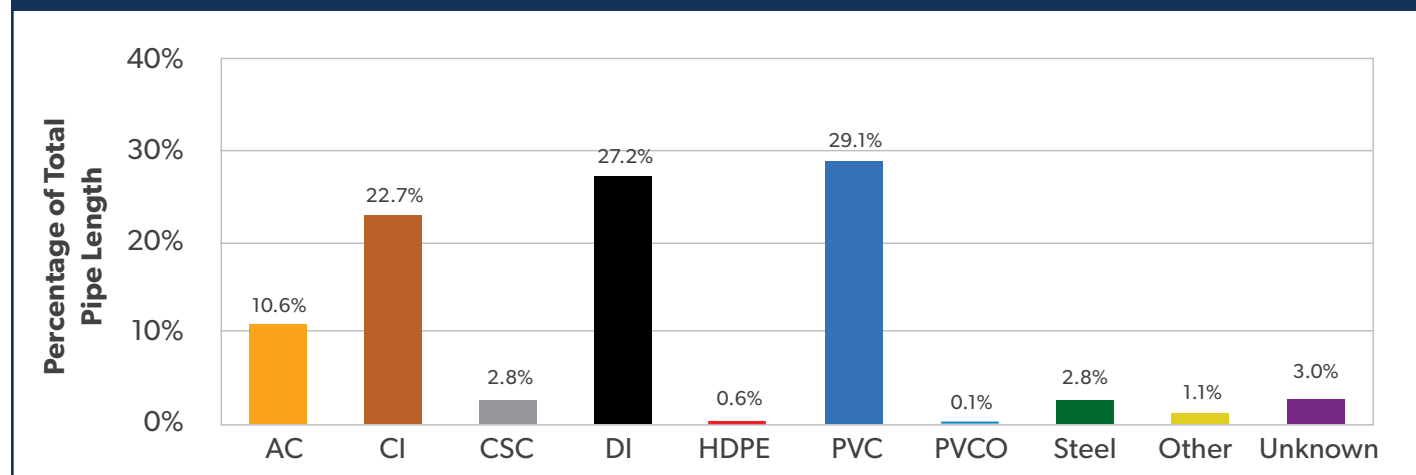
FIGURE 13: PERCENTAGE OF PIPE LENGTH BY MATERIAL TYPES (BASIC SURVEY)

Figure 13 illustrates the percentage of total length of water mains by pipe material. It is significant to consider that nearly 90% of the water mains reported are made from cast iron (CI), asbestos cement (AC), ductile iron (DI), and polyvinyl chloride (PVC) materials. This is consistent with earlier USU studies (Folkman, 2012; 2018). The EPA provides a summary of the timelines of when these materials have been in use: *The majority of distribution piping installed in the United States, beginning in the late 1800's up until the late 1960's, was manufactured from cast iron... referred to today as "pit" cast iron pipe. ...In 1920, the process of centrifugally casting pipe in a sand mold was introduced... referred to as "spun" or "centrifugally" cast iron pipe (which was commonly installed until the 1970's). Asbestos cement became commercially available in the 1930's and was commonly installed during the 1950's and 1960's. Following this was the introduction of ductile iron pipe in the late 1960's. Shortly after the introduction of ductile iron, the use of ... polyvinyl chloride (PVC) ... in this country began to emerge in the 1970's (EPA, 2002).*

As shown in Figure 13, the percentages for the installed CI and AC pipe in 2023 are 22.7% and 10.6%, respectively. Figure 13 also illustrates that PVC has the highest percentage of all pipe materials at 29.1%, with DI pipe at 27.2%. As shown in Figure 14, in 2018 CI and AC pipe accounted for 28.4% and 12.7% of all pipe miles, respectively. The combined inventory for these two materials in 2018 was 41.1%, and 33.3% in 2023. This represents a decrease of 7.8%. During the same 5-year period, PVC pipe length increased by 7.0% and DI remained approximately the same. It is noteworthy that the reduction in CI and AC is similar to the increase in the installed length of PVC pipe.

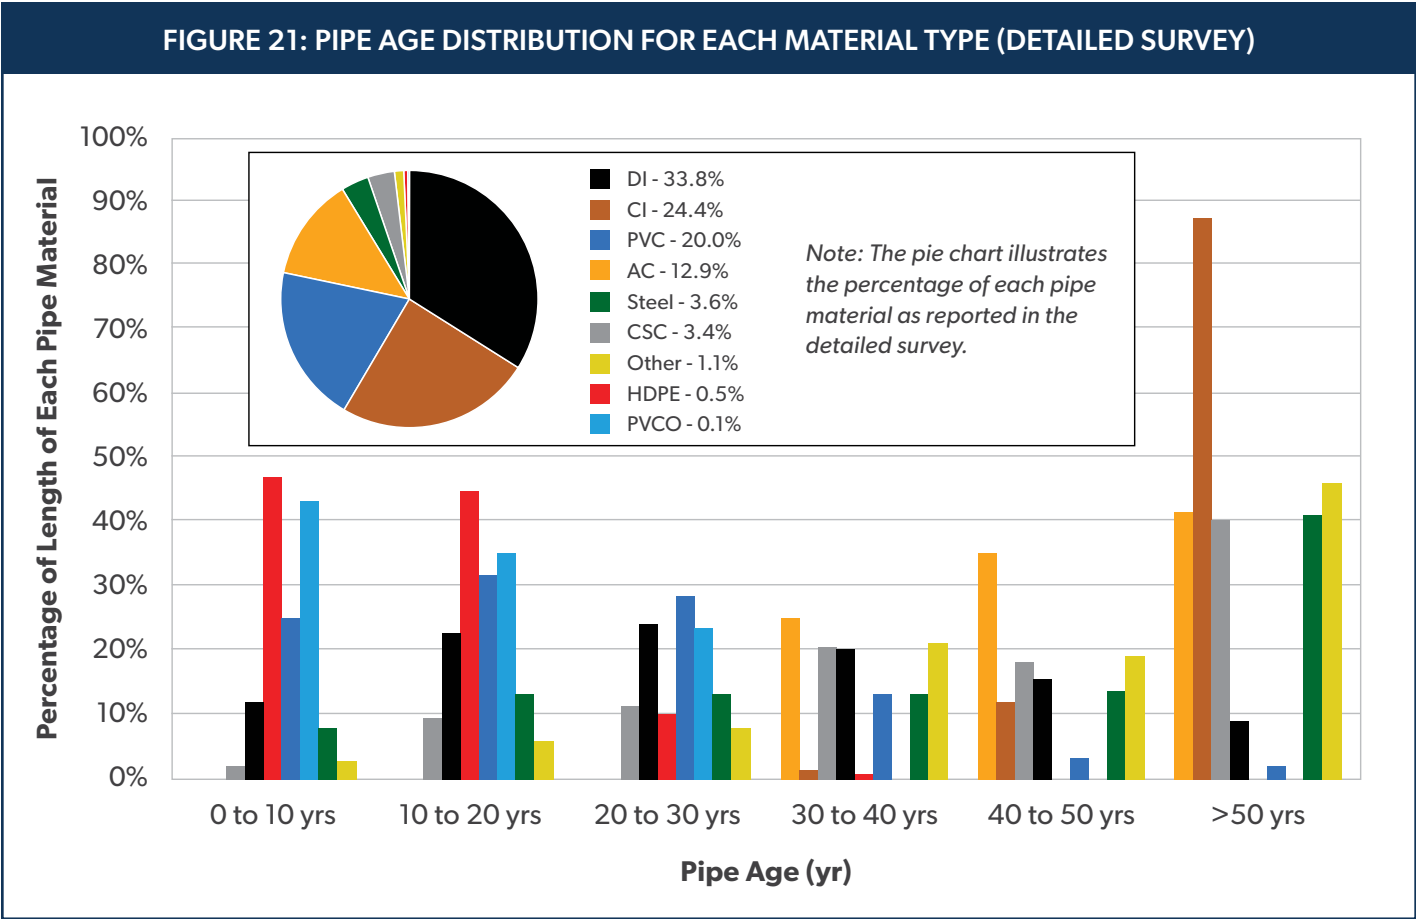
Figure 22 shows the age distribution as a percentage of the total length of all pipe materials from the detailed survey. For example, CI older than 50 years is 21% of all installed pipe. For ages between 0 to 10 years, DI and PVC both have about 4 to 5% of the total installed length. This means that the most common pipe materials installed over the last 10 years are DI and PVC.

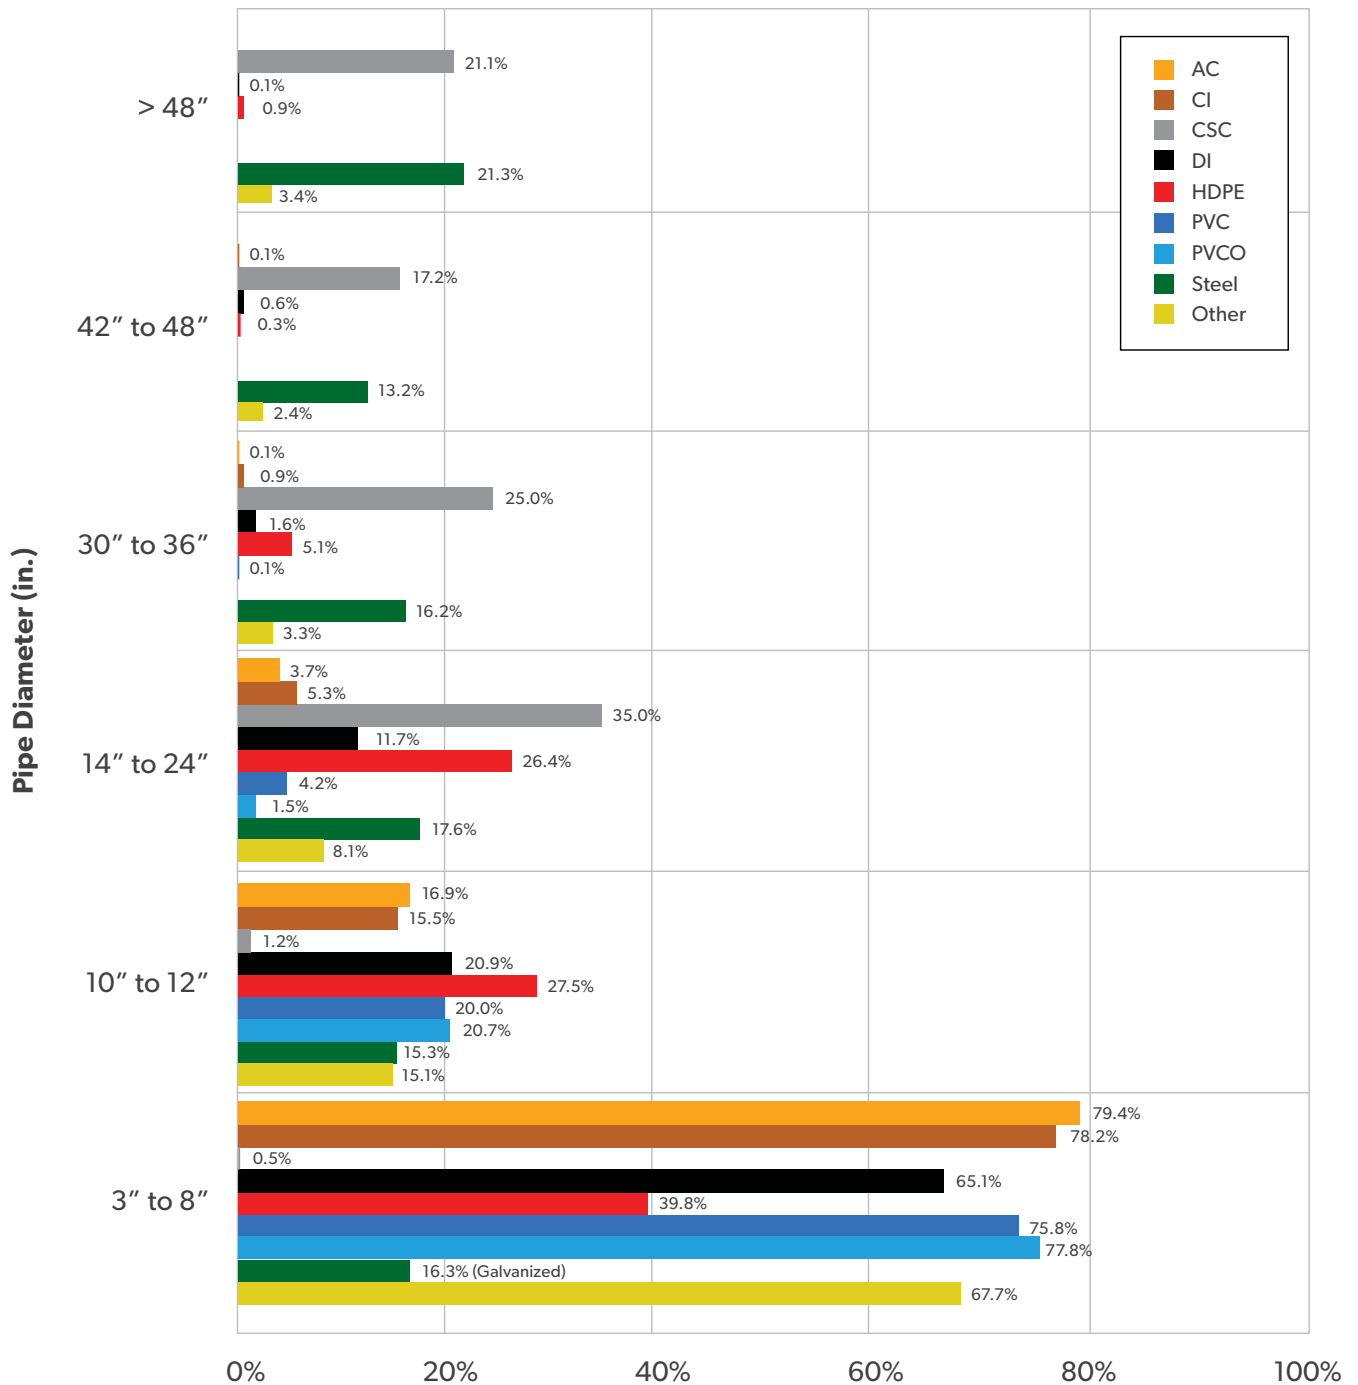
FIGURE 24: PIPE DIAMETER DISTRIBUTION BY MATERIAL TYPE (DETAILED SURVEY)

Figure 24 illustrates the diameter distribution for each material type as reported from the detailed survey. The figure shows that most large diameter pipes (14-inch and larger) are predominantly steel and CSC, with each material having more than 21% of their length in sizes larger than 48-inch. More than 98% of the CSC pipe was in sizes 14-inch and larger. The figure also shows that over 75% of all AC, CI, PVC and PVCO pipe, respectively, is 8-inch or smaller.

Adding up all values for a given material equals 100%.

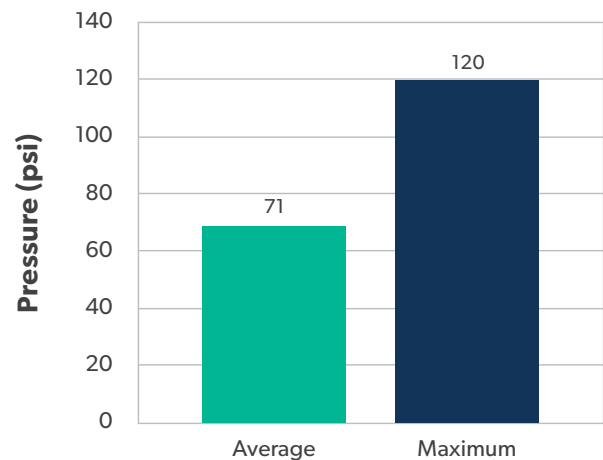
FIGURE 26: AVERAGE AND MAXIMUM WATER SUPPLY PRESSURES (BASIC SURVEY)

The basic survey asked for the average and maximum water supply pressures. As shown in Figure 26, the mean average and maximum water supply pressures are 71 and 120 psi, respectively. In the 2018 survey, the mean and maximum pressures were 69 and 119 psi, respectively, which is consistent with this survey result.

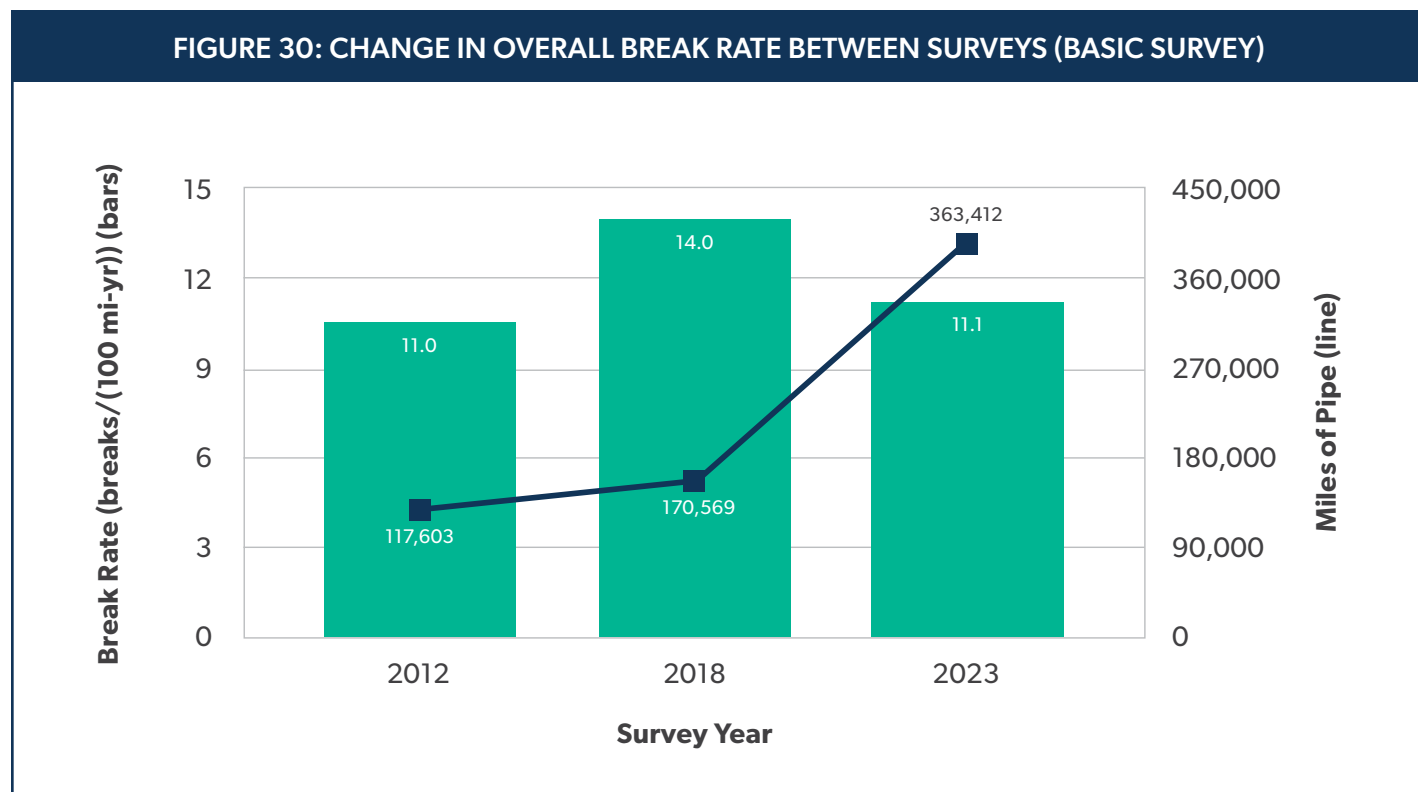
Figure 30 illustrates the overall reported break rates from this survey and the two previous reports (Folkman, 2012; 2018). It is apparent from the figure that the current survey represents a significant number of pipe miles. Even with this large sample size, the overall break rates are relatively consistent with only a slight reduction in failure rates in the last six years. This decrease may indicate that more utilities are applying asset management techniques and replacing pipe with the highest break frequency.

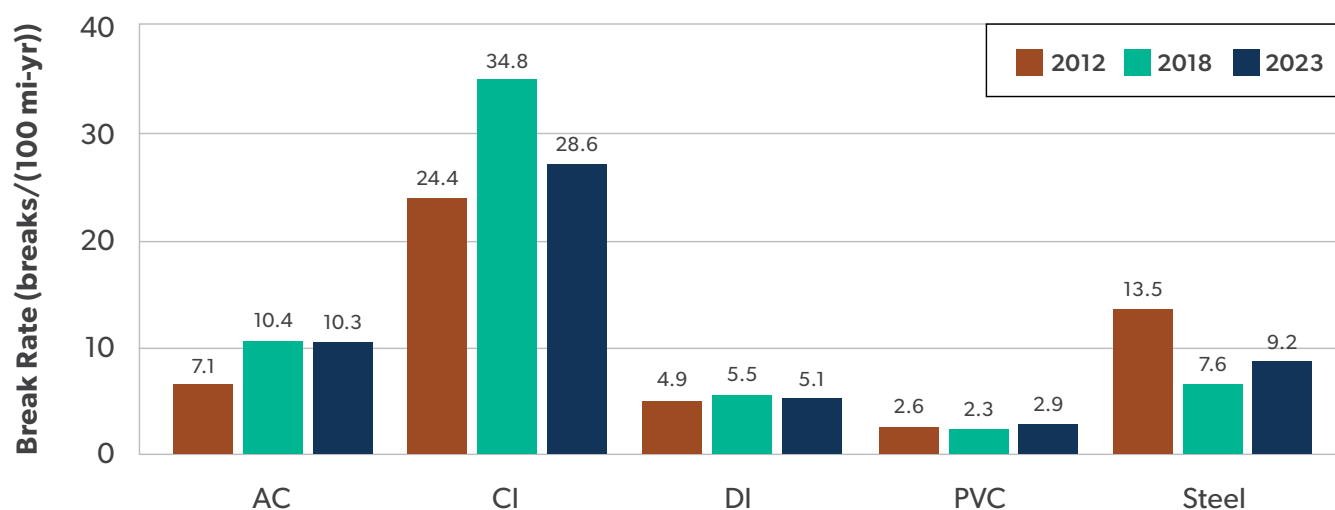
FIGURE 31: COMPARISON OF BREAK RATES FROM THE 2012, 2018, AND 2023 BASIC SURVEYS

Figure 31 compares the break rates of common water pipe materials from the 2012, 2018, and 2023 USU surveys. The consistent break rates across the three studies help to validate the accuracy of the data. Small variations can be assumed to be data scatter. Since about 90% of installed pipe consists of AC, CI, DI, and PVC, the break rates for these materials are the most accurate, which avoids inaccurate calculations for pipe materials with low reported mileage. Figure 31 shows an insignificant break rate change over time for PVC and DI pipe.

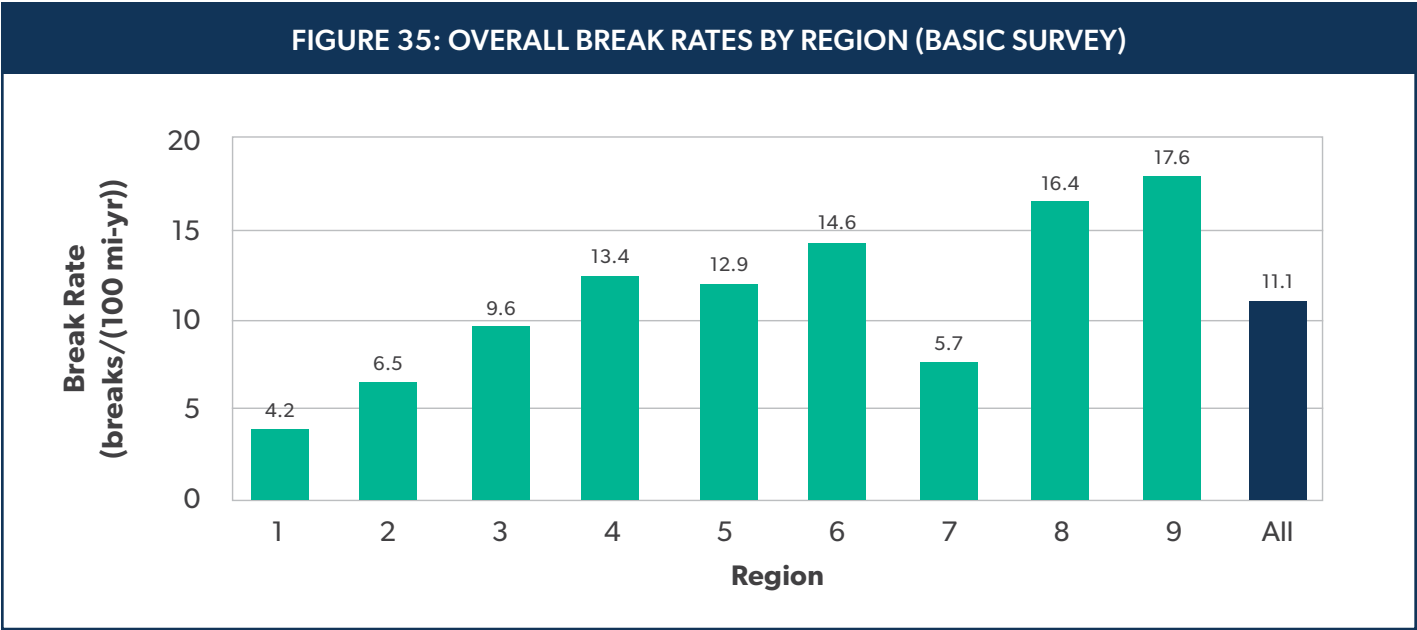
Figure 35 illustrates the reported overall break rates by region (Figure 15). In Table 1, the number of respondents for each region is summarized. Not all regions are experiencing the same failure rate. Five of the regions (4, 5, 6, 8, and 9) are above the overall average break rate.

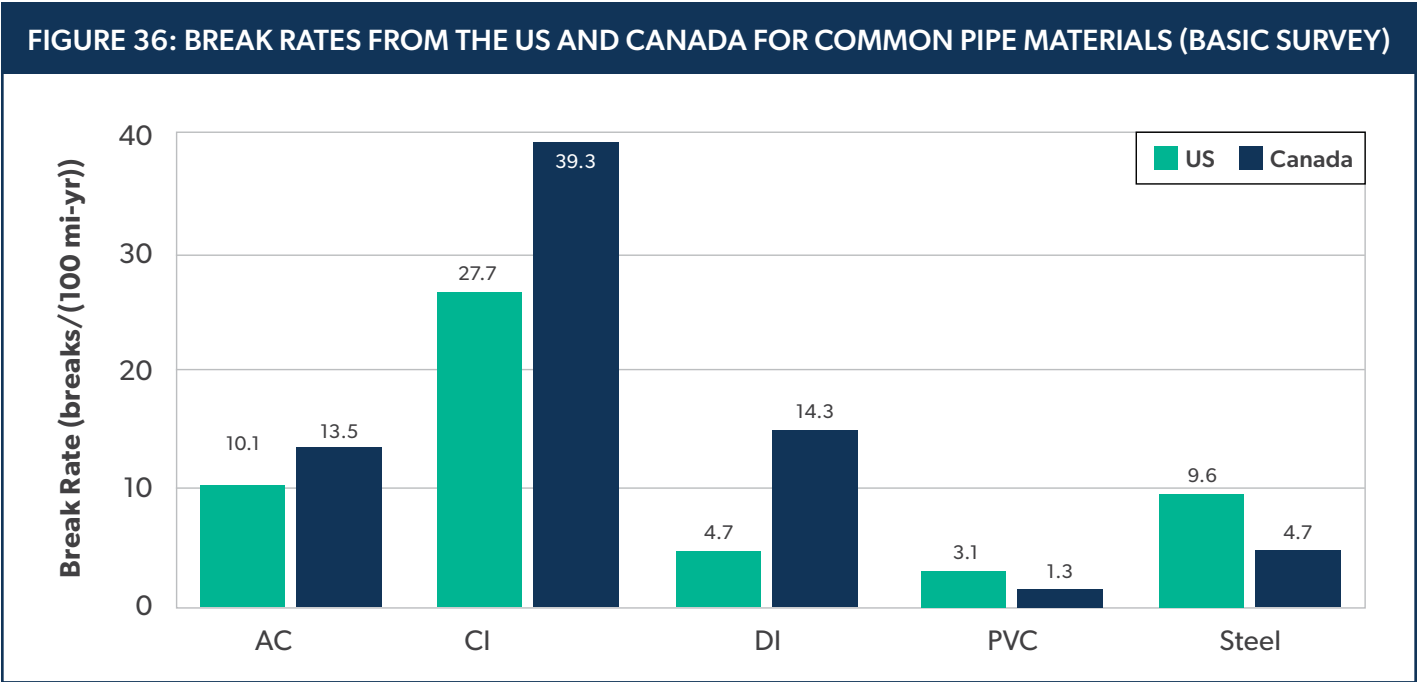
Figure 36 shows the break rates between US and Canada for the most common water pipe materials. It should be noted that portions of Canada have very corrosive soils and can have extremely cold weather. These factors could potentially explain the high Canadian break rates for CI and DI pipes (Seargeant, 2018).

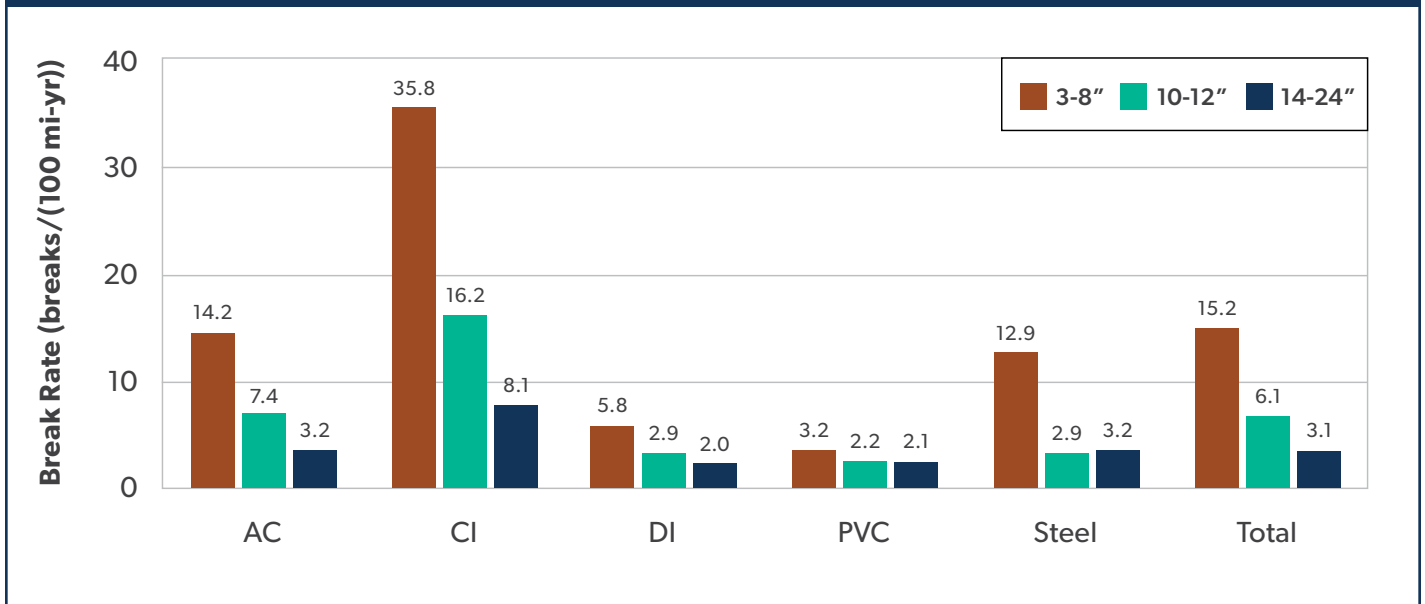
FIGURE 38: BREAK RATES FOR 3- TO 8-INCH, 10- TO 12-INCH, AND 14- TO 24-INCH PIPE BY MATERIAL (DETAILED SURVEY)

Figure 38 displays the break rates for the following size ranges: 3- to 8-inch, 10- to 12-inch, and 14- to 24-inch pipe. The objective is to focus more on the most used pipe diameters. The 14- to 24-inch sizes are commonly considered transmission mains, while 12-inch pipe and smaller is usually categorized as distribution pipe. Figure 23 indicates that 86% of all miles of water pipes are 3- to 12-inch in diameter, and a total of 68% are 3- to 8-inch in size.

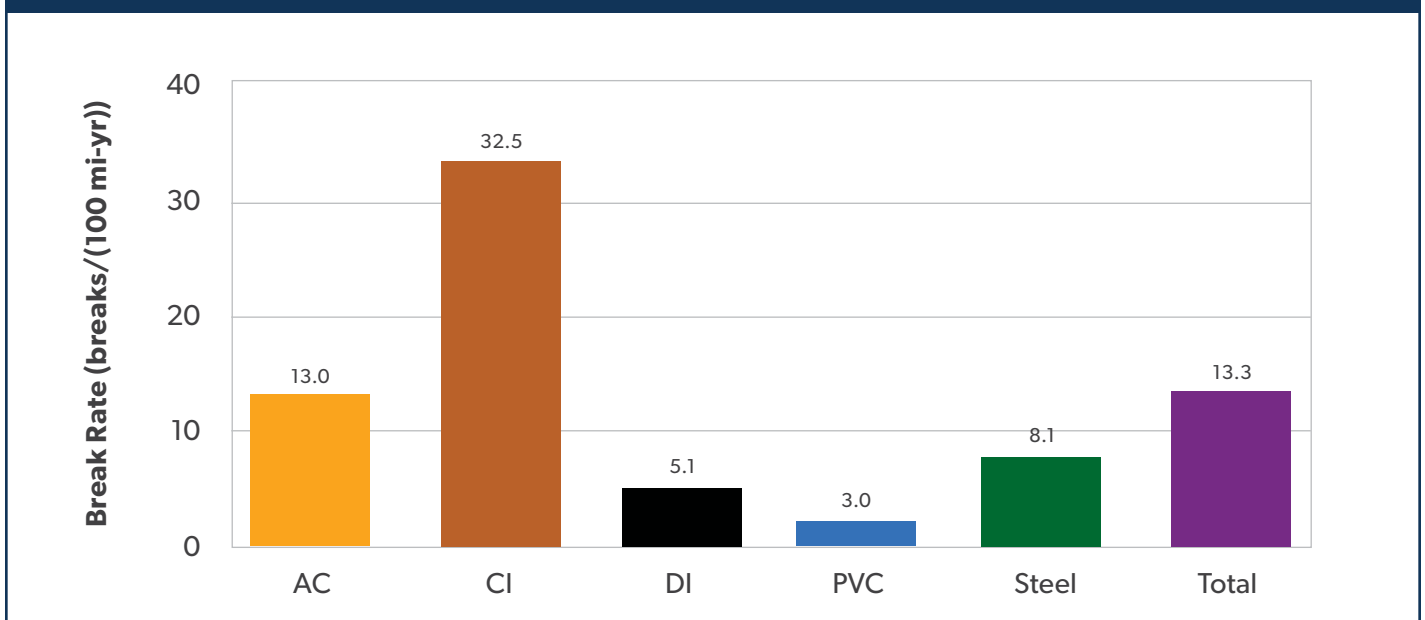
FIGURE 39: BREAK RATES OF 3- TO 12-INCH PIPE BY MATERIAL (DETAILED SURVEY)

Figure 39 illustrates the break rate of 3- to 12-inch pipe, while Figure 40 indicates the break rates of 3- to 8-inch pipe. Comparing these two figures shows a small difference in break rates. The 3- to 12-inch diameter range represents 86% of all pipe materials.

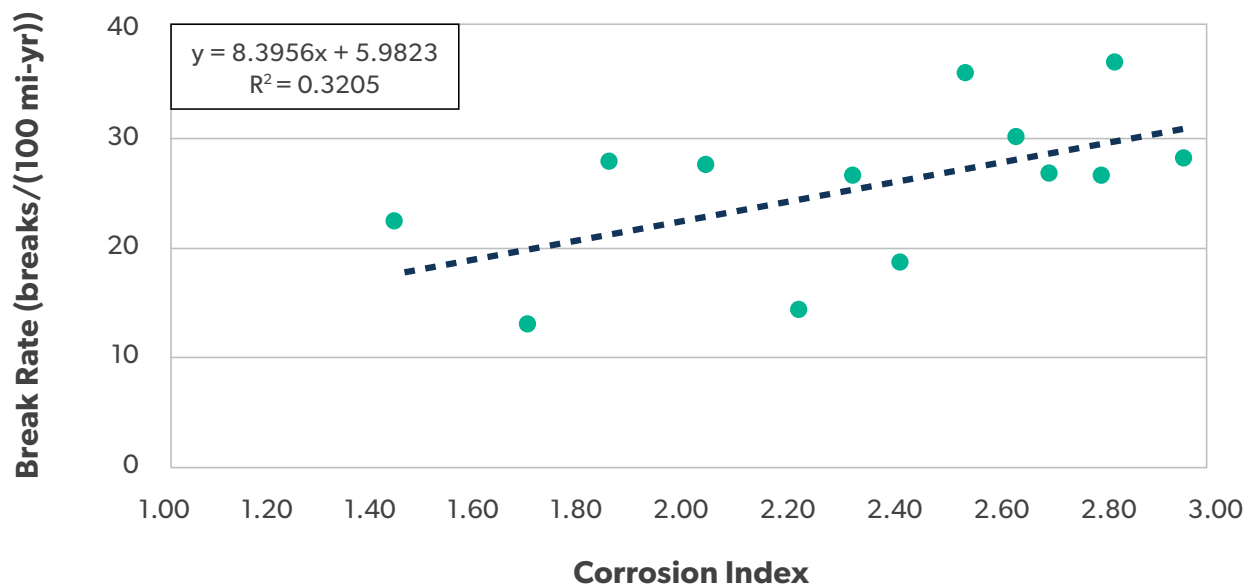
FIGURE 45: CAST IRON PIPE BREAK RATE BY CORROSION INDEX (BASIC SURVEY)

The slope of the line in Figure 45 demonstrates that CI pipe in highly corrosive soil (corrosion index of 3.0) is expected to have more than twice the break rate of one in low corrosive soil (corrosion index of 1.0). Similarly, Figure 46 shows that DI pipe in highly corrosive soil (corrosion index of 3.0) will have a break rate approximately six times greater than one in low corrosive soil (corrosion index of 1.0). Very poor correlations were found for all other pipe materials in this survey. It is understood that other factors not included in the survey may contribute to DI and CI pipe's failure rates.

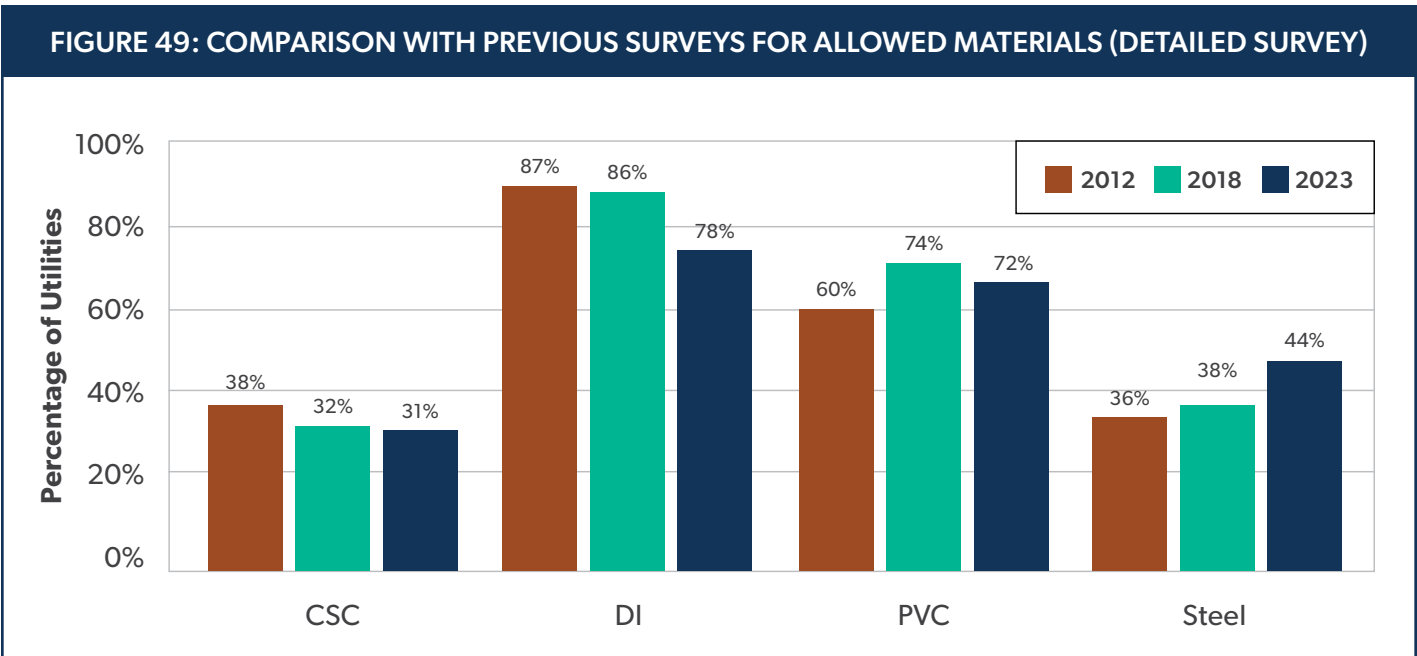
Figure 49 compares the pipe materials approved for use by utilities in the 2023 survey along with the data obtained in the 2012 and 2018 surveys; CI and AC are not listed because these materials are no longer manufactured. The number of utilities approving CSC and PVC pipes for use in water systems remained essentially the same as in 2018. The largest change is the 8% decrease in the acceptance of DI water pipe. The next largest change is the 6% increase in acceptance of steel pipe. It is important to note that HDPE and PVCO were not included in Figure 49 due to limited usage and data from the 2012 USU report. However, between 2018 and 2023, the percentage of acceptance for HDPE and PVCO did not significantly change. For comparison, Figures 17 through 19 illustrate actual pipe use across the three study periods by region.
