SUBJECT : Investigation report on the alleged air and water pollution from a mobile batching plant along Aringay River in Aringay, La Union

Regional Office No. 1
DENR Bldg., Government Center, Sevilla, City of San Fernando,
La Union
INVESTIGATION REPORT ON COMPLAINT

SUBJECT : INSPECTION AND INVESTIGATION REPORT ON THE MOBILE BATCH
PLANT ALLEGEDLY CAUSING AIR AND WATER POLLUTION,
LOCATED AT THE EASTERN SIDE OF ARINGAY BRIDGE, LOCATED
IN BRGY. CECILIA, ARINGAY, LA UNION.

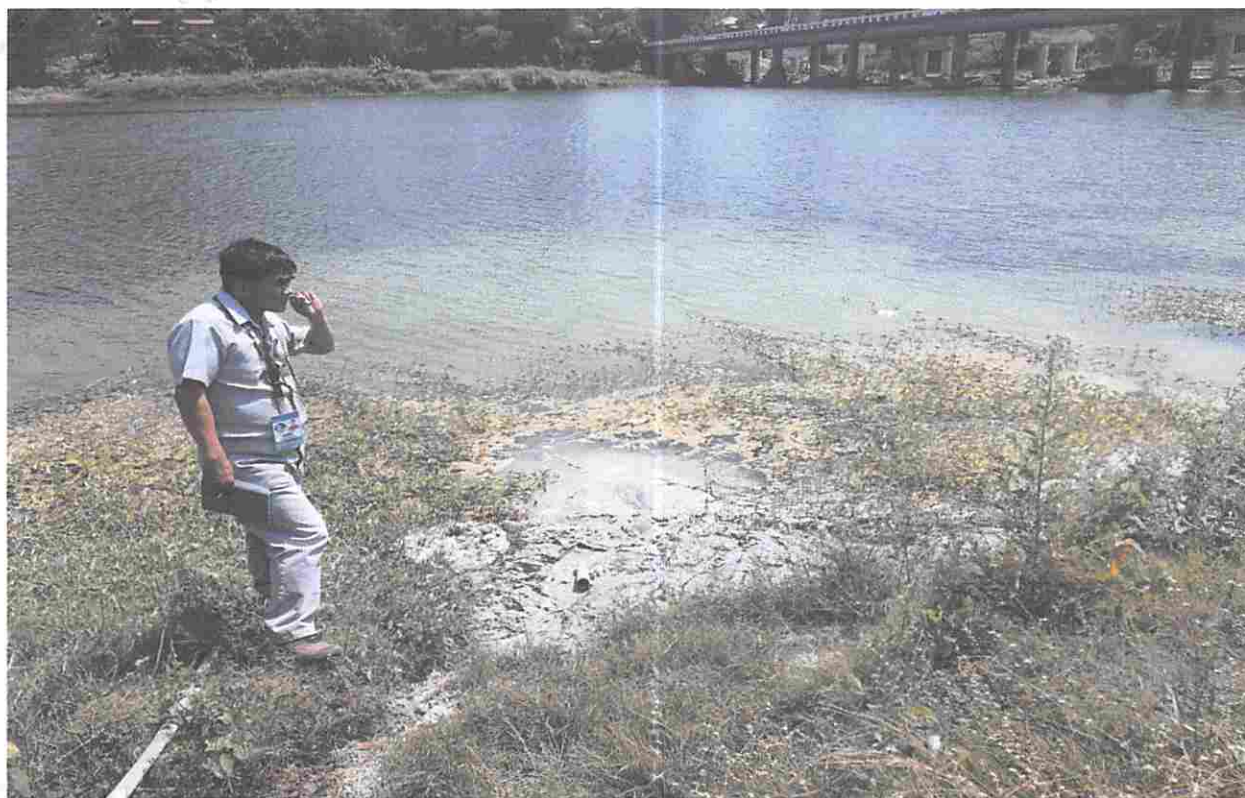
During the inspection, there are silts coming from the batch plant that is discharged directly to the river. Drums of chemicals (RC Superconplas-SRW) are also present in the area. Dust is also observed during the loading of aggregates and cement to the concrete mixer truck.

Photo showing the silt and chemical discharged in the river.

1. Require the contractor to increase the frequency of sprinkling water along the haul access roads especially during concrete mixing operation.
2. Require the contractor to refrain from discarding unused and diluted concrete mixtures along the river bank. Furthermore, the contractor must remove the hardened concrete mixture deposited along the riverbank.
3. The contractor must present authority over the area to use as a temporary concrete mixing area for the on-going bridge upgrading project else must vacate the said area.
4. The construction shall be monitored periodically until the project completion to verify the consistent sprinkling of water along their haul access roads and the non-disposal of excess concrete mixture along the riverbank.
