GSI implementation along the Sammamish river in Kenmore

**Geog 482 - GIS Data Management
Prof. Nyerges
University of Washington**

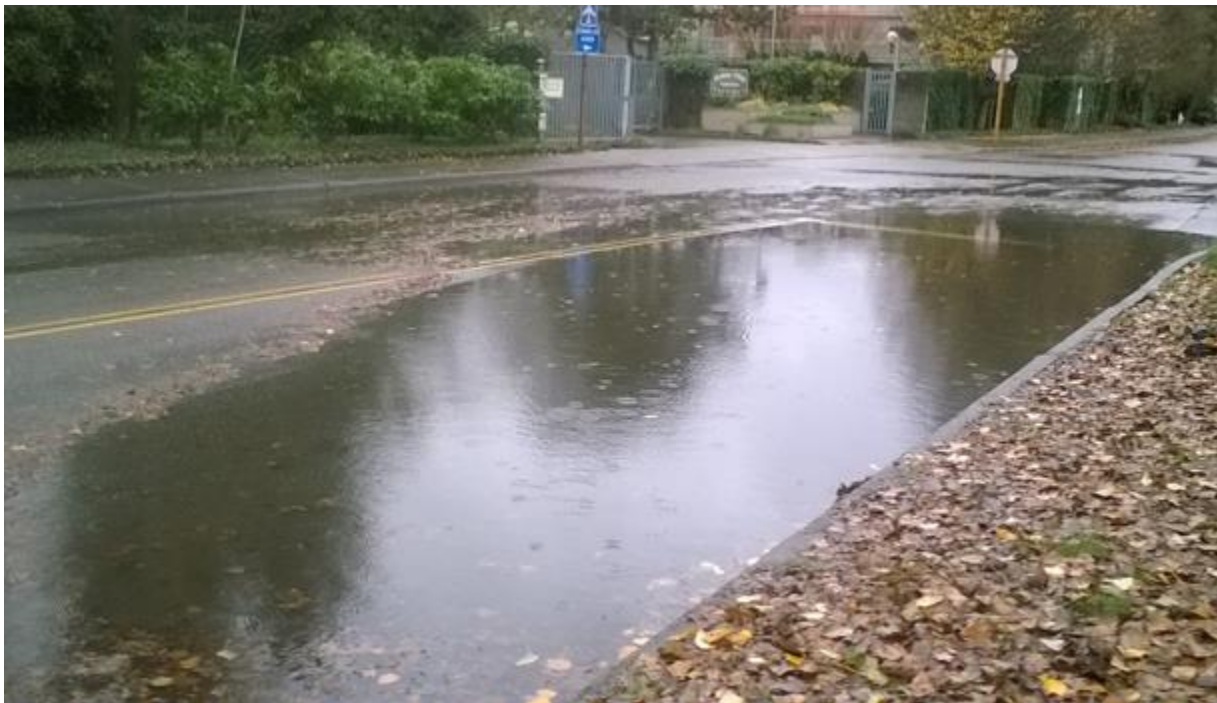
Figure 2. Picture by Sean Fisher.

Finally, some GIS fieldwork was performed by one of the group members. Pictures of trouble areas helped us focus in certain areas, and gave us an idea of the seriousness and scope of the problem (figure 2).
