Jordan Loll
Tony Rogers
July 20, 2018

Prototype Spectrometer Testing with Picam v2

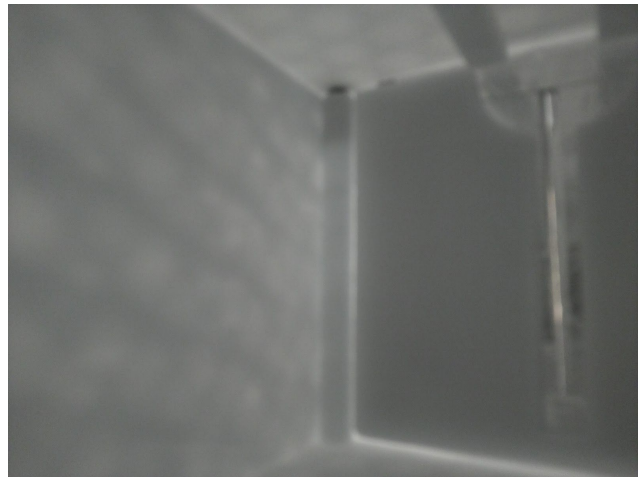
First functional image:

Using a white light source directed solely towards the front of the spectrometer, we can see a large amount of light bleed directly through the walls of the spectrometer. Perhaps the material isn't dense enough or there is a large amount coming through the slit and illuminating the interior.

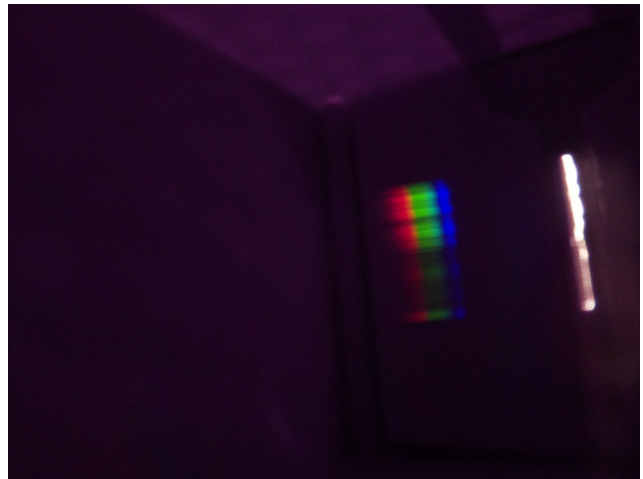
Fourth Image:

Removed excess tape over slit, but keeping it as a cover for the outside we can see the background is quite purple; suggesting it is merely reflected light from the inside. Including the baffle should eliminate this excess. Also with the light source at a better angle we can finally get a view of the spectrum we are looking for. The black blotches through the middle are indicative of the imperfections on the opening since we do not yet have a functional slit to insert into the device.

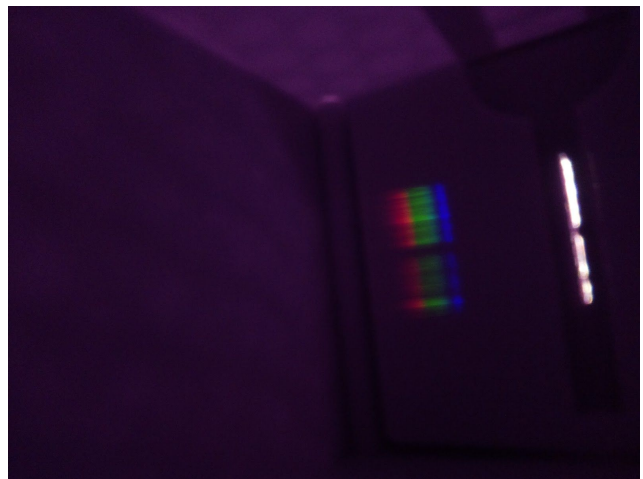
Fifth Image:

Although not the brightest, we believe this is the best image we were able to capture. We made small changes, using tape, to the slit to reduce the amount of light to make the spectrum clearer (however it is far from perfect).

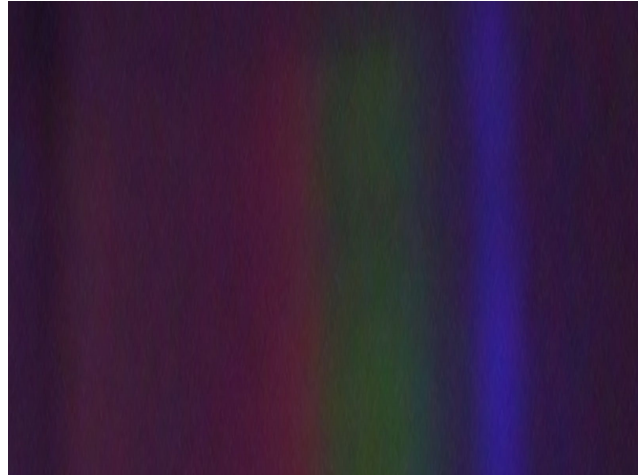
Final image:

Using the Region of Interest option with the camera, we could successfully zoom in to a small portion of the image; capturing just the spectrum.

For all of these images, the camera was only attached with scotch tape so there is a tilt on the images. But another issue is the focus of the image.

According to the pi camera data sheets, the pi cam is a fixed focus camera that has a minimum distance of 1m. The focal length is 3.04 mm. Looking through online sources, there is ways of refocusing the camera that require unscrewing the lens and consequently voiding the warranty on the camera. This issue may require a closer look and a clever solution.
