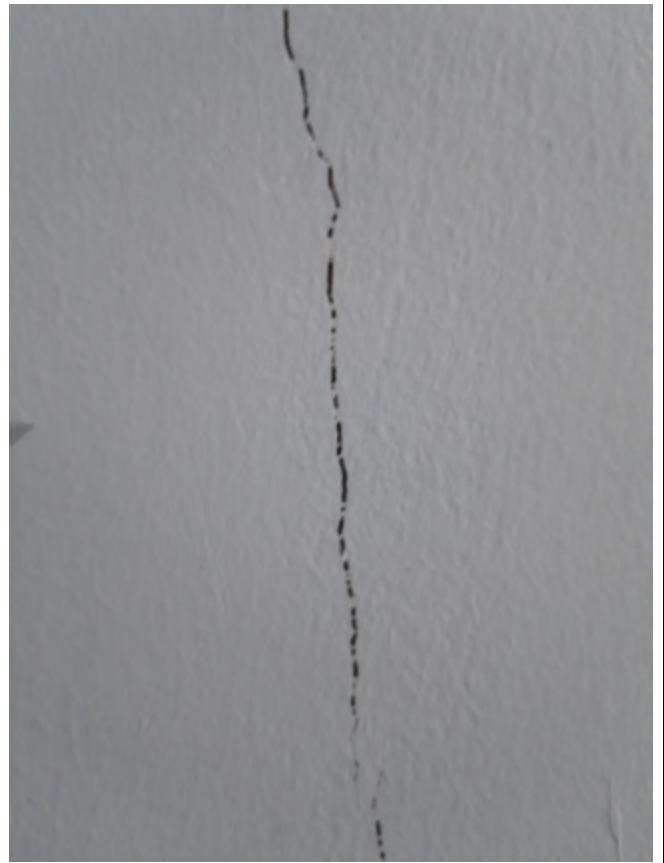
The image classified as: Contains Crack  
Length: 5.86 cm  
Width: 0.88 mm  
Orientation: horizontal  
Positive Crack Probability: 72.96%  
Negative Crack Probability: 27.04%  
Location of Crack: None  
Crack Type: None  
Crack Progression: None  
Date Added: 2023-04-06 22:10:39
