The image classified as: Contains Crack

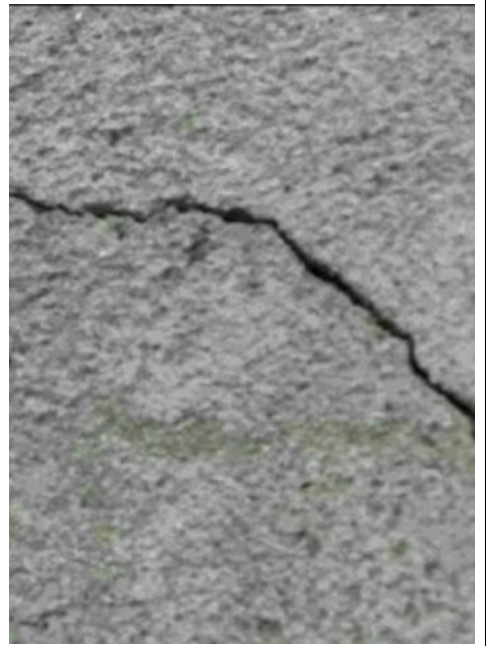
Length: 31.78 cm

Width: 0.75 mm

Orientation: horizontal

Positive Crack Probability: 59.21%

Negative Crack Probability: 40.79%
