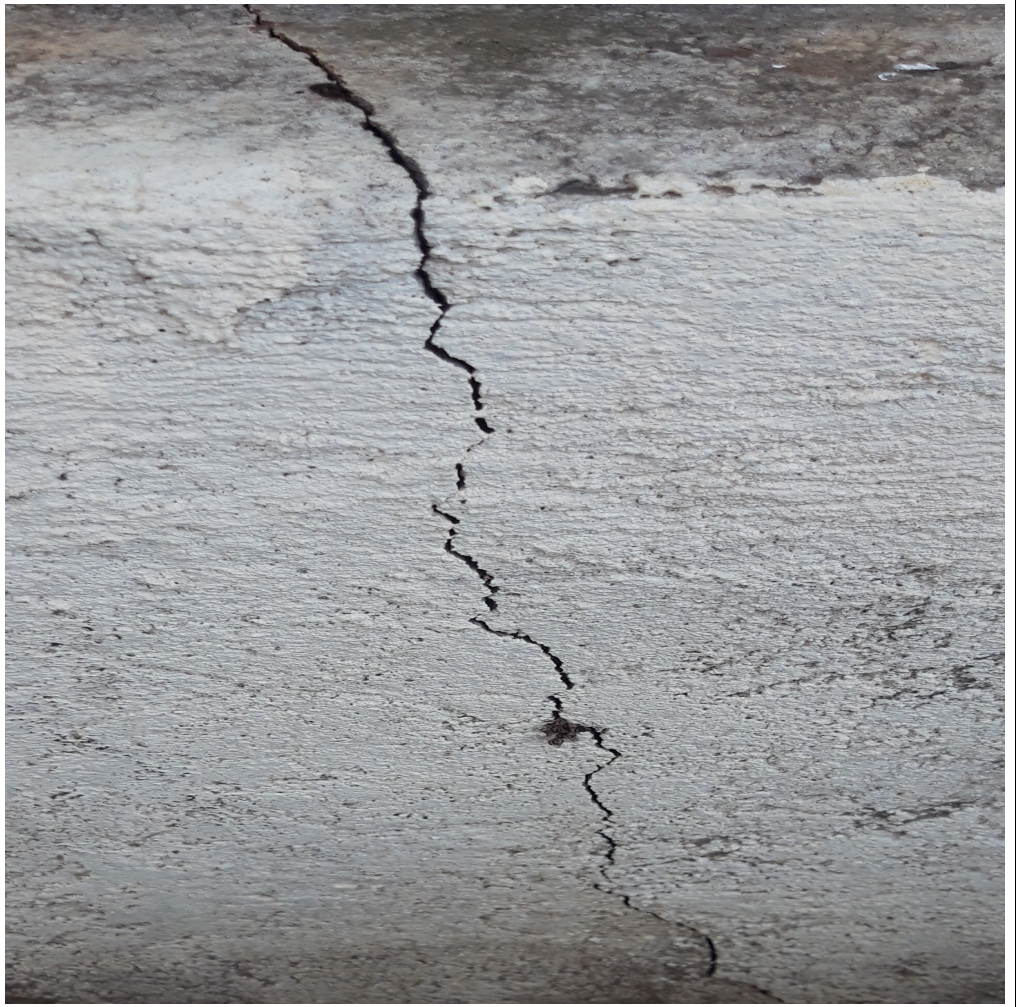
The image classified  
as: Contains Crack  
Length: 47.26 cm  
Width: 2.37 mm  
Orientation: vertical  
Positive Crack  
Probability: 73.11%  
Negative Crack  
Probability: 26.89%
