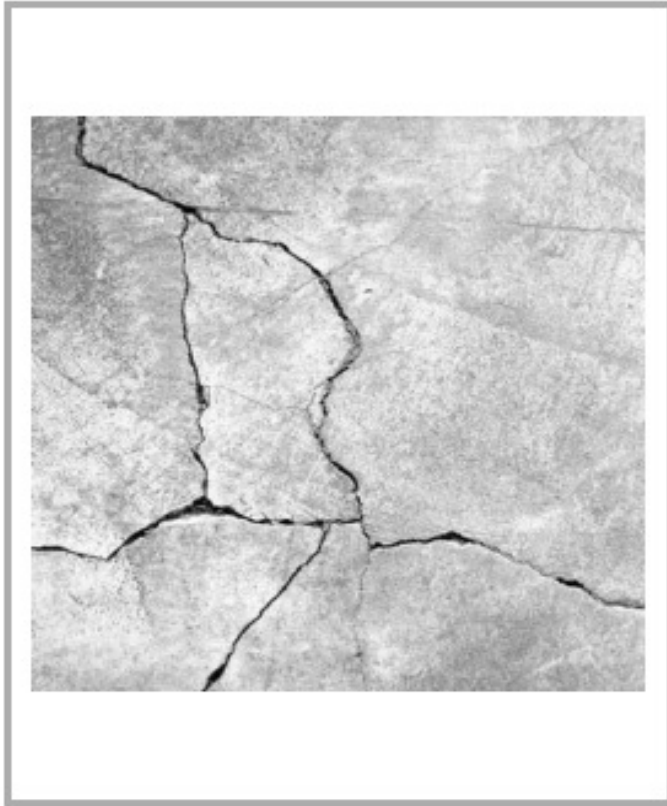
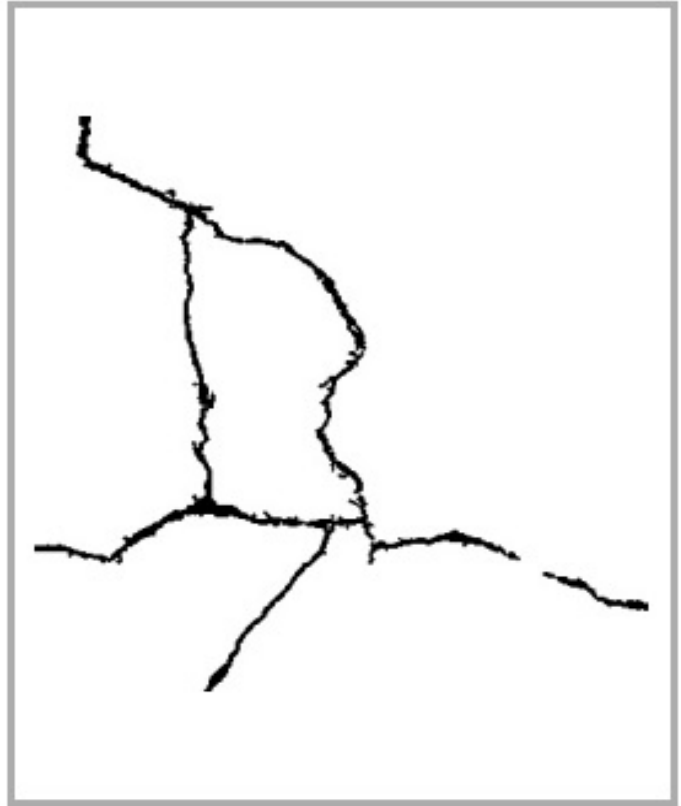
The image characterized as: **Contains Crack**

Length: **6.03 cm**

Width: **1.14 mm**

Positive Crack Probability: **73.11%**

Negative Crack Probability: **26.89%**

Location of Crack: **Column**
