# Crackterized Result

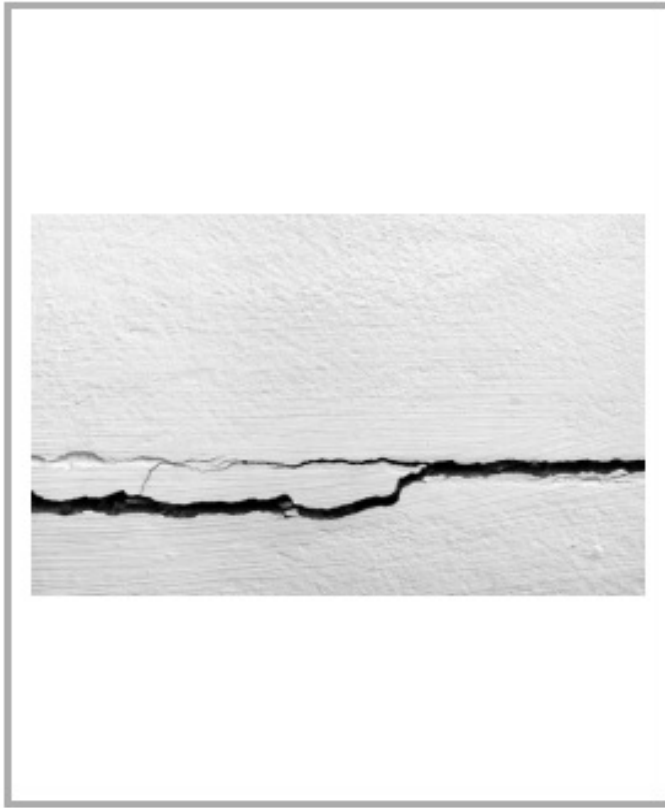
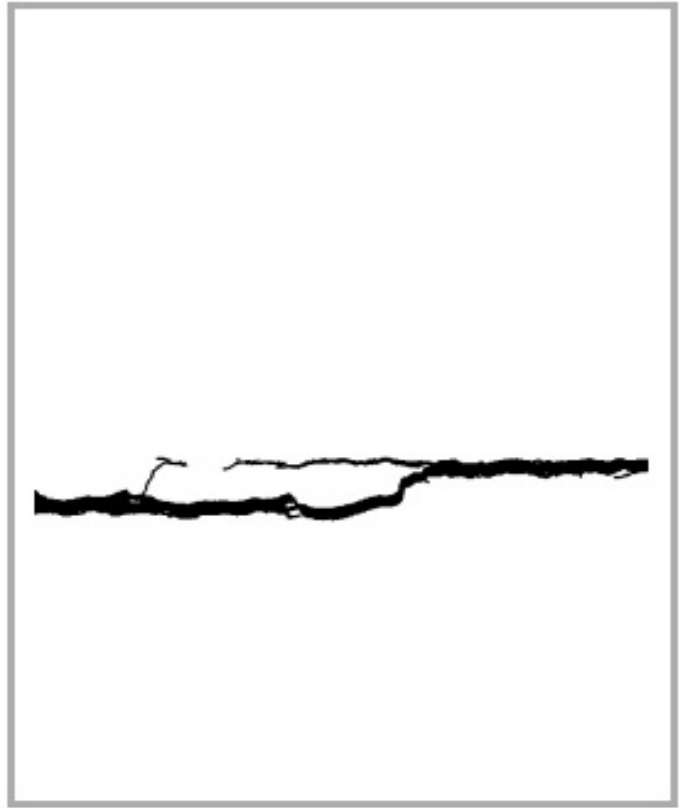
The image characterized as: **Contains Crack**

Length: **120.09 cm**

Width: **114.35 mm**

Positive Crack Probability: **73.11%**

Negative Crack Probability: **26.89%**

Location of Crack: **Beam**
