The image classified as: Contains Crack

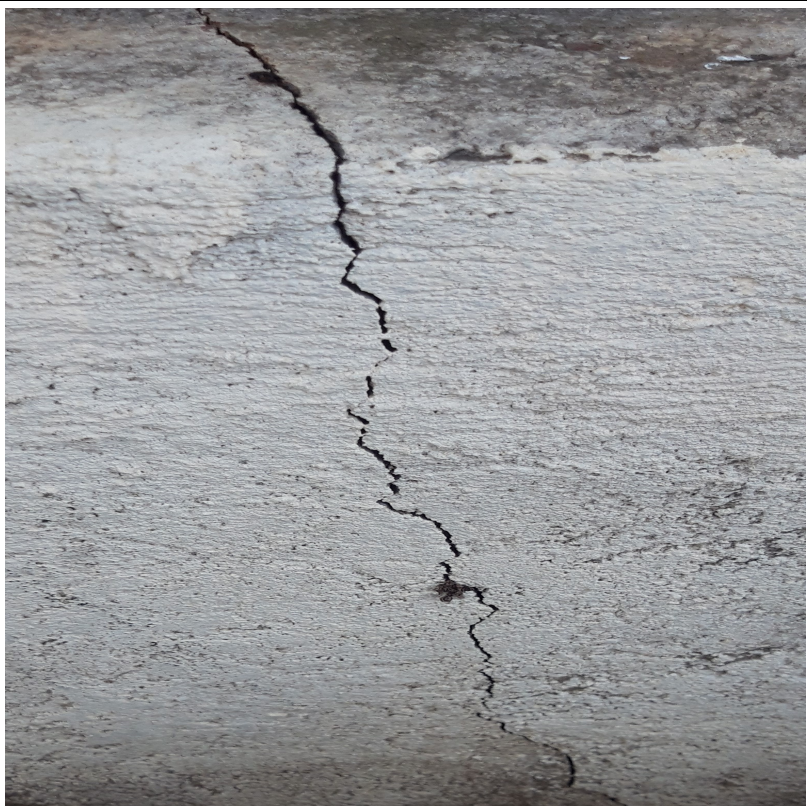
Length: 43.22 cm

Width: 2.19 mm

Orientation: None

Positive Crack Probability: 73.11%

Negative Crack Probability:

26.89%
