# Boulder Flood Impacts Pre-flood and Post-flood - 2013

## Abstract

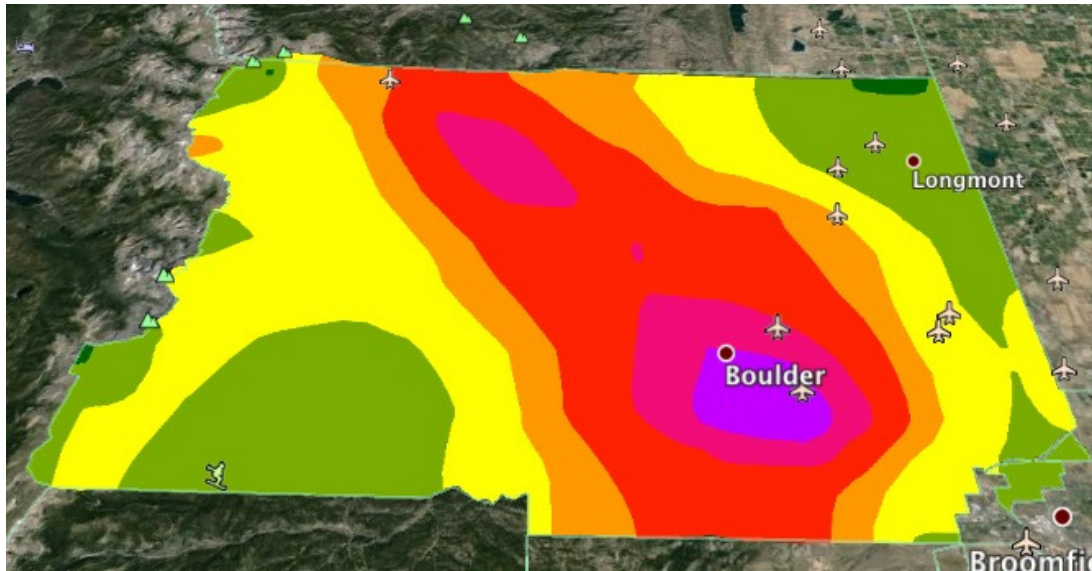
Figure 2: Rainfall Distribution over Boulder County

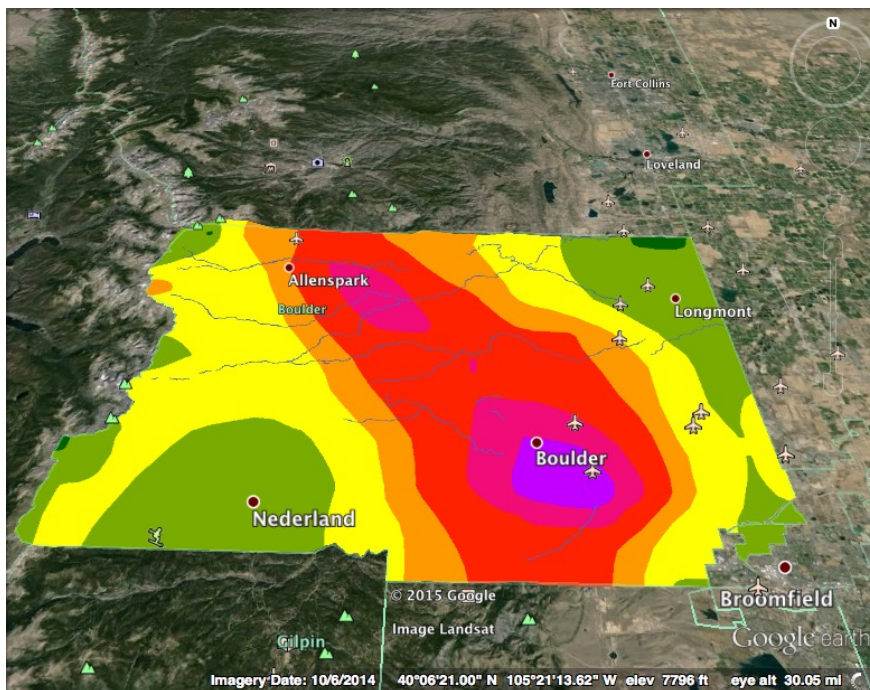
Figure 3: Pre-Flood Stream Channel and Rainfall Distribution

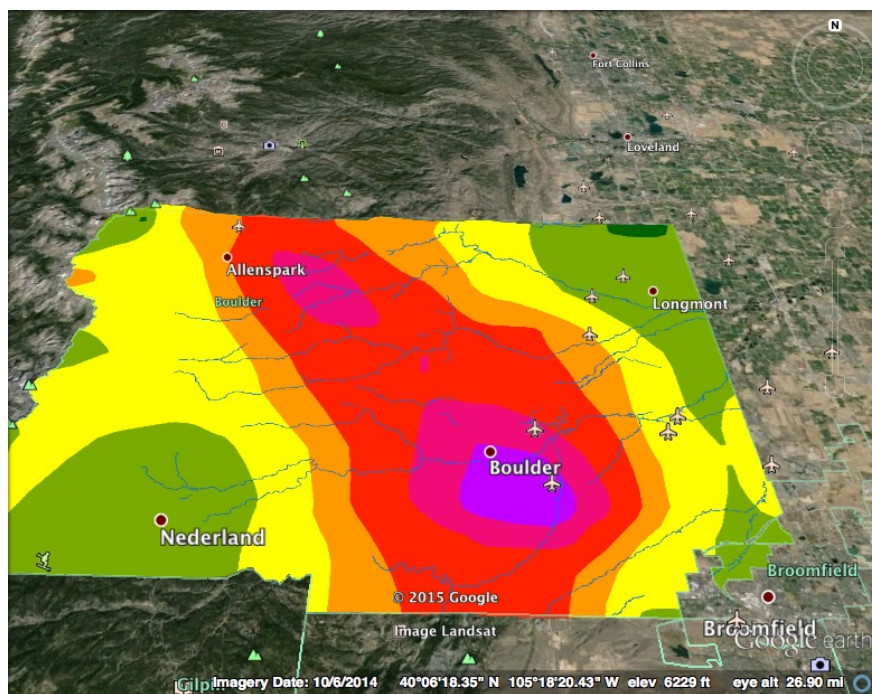
**Figure 4:** *Post-Flood Stream Channel and Rainfall Distribution*

The correlation was created by implementing Spatial Autocorrelation within Qgis. It was also easily viewed by overlapping the rainfall data with the post-flood stream channel shapefile. Which can be viewed at figure 4.

About (put percent here) of the stream channel stayed consistent with the pre-flood stream channel during this disaster. The mass of the findings concluded that most of the now stream channel was newly created. The post-flood stream channel is mostly represented by the rainfall that happened during the flood. Where there was less rain, most of those channels have disappeared and dispersed into the areas where there was the most rainfall. There was very little stream channel in Boulder, CO pre-flood, but now there are many new streams that have been created because of this flood and it mostly amounts to the mass rainfall that was recorded in the Southwestern part of the county.
