Boulder Flood Impacts Pre-flood and Post-flood - 2013

Abstract

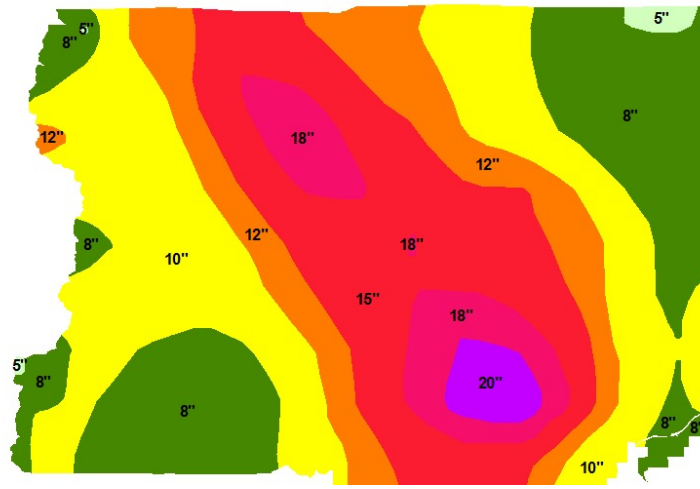
Figure 1: Rainfall Distribution

The purpose of this part was to assign a general legend for each area that fell into similar rainfall minimum and maximum ranges. The numbers can be viewed in figure 1. It was based upon finding a general rule for each set of values for the designated areas.

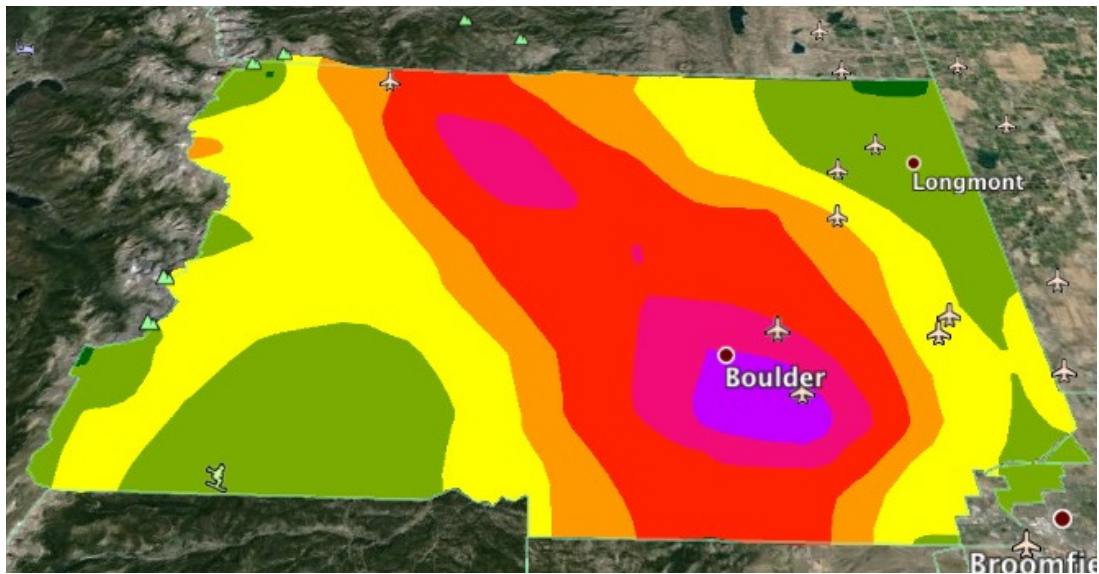
Figure 2: Rainfall Distribution over Boulder County

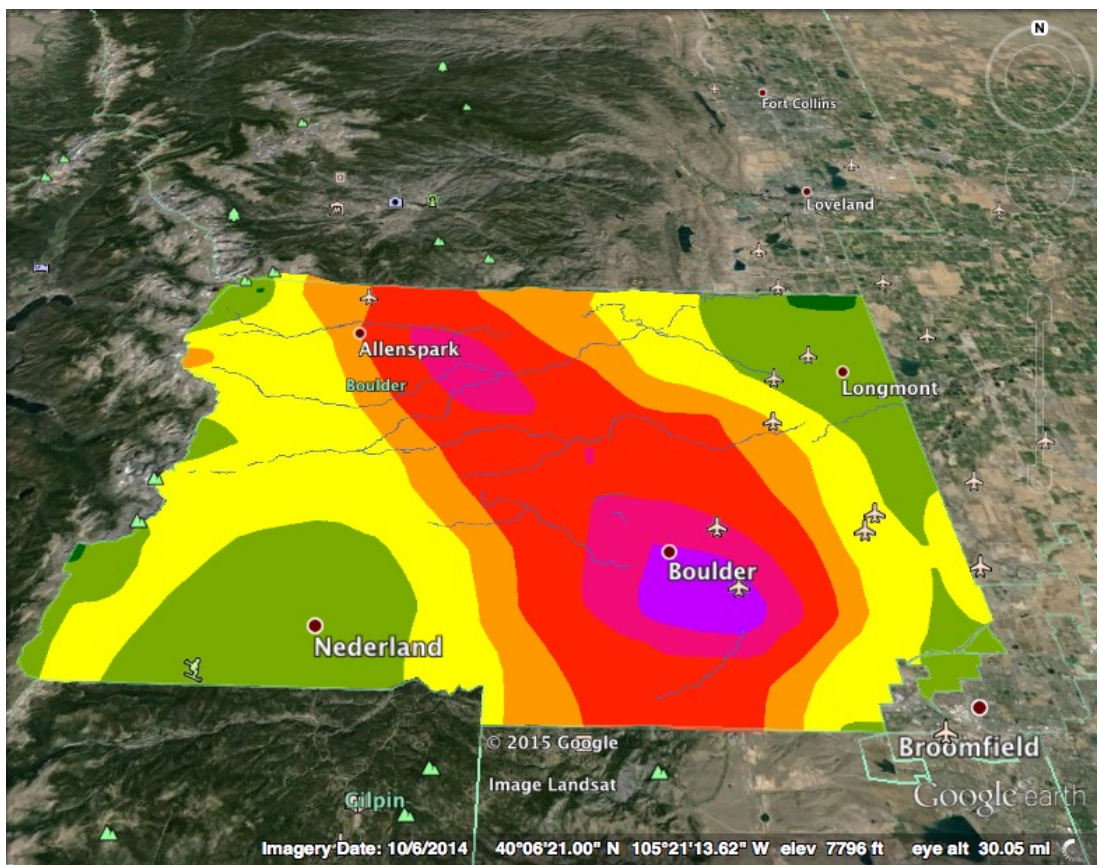
Figure 3: Pre-Flood Stream Channel and Rainfall Distribution

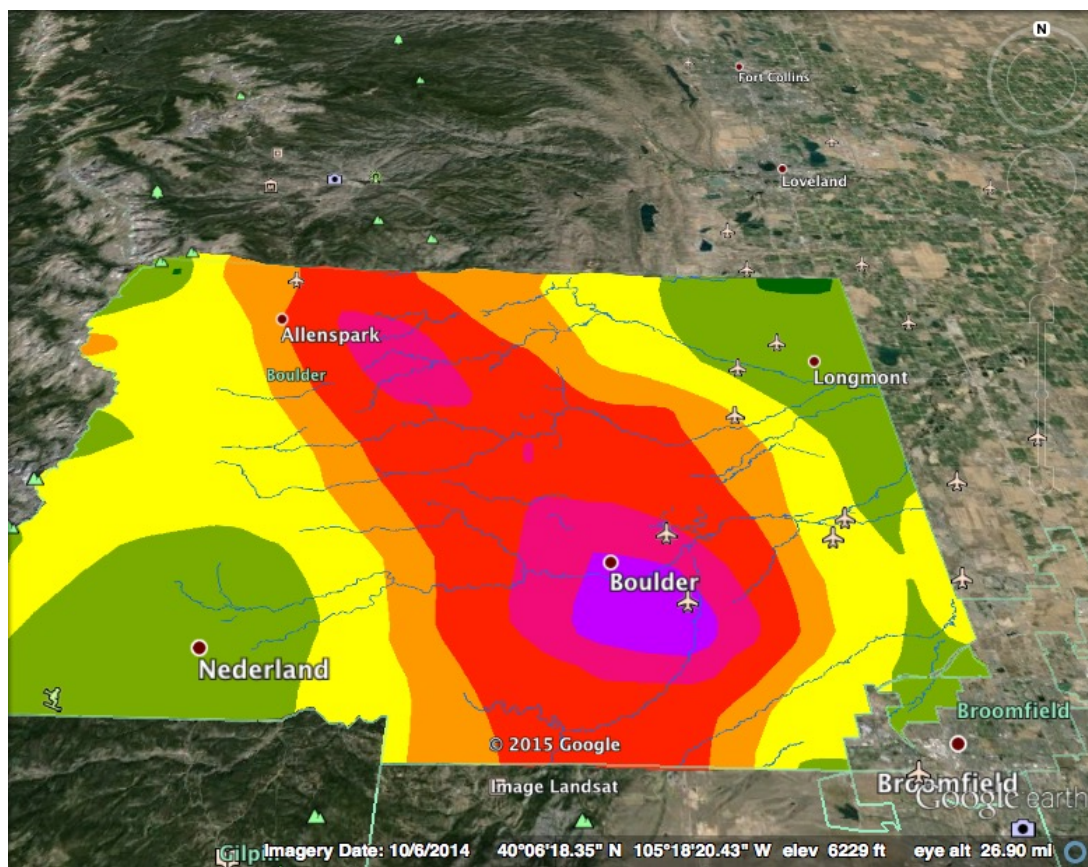
Figure 4: *Post-Flood Stream Channel and Rainfall Distribution*

The correlation was created by implementing Spatial Autocorrelation within QGIS. It was also easily viewed by overlapping the rainfall data with the post-flood stream channel shapefile. Which can be viewed at figure 4.

Only 48.4% of the stayed consistent with the pre-flood stream channel during this disaster. The mass of the findings concluded that most of the now stream channel was newly created. The post-flood stream channel is mostly represented by the rainfall that happened during the flood. Where there was less rain, most of those channels have disappeared and dispersed into the areas where there was the most rainfall. There was very little stream channel in Boulder, CO pre-flood, but now there are many new streams that have been created because of this flood and it mostly amounts to the mass rainfall that was recorded in the Southwestern part of the county.
