# Minimum Standards Audit

**Property Address: 25 Tetrabine Way Lyndhurst Vic 3975**

**Audit Date: 09/10/2024**

Audit No. #		Auditor		
00004803		Andrea Mamone		
Inspection Address		Managing Agent		Audit Date
25 Tetrabine Way Lyndhurst Vic 3975		All Avenues Real Estate - CRANBOURNE		09/10/2024

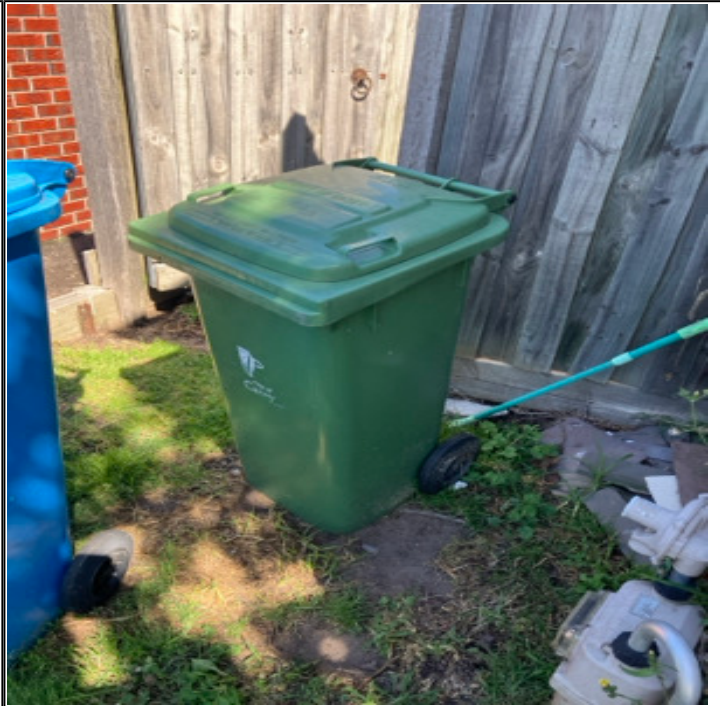
Does the property have a council style GENERAL waste bin?	Yes
Is the general waste bin in good working condition/vermin proof?	Yes
Photo of council style GENERAL waste bin

MINIMUM STANDARDS: Does the General Waste bin provided meet the minimum standards?	Yes

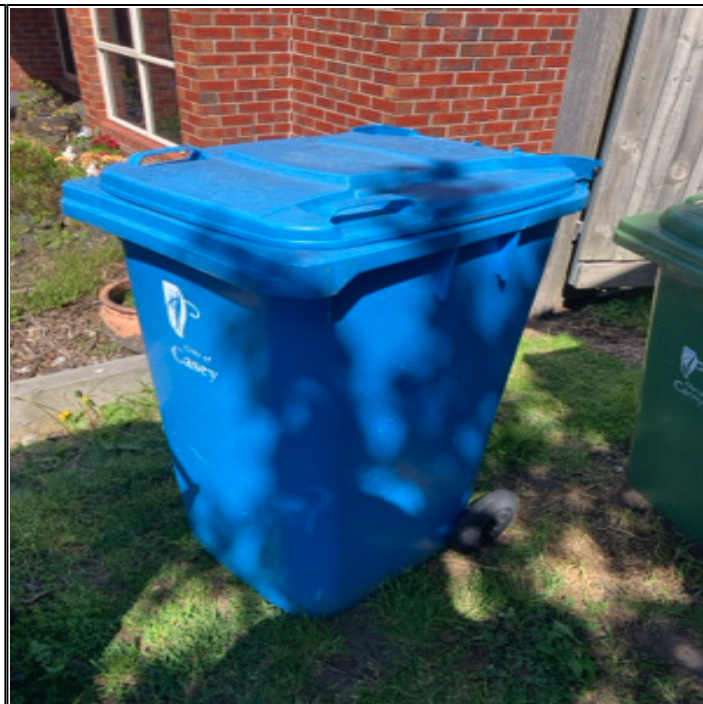
Photo of recycle council style waste bin

MINIMUM STANDARDS: Does the recycle bin provided meet the minimum standards?

Yes

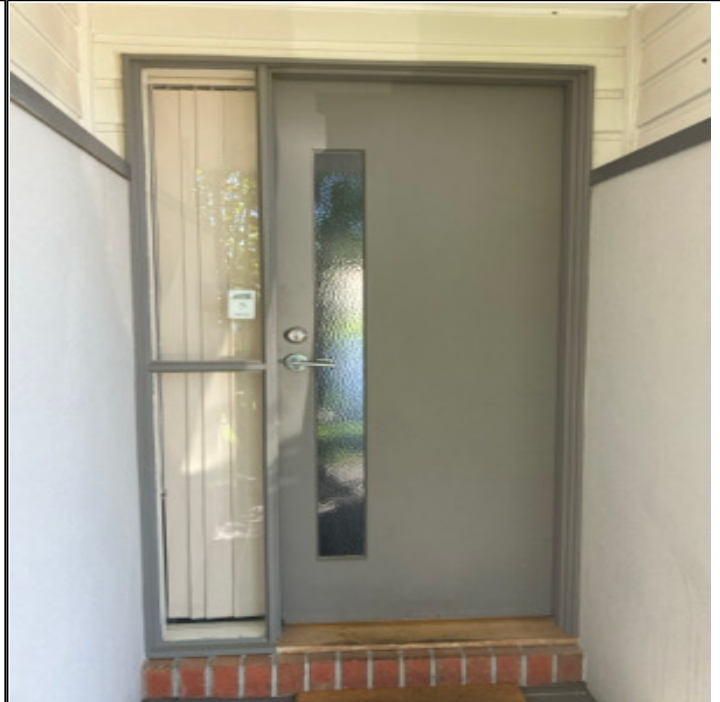
Detailed photo of Front Entrance

Is the deadlock/deadlatch feature on the external door functioning?	Yes
Does the external door meet minimum standards? SubNote: All external entry doors must have a deadlock/deadlatch feature. Exceptions: The door is a public lobby door to common property; The door has a heritage restriction	No
Please Comment on External Door	The front entry locks however the key can't be removed from the rear of the door

Overall room Pass/Fail + Additional Notes	
"ROOM OVERALL: Does the area OVERALL meet the minimum standards?" (Consider if any fails in the room)	No
Mandatory Additional comments on the area for the owner on why it failed or was unable to determine	The front entry locks however the key can't be removed from the rear of the door

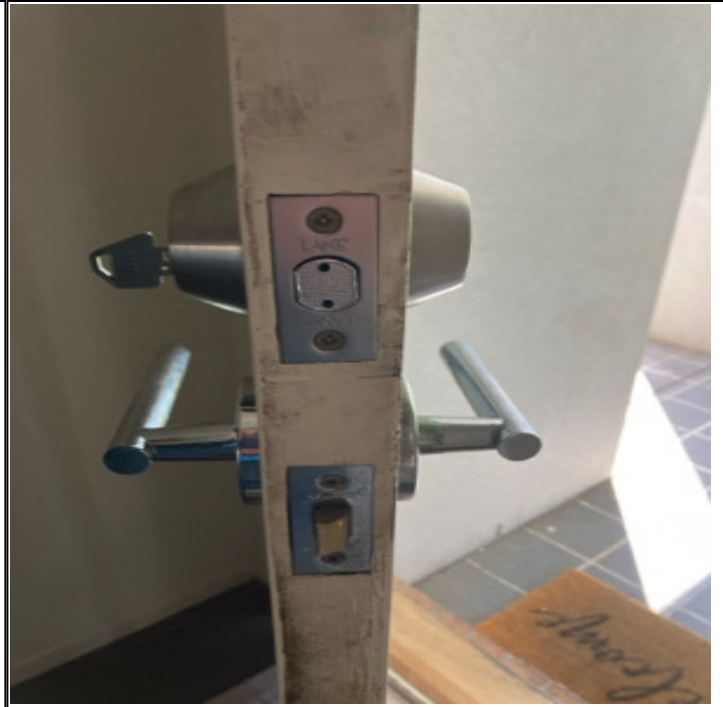
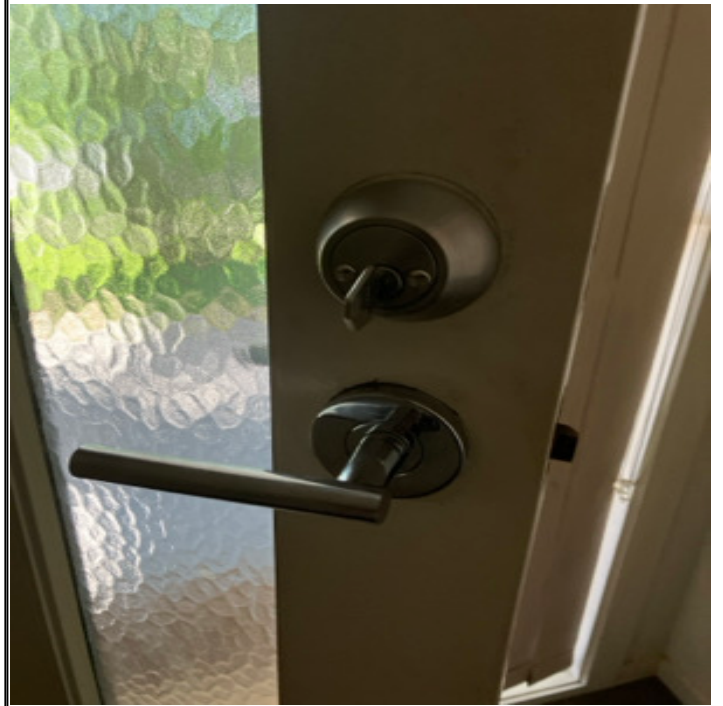
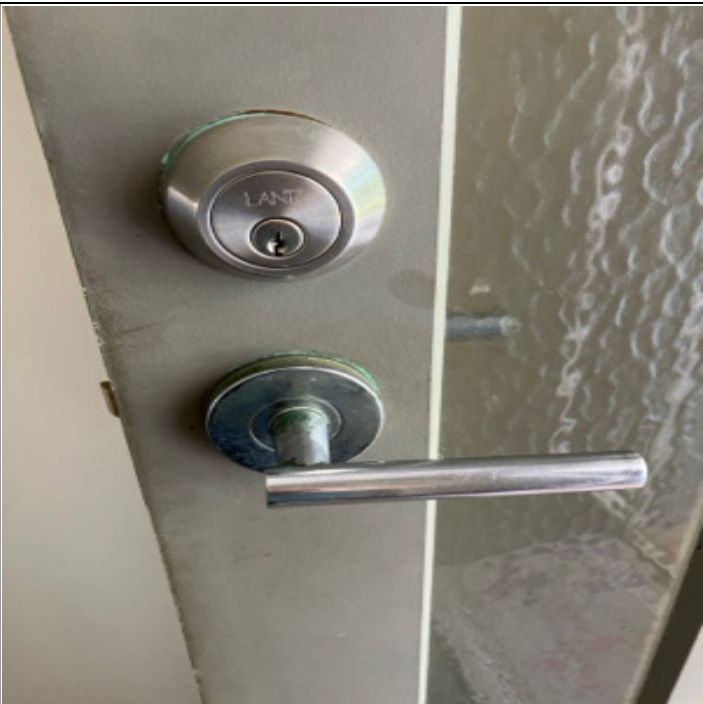
External Door and Deadlock/Deadlatch	
Is there an External Door Present	Yes
Is this a PUBLIC LOBBY door that opens to common property?	No
Photo of external door (from outside and inside)	<div> </div> <div> </div>
Does the external door have a deadlock/deadlatch function?	Yes
"3X CLOSE UP Photo evidence of deadlock/deadlatch (from the outside, Inside and in an operated position or with pin visible)"

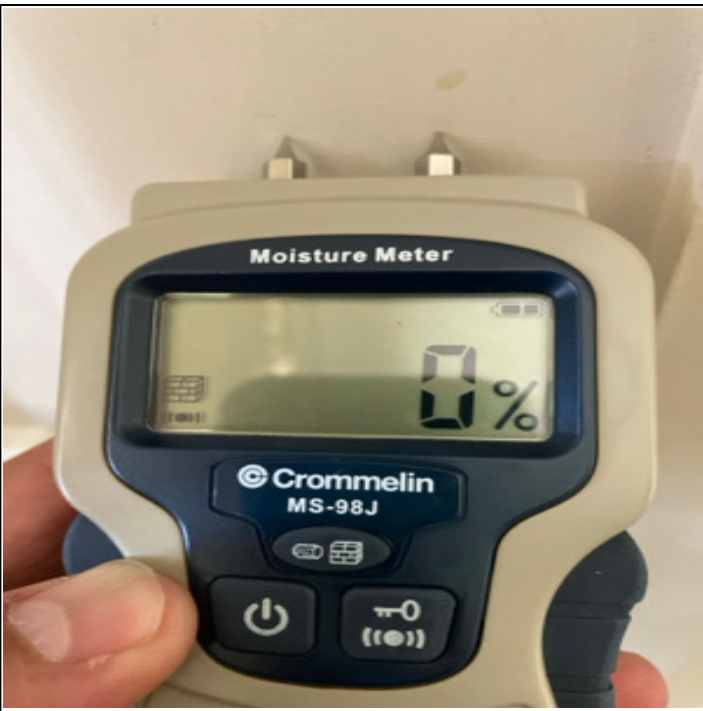
Photo of moisture reading ON a wall

Moisture reading meter (Dry or Wet?)	0
Is there any mould present?	No
Is there any water staining or dampness present?	No
"MINIMUM STANDARDS: Does the mould and dampness meet the minimum standards? SubNote: Any sign of mould is a fail. Water staining and dampness on a case by case basis."	Yes

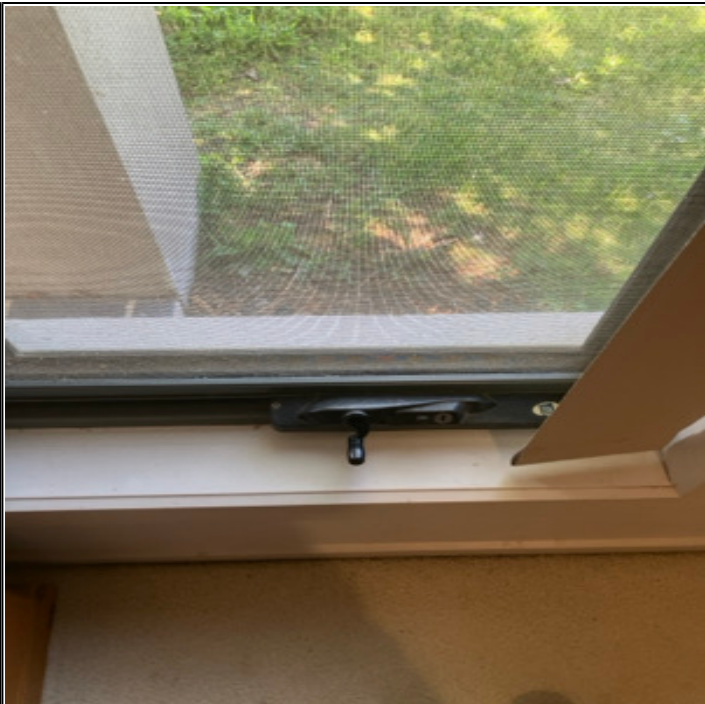
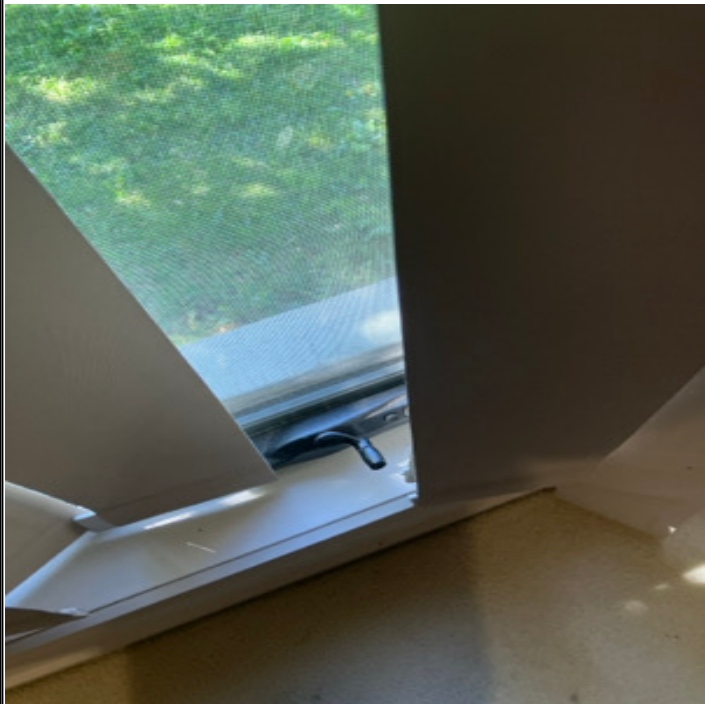
Photo of every openable window with latch visible/missing

Do all the openable windows in this room have functioning latch or lock?

Yes

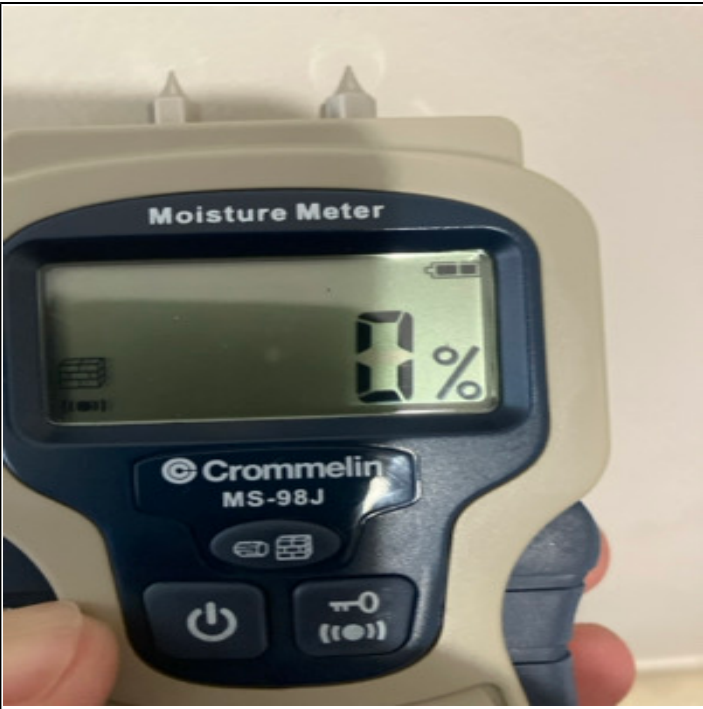
Photo of moisture reading ON a wall

Moisture reading meter (Dry or Wet?)	0
Is there any mould present?	No
Is there any water staining or dampness present?	No
"MINIMUM STANDARDS: Does the mould and dampness meet the minimum standards? SubNote: Any sign of mould is a fail. Water staining and dampness on a case by case basis."	Yes

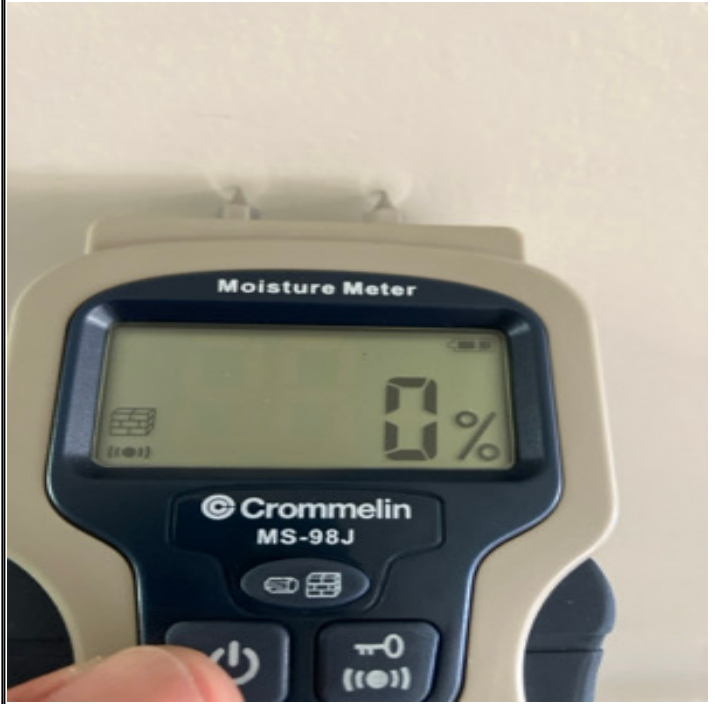
Photo of moisture reading ON a wall

Moisture reading meter (Dry or Wet?)	0
Is there any mould present?	No
Is there any water staining or dampness present?	No
"MINIMUM STANDARDS: Does the mould and dampness meet the minimum standards? SubNote: Any sign of mould is a fail. Water staining and dampness on a case by case basis."	Yes

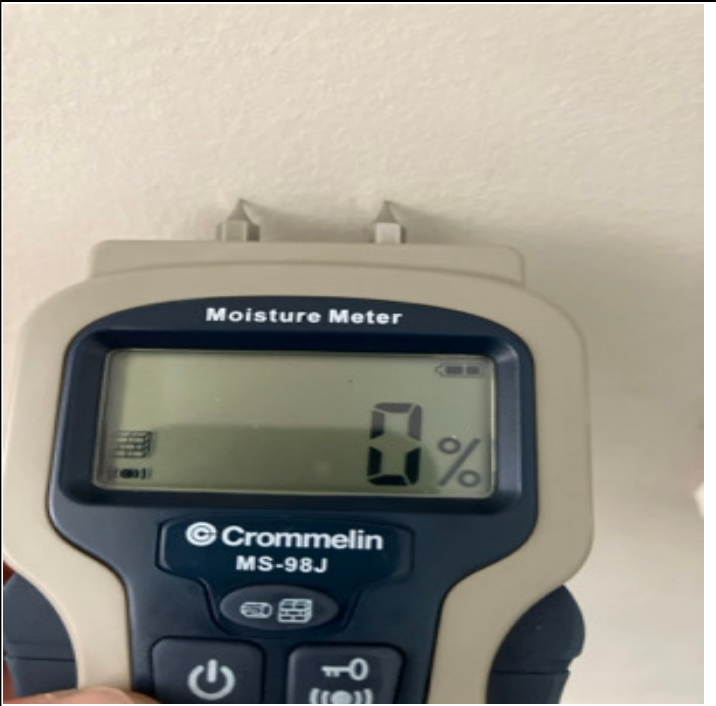
Photo of moisture reading ON a wall

Moisture reading meter (Dry or Wet?)	0
Is there any mould present?	No
Is there any water staining or dampness present?	No
"MINIMUM STANDARDS: Does the mould and dampness meet the minimum standards? SubNote: Any sign of mould is a fail. Water staining and dampness on a case by case basis."	Yes

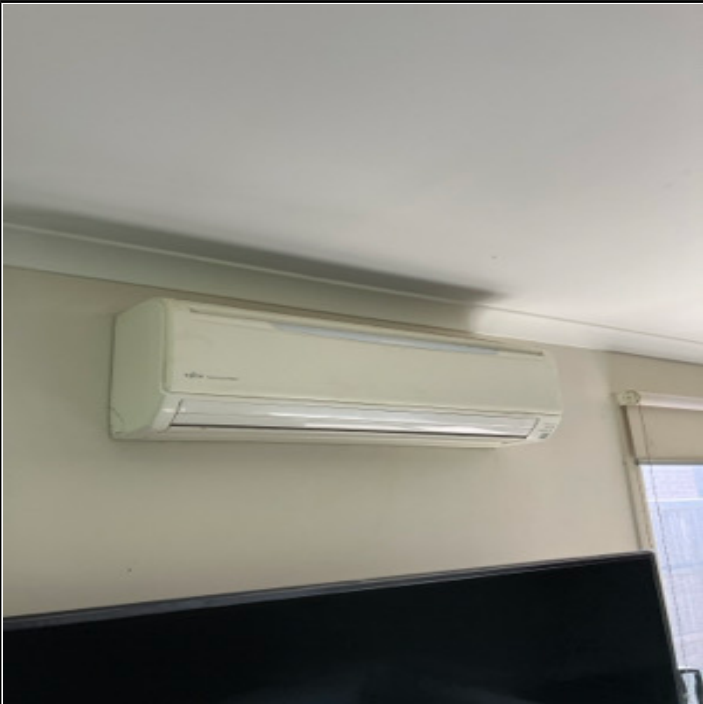
Is there a fixed heater in the Main Living area?	Yes
Photo of the heating unit in the Main Living area

What type of heating device is present in the Main Living area?	Split system
The make and model of the heating unit	Fujitsu
Is the heater plugged in?	Yes
I confirm I have turned the heater on.	Yes
Is the heater in the Main Living area turning on and in good working order?	Yes
Is the heater control accessible?	Yes
Visible Energy Rating	No
"MINIMUM STANDARDS: Does the Main Living area heating meet the minimum standards? SubNote: There must be a fixed heater in the Main Living area to meet minimum standards "	Yes

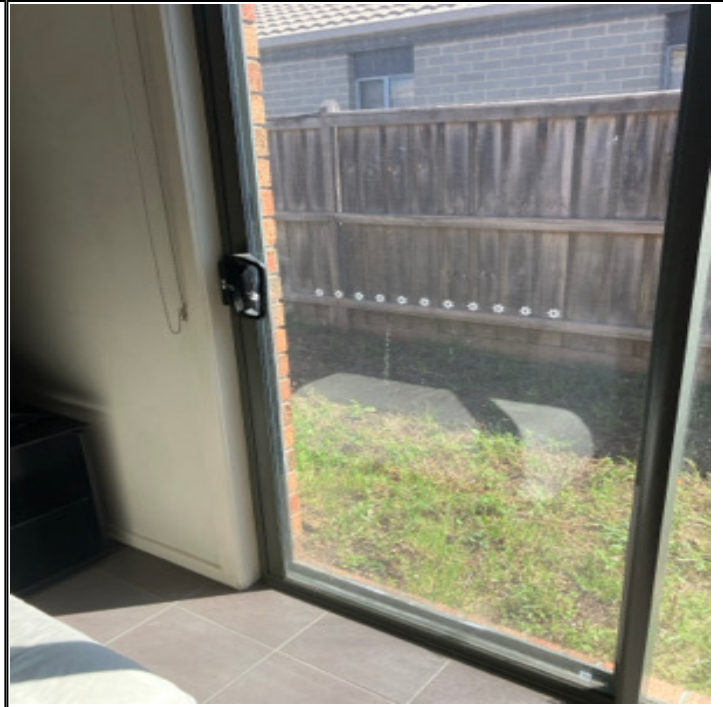
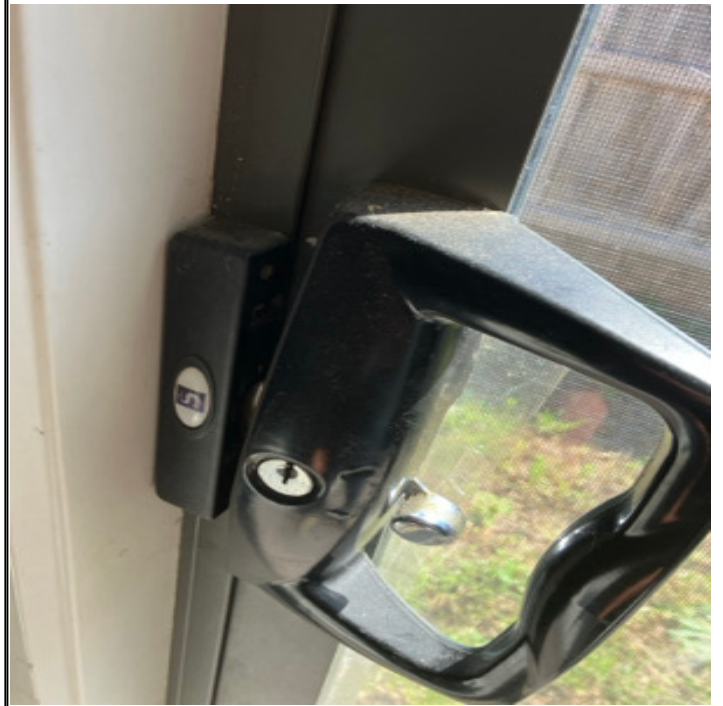
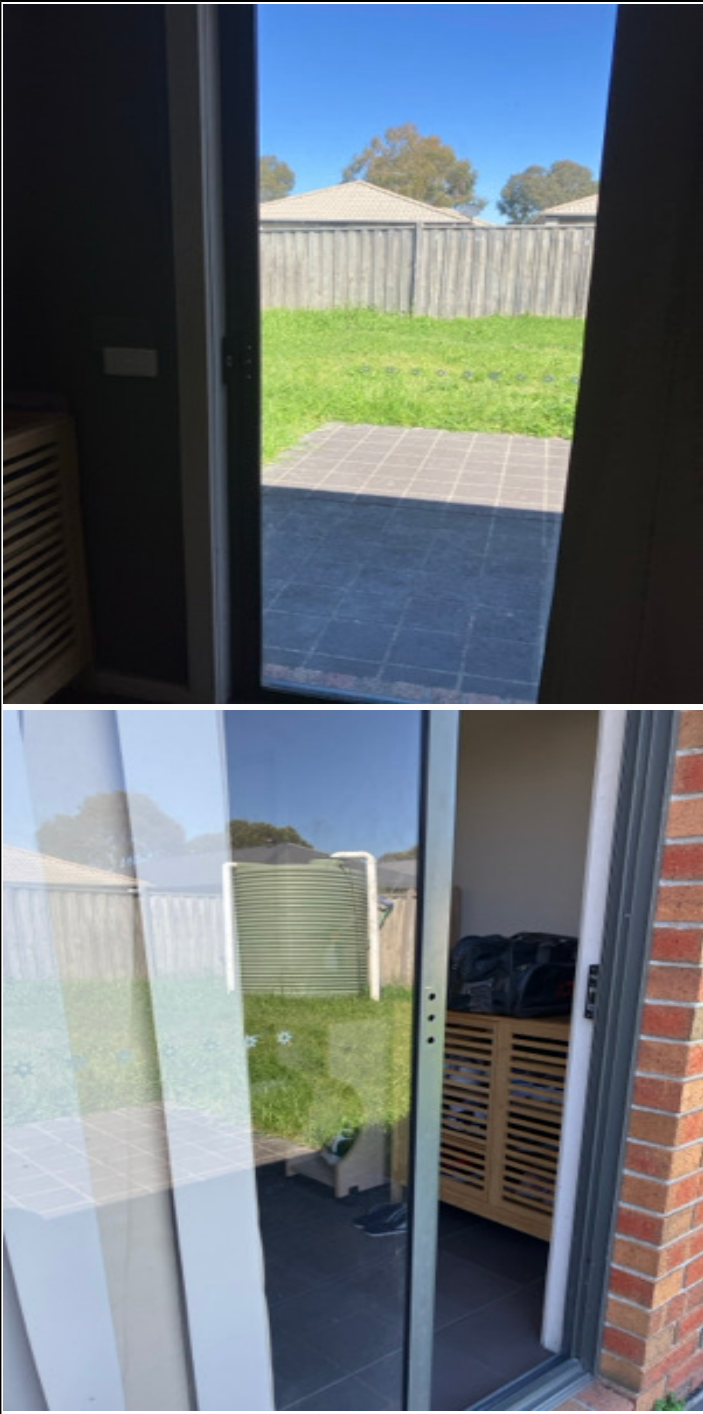
Is there an External Door Present	Yes
Is this a PUBLIC LOBBY door that opens to common property?	No
Photo of external door (from outside and inside)

Does the external door have a deadlock/deadlatch function?	No
Is a deadlock/deadlatch able to be installed on this door?	Yes
Does the external door meet minimum standards? SubNote: All external entry doors must have a deadlock/deadlatch feature. Exceptions: The door is a public lobby door to common property; The door has a heritage restriction	No
Please Comment on External Door	No lock and no sliding door guide and second door handle is faulty can't be opened or closed

Fail Comment:	There is no locking feature at all on this external door and there is no additional security barrier for example: a locked door to an apartment building or a locked gate.
---------------	--

"ROOM OVERALL: Does the area OVERALL meet the minimum standards?" (Consider if any fails in the room)	No
Mandatory Additional comments on the area for the owner on why it failed or was unable to determine	Doors are defective

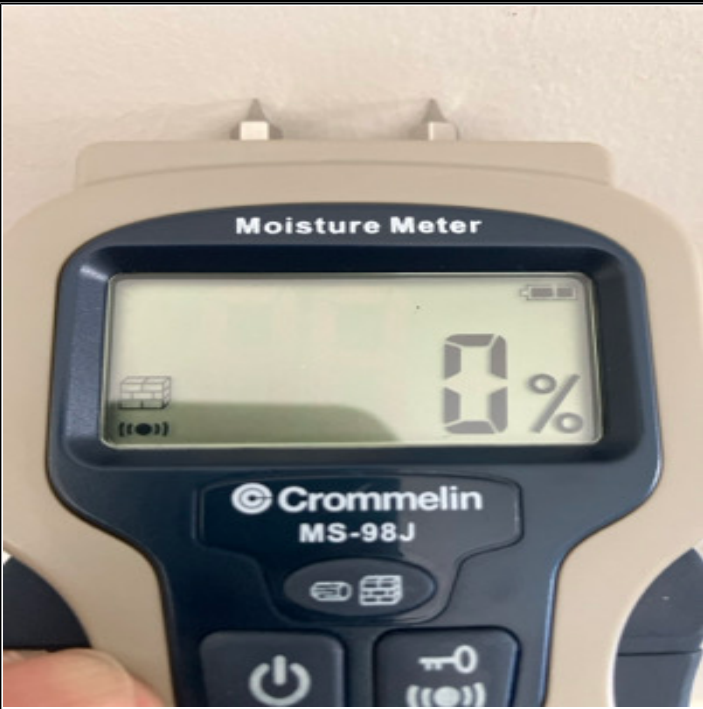
Mould and Dampness	
Photo of moisture reading ON a wall

Moisture reading meter (Dry or Wet?)	0
Is there any mould present?	No
Is there any water staining or dampness present?	No
"MINIMUM STANDARDS: Does the mould and dampness meet the minimum standards? SubNote: Any sign of mould is a fail. Water staining and dampness on a case by case basis."	Yes

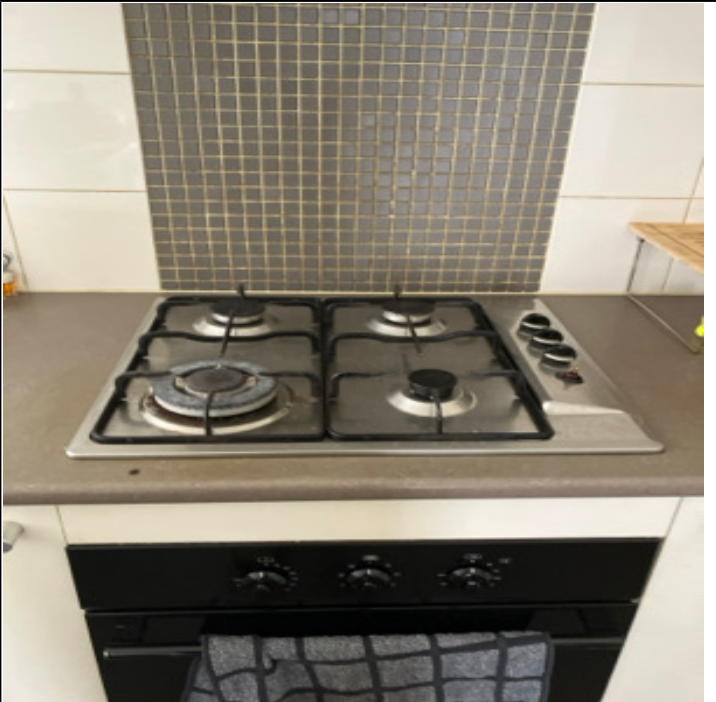
Is there a Stovetop	Yes
Photo of Stovetop

Is the cooktop Gas or Electric	Gas
Are there at least 2 burners on the cooktop	Yes
Are there 2 or more burners in good working condition?	Yes
Does the cooktop meet minimum standards?	Yes

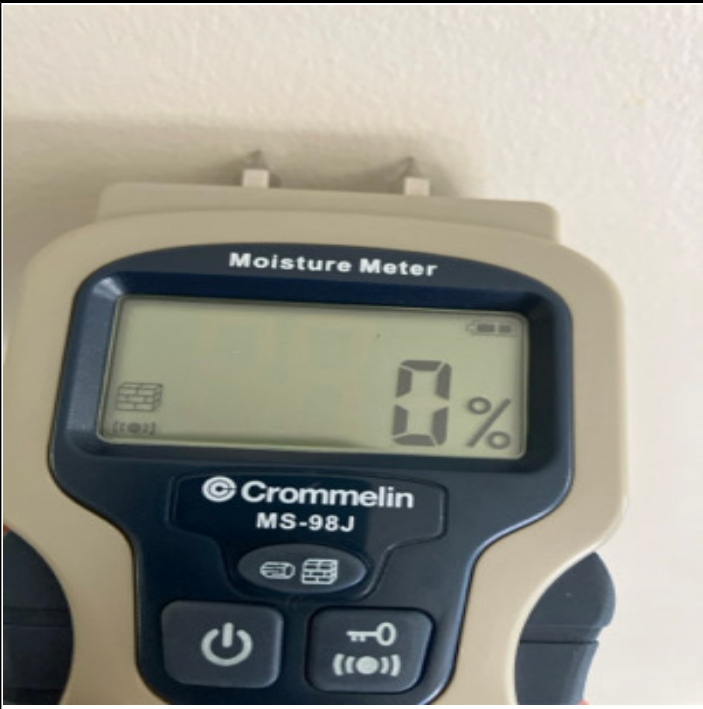
Photo of moisture reading ON a wall

Moisture reading meter (Dry or Wet?)	0
Is there any mould present?	No
Is there any water staining or dampness present?	No
"MINIMUM STANDARDS: Does the mould and dampness meet the minimum standards? SubNote: Any sign of mould is a fail. Water staining and dampness on a case by case basis."	Yes

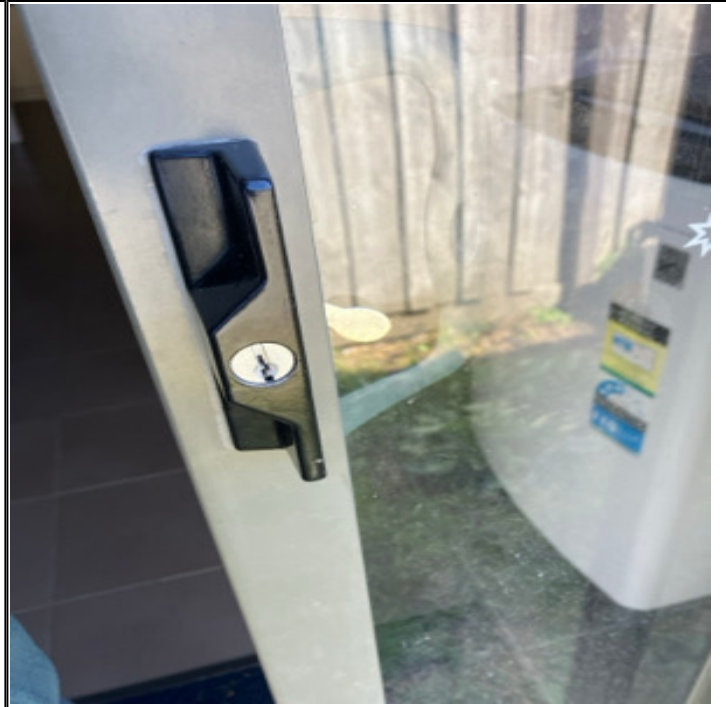
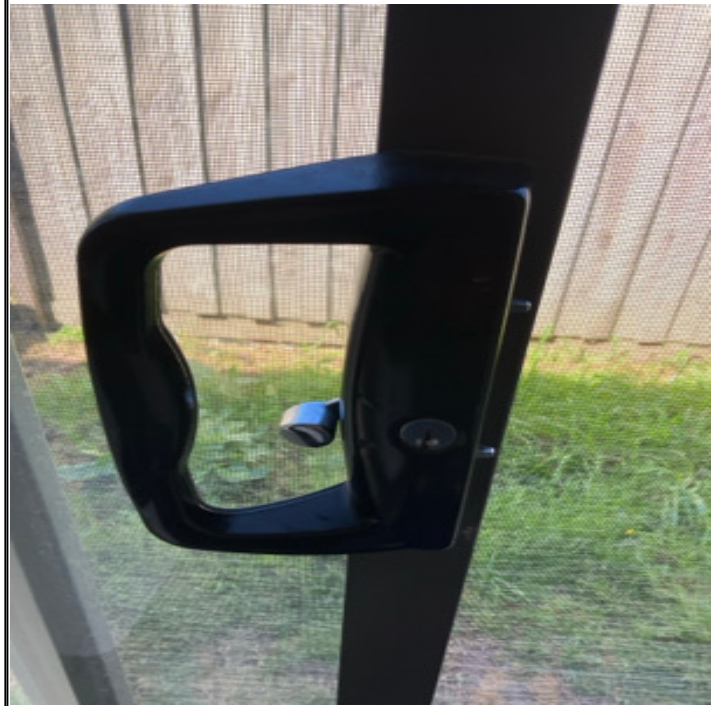
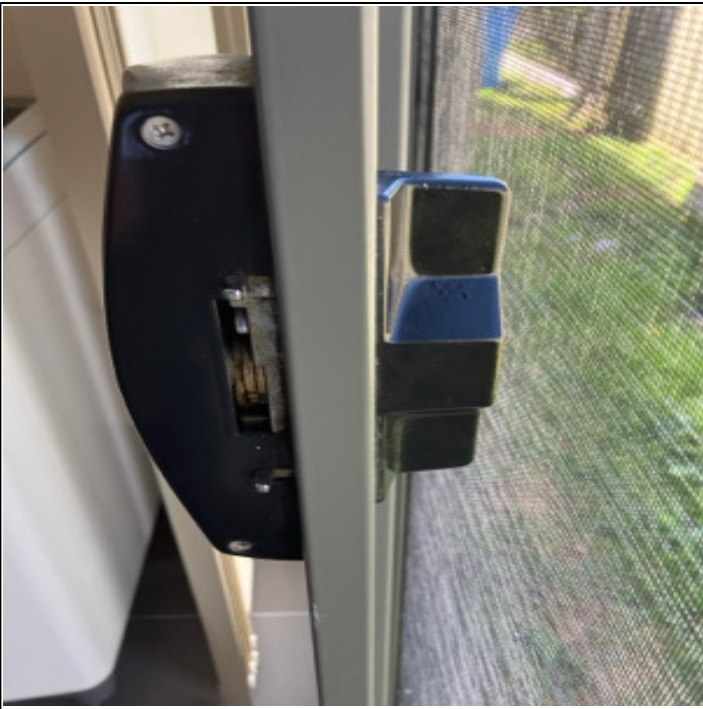
"3X CLOSE UP Photo evidence of deadlock/deadlatch (from the outside, Inside and in an operated position or with pin visible)"

Is the deadlock/deadlatch feature on the external door functioning?	Yes
Does the external door meet minimum standards? SubNote: All external entry doors must have a deadlock/deadlatch feature. Exceptions: The door is a public lobby door to common property; The door has a heritage restriction	Yes

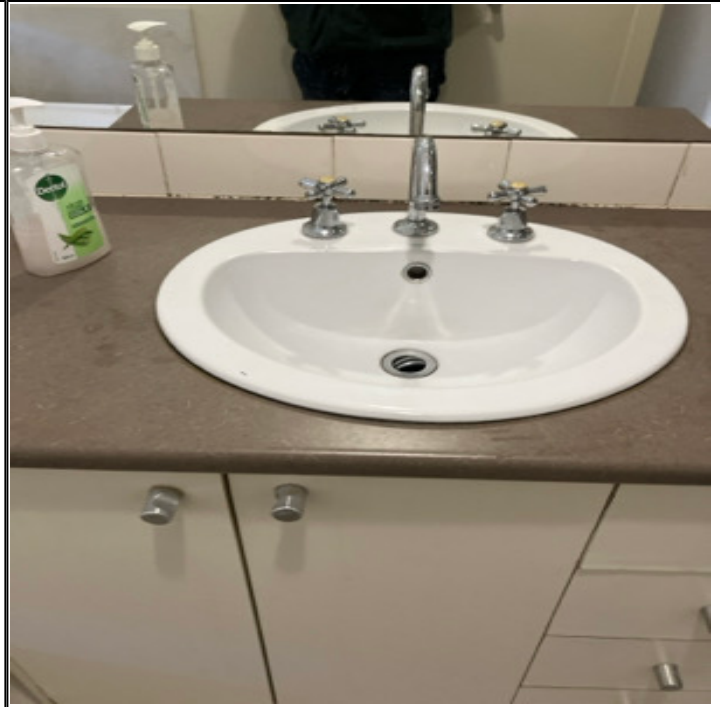
Photo of washbasin in the bathroom ?

Mould on caulking to vanity splash back

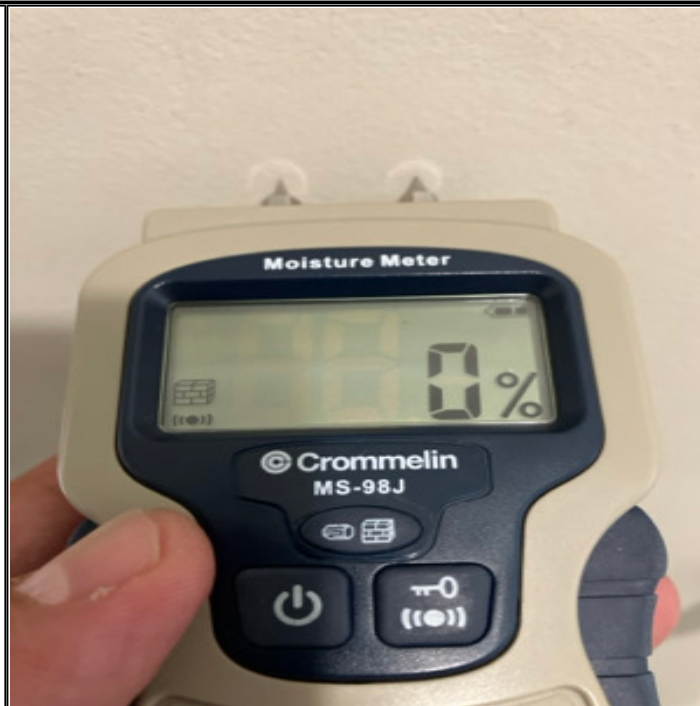
Photo of moisture reading ON a wall

Moisture reading meter (Dry or Wet?)	0
Is there any mould present?	Yes
Please select where mould is present	Wall

Is there any water staining or dampness present?	No
"MINIMUM STANDARDS: Does the mould and dampness meet the minimum standards? SubNote: Any sign of mould is a fail. Water staining and dampness on a case by case basis."	No
If no or unable to determine please make a comment for the owner	Mould to caulking and grout

Fail Comment:	Exhaust fan does not work when one exists in this area.
---------------	---

"ROOM OVERALL: Does the area OVERALL meet the minimum standards?" (Consider if any fails in the room)	No
Mandatory Additional comments on the area for the owner on why it failed or was unable to determine	Mould and fan not working

Fail Comment:	Mould present that is caused by/related to the building structure is present. Remediation of this mould will prevent future issues as mould is a living organism and will continue to grow and spread. Recommendation of a specialist attend to remediate correctly and ensure all spores are removed.;Mould in/on silicone.;Mould in/on grout.
---------------	---

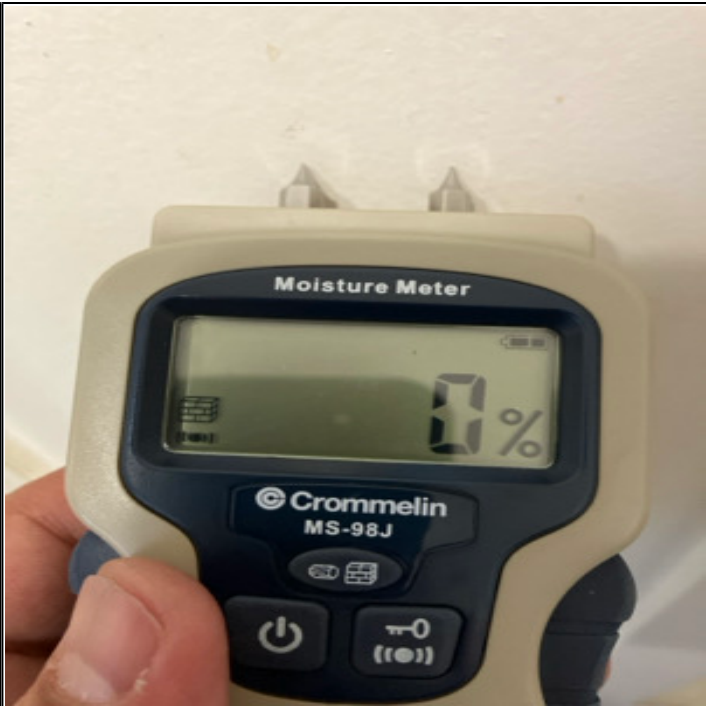
Photo of moisture reading ON a wall

Moisture reading meter (Dry or Wet?)

0

Is there any water staining or dampness present?	No
"MINIMUM STANDARDS: Does the mould and dampness meet the minimum standards? SubNote: Any sign of mould is a fail. Water staining and dampness on a case by case basis."	No
If no or unable to determine please make a comment for the owner	Mould to grout and caulking

"ROOM OVERALL: Does the area OVERALL meet the minimum standards?" (Consider if any fails in the room)	No
Mandatory Additional comments on the area for the owner on why it failed or was unable to determine	Mould to grout and caulking

Fail Comment:	Mould present that is caused by/related to the building structure is present. Remediation of this mould will prevent future issues as mould is a living organism and will continue to grow and spread. Recommendation of a specialist attend to remediate correctly and ensure all spores are removed.;Mould in/on silicone.;Mould in/on grout.
---------------	---
