Marine Surveying

– It's benefits to Commercial Shipping & your Company's bottom line

ICS ME SILVER JUBILEE CPD WEBINAR SERIES

22ND NOVEMBER 2020

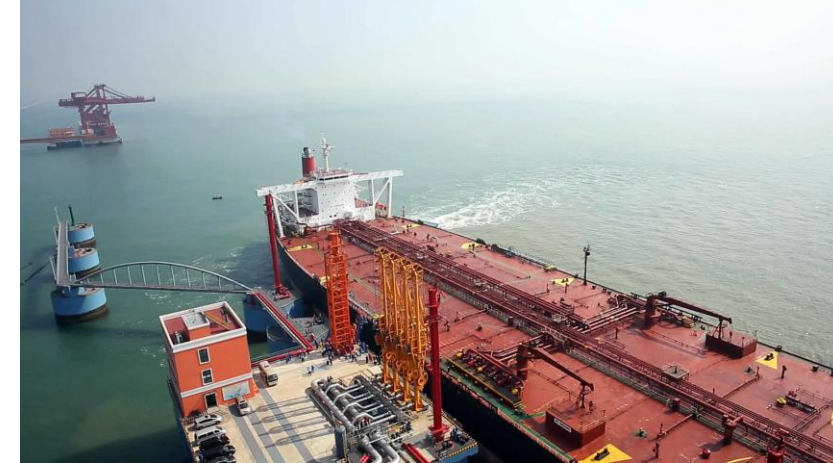
Fact: *A 99K DWT tanker vessel was presented for inspection upon completion of its first foot loading of a cargo of gasoline*

- Joint sampling conducted by Shippers and charterers surveyors, and subsequent testing, showed the cargo loaded to be off specs. (Failed flash point parameters)
- The vessel shifted to anchorage, pursuant to which the vessels owners IG P&I club requested us to attend.

- Attended the lab for testing of these samples together with other interests. (upon witnessing first foot sample extraction)
- We discovered, post testing that Gasoil in all the nominated tanks 1P&S, 4P&S, Slop P&S was Off Specification (as the minimum flash point requirement was 60 degree Celsius.)
- The shore tank sample was jointly tested by us for flash point, and it was observed passed (flash point very close to the minimum required).
- This presented a unusual problem for the owners, since the supplier cargo was in specs.

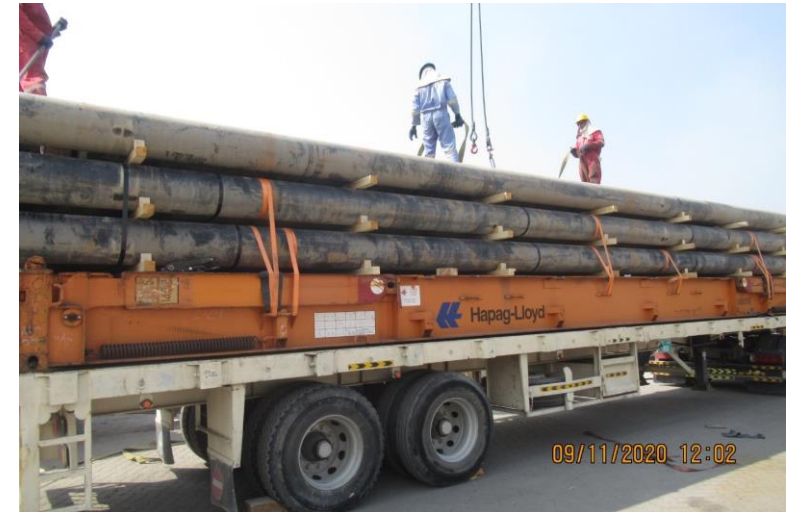
Fact: *The shipper intended to secure feet long pipe casing on multiple 40 feet flat rack as per the international safe practice .*

- Naval Architects prepared sketch for the cargo arrangement on flat rack container as per CSS and CTU Guideline.
- Collaborated with lashing team for full loop and Olympic loop lashing.
- Supervise each tier lashing. (clarifying important distinction)
- Supervised & certified securing of pipes casing on flat-rack container. (Taking to the account vessels GM)

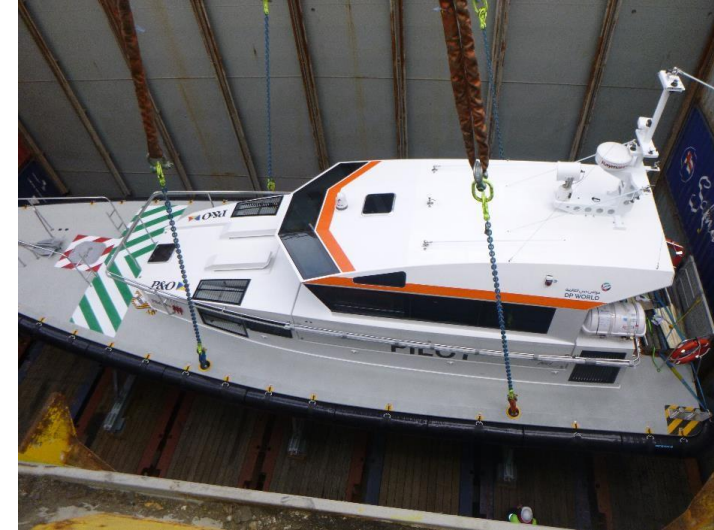
Fact: Boat provided afloat & specs with vessel's GM & location planning given

- We reviewed the lifting plan proposed by the port by calculating the loads with reference to SWL.
- We developed the lashing plan as per the IMO Annex 13, CSS Code.
- Pre-load condition of the cargo was recorded and documented.
- Master Mariner surveyed the safe lifting loading and securing of the cargo on the carrier as per the Method Statement drawn out by us and accepted.

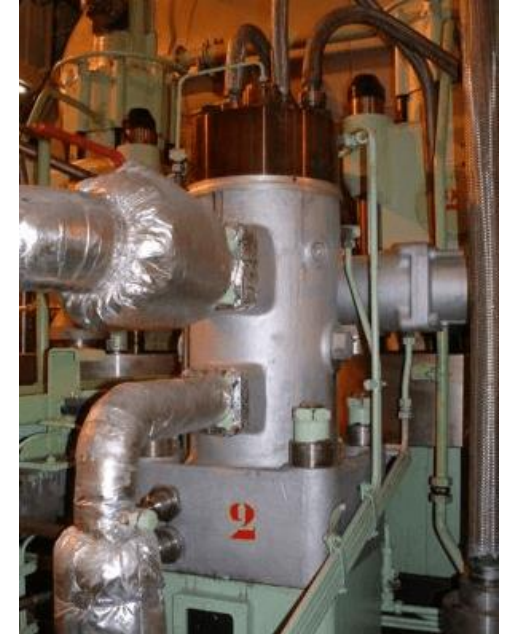
Fact: 12 Nos. plunger and barrels of the fuel pump of the Auxiliary engines belonging to a ship had seized. 8 Nos plunger and barrels of the fuel pump of the Main engine had also seized. There was sludging of the fuel evident.

- The plunger and barrels of fuel pumps of both Main engines and Auxiliary engines were worn out and sticking. The chrome polish on the plunger had vanished.

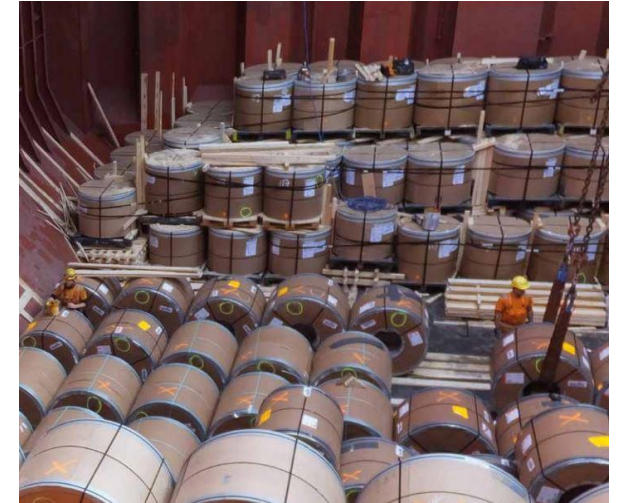
Fact : *Surveyor was nominated to attend a joint survey to investigate cargo appearing in rusty condition.*

- The attending surveyor had checked the shipping marks stipulated on the cargo with the packing list and Bill of Lading. (Which indicated clean cargo – free of rust).
- Silver Nitrate test was carried out at 10% random basis on the rust affected cargo and was found that there was no salinity on the cargo. Further investigated on this matter and it was proven that few days ago there was heavy rain fall (As per the weather reports), and all the cargo which they stored in their open yard and was completely affected by the water rain.

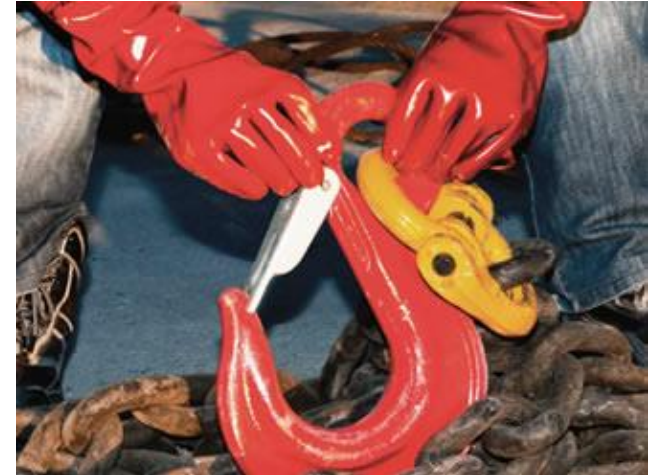
- Condition inspection of each gears with identification marks.
- Checking of operating condition of each gears
- Inspection of load test certificate
- Bridle wire of the barge was seen rusted with lack of greasing (effected immediately)
- Strands of steel was broken which could have reduced the actual SWL of the wire
- The damaged wire was replaced with new spare wire

- The broken strands bridle wire if not replaced it would have parted during the loaded tow voyage and , may have damaged own and other vessel or ports property resulting in avoidable claims.
- If the loose gear was inspected timely the spread, could be rejected for towing and delay charges from port would become to the owners /account
