# Li-Ion Battery Fire Report

Report of Lithium Ion Battery, South Africa

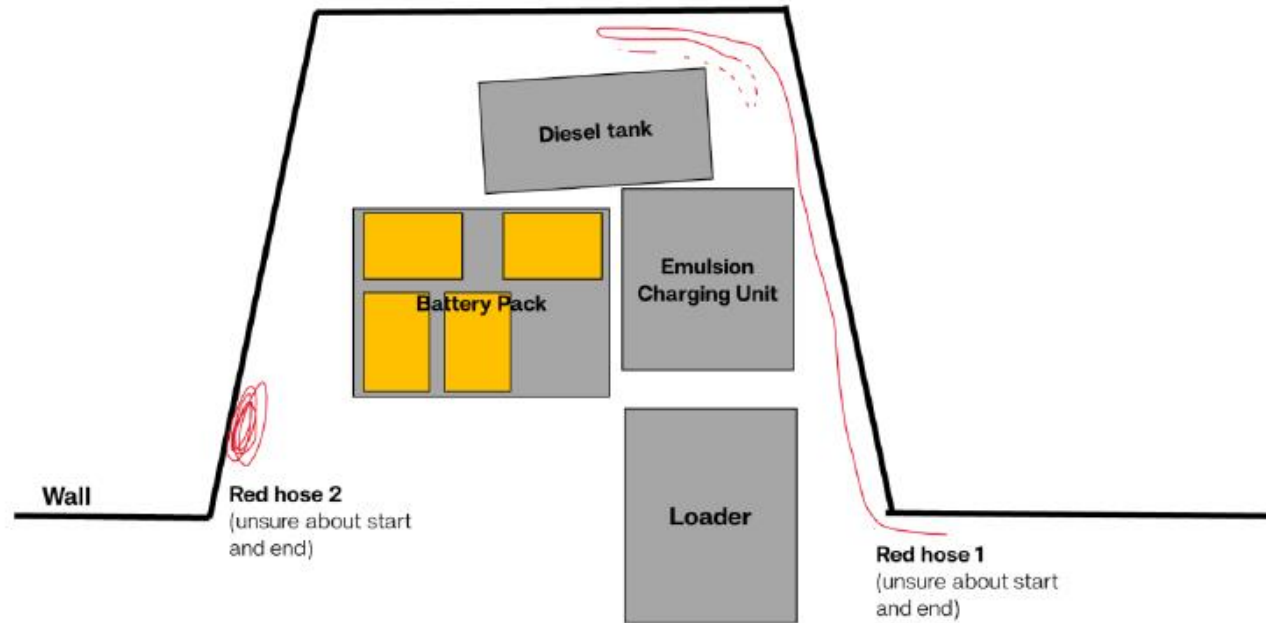
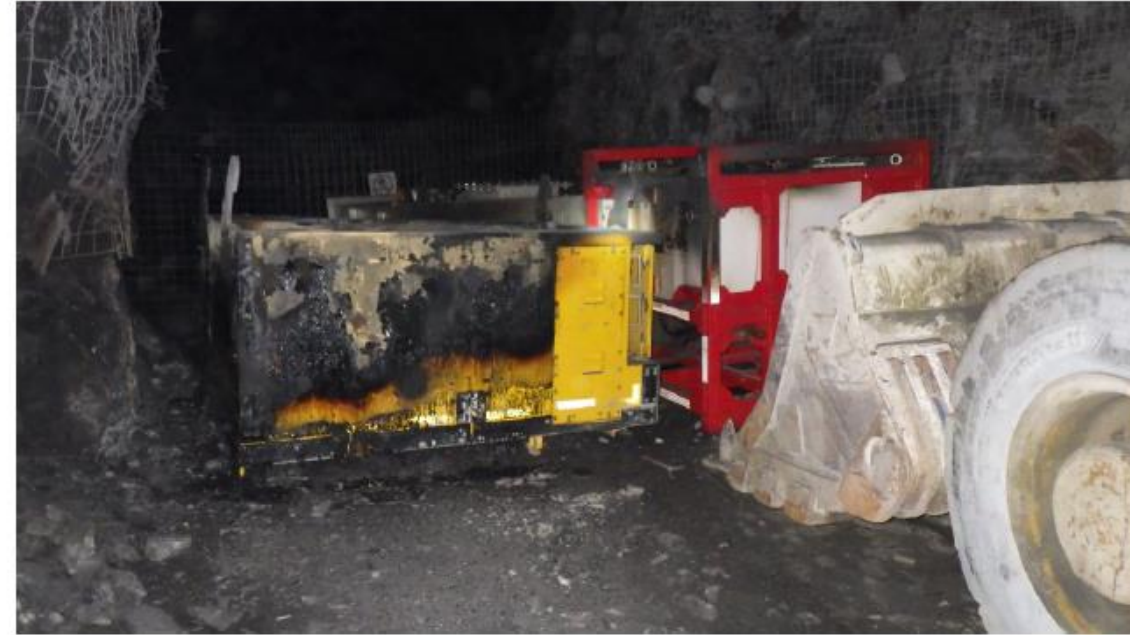
- On the morning of the 31 January 2025, a battery fire was reported to Epiroc having occurred in a underground mining operation
- The battery, at the time of fire, was not in use, either charging or discharging and was booked down for repairs during this period
- The fire was reported at approximately 00:12, where a mine evacuation was initiated. The battery was doused with service water whilst burning, for approximately 25 minutes, after which it was reported that battery flames had completely subsided.
- No injuries or gas inhalation was reported as a result of the battery fire.
- Mining operations resumed during the night shift of the 31 January 2025, after the battery and area had been declared safe.

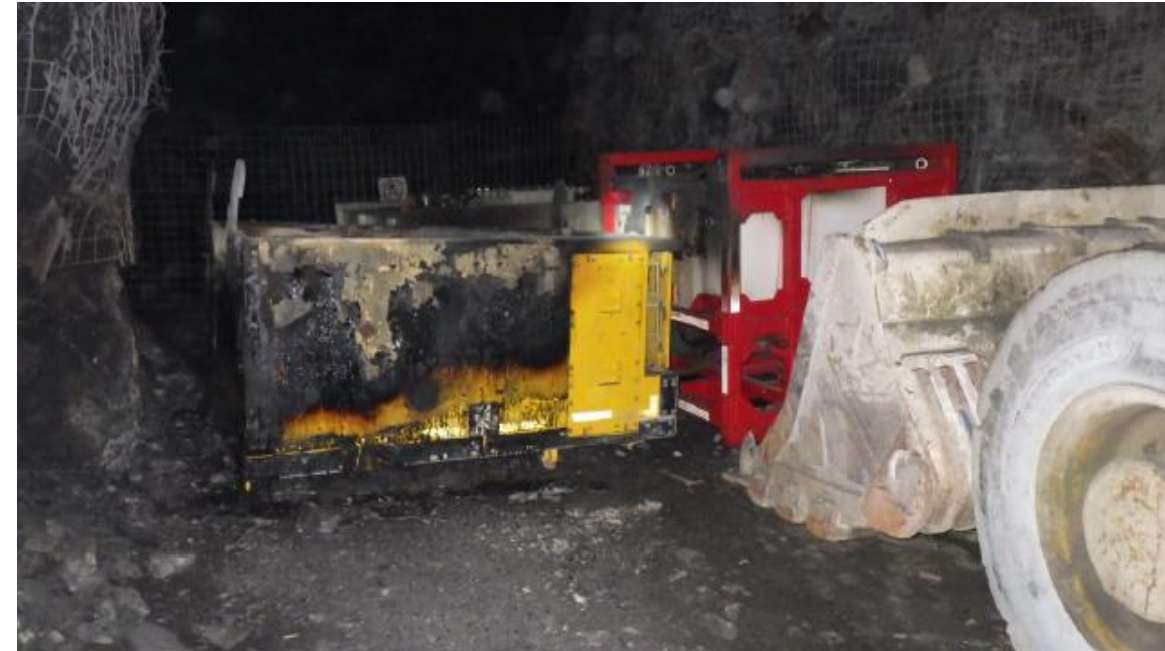
- During the investigation, the battery was found to be located in a state with the battery cover and Thermal Management System (TMS), removed from the battery
- The battery was found stored in an area, close to other equipment
- All subpacks had shown signs of thermal runaway, indicating all cells had been burnt within the battery
- Foreign objects found within the battery casing

- Storage & Handling
  - Ensure all storage & handling conditions are incorporated into Mine Operational Risk Assessment & Procedures
  - Ensure personnel involved with Battery pack operations are aware of storage and handling conditions

- Mine to ensure areas allocated for battery storage are conducive to OEM Storage/Handling Recommendations
  - Correct Tools to be utilized for lifting and moving of battery packs

- Safe Operating Procedures
  - Any battery pack on breakdown, to be locked out to prevent accidental use of the battery pack
  - Battery packs to not be left open within an underground environment

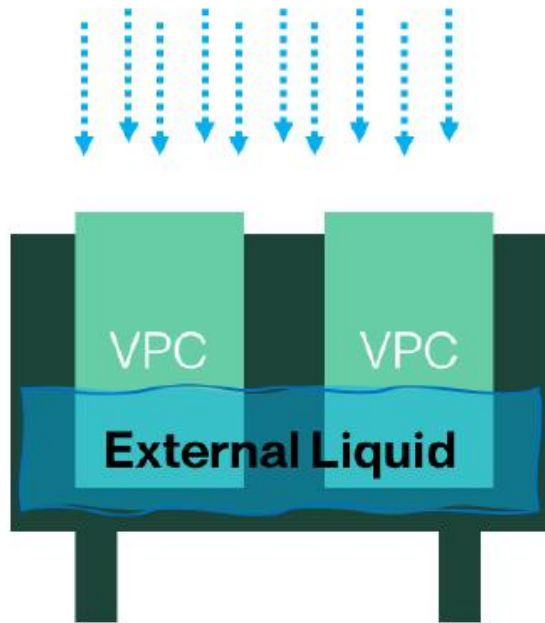
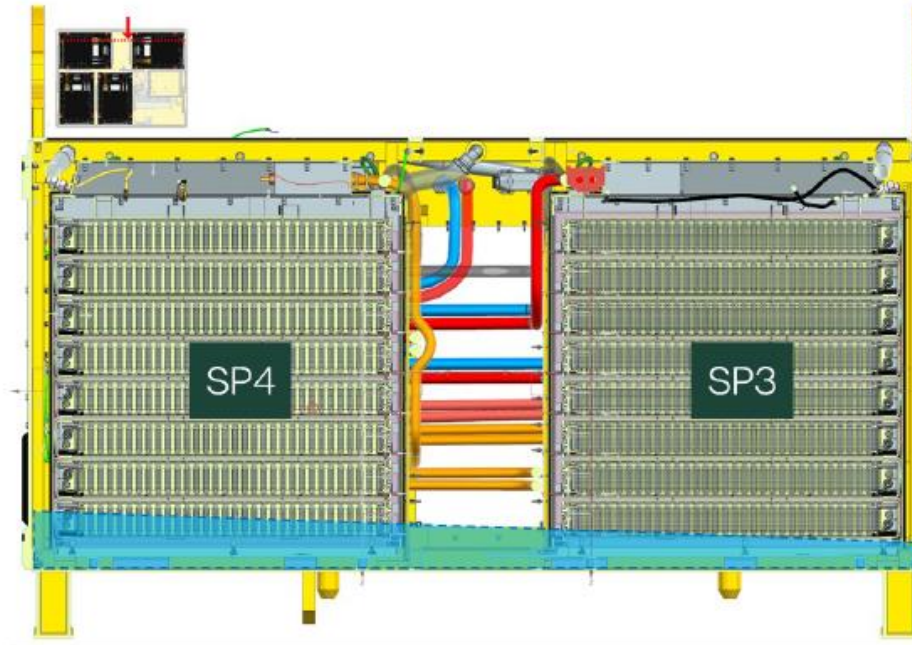
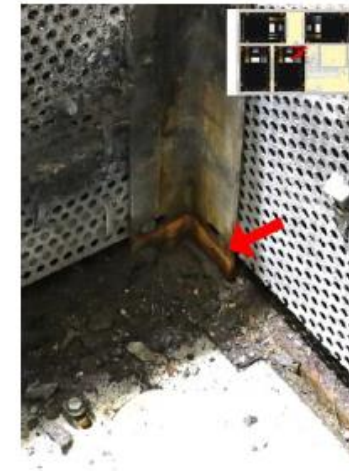
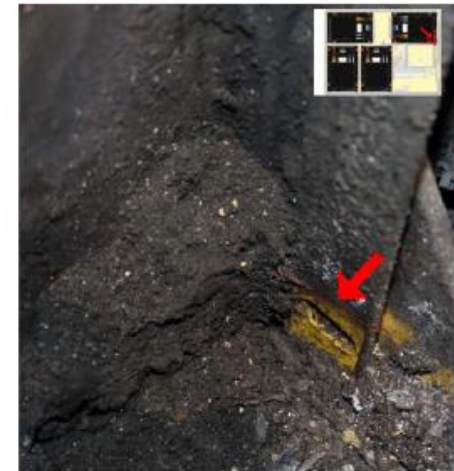
- Further investigation, noted burn patterns of the battery, coinciding with water ingress into the battery cavity, where no fire damage was incurred at a level lower than the water level believed to be within the pack during the thermal runaway
- With the Battery Lid and TMS removed, the IP rating of the battery pack was compromised, and battery subpacks exposed to conditions, not in accordance with storage and handling conditions of subpacks
- Drainage valves on the battery pack were also not opened, preventing water ingress from building in the battery pack

- All Plug Covers to be in place when battery pack is stand alone
- Li-Ion Battery Knowledge
  - Educate organisation around the risk related with Li-Ion Batteries and Dangerous goods
