Inspect manual bleed valve

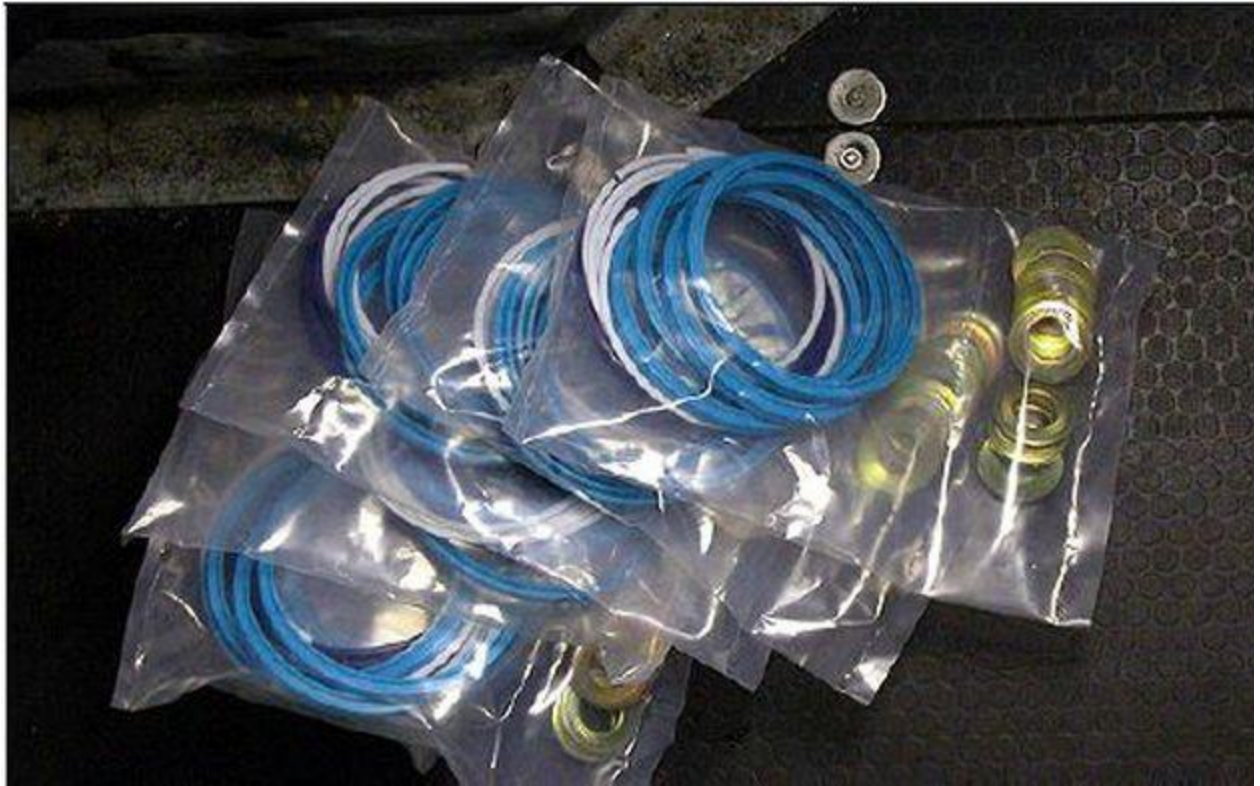
Gasket Set (1 per half caliper)

Check for external leakage at brake calipers, hose connections & hyd. power unit (if leakage is from caliper seals, replace seals. Check condition of pistons and replace if you see abnormal wear.

Relevant spare parts	
Description	Item No.
Gasket Set, FCHR90A-GF-B-828 (1 per half caliper)	60107597
Piston FCHR 90GF (2 per half caliper)	60113057

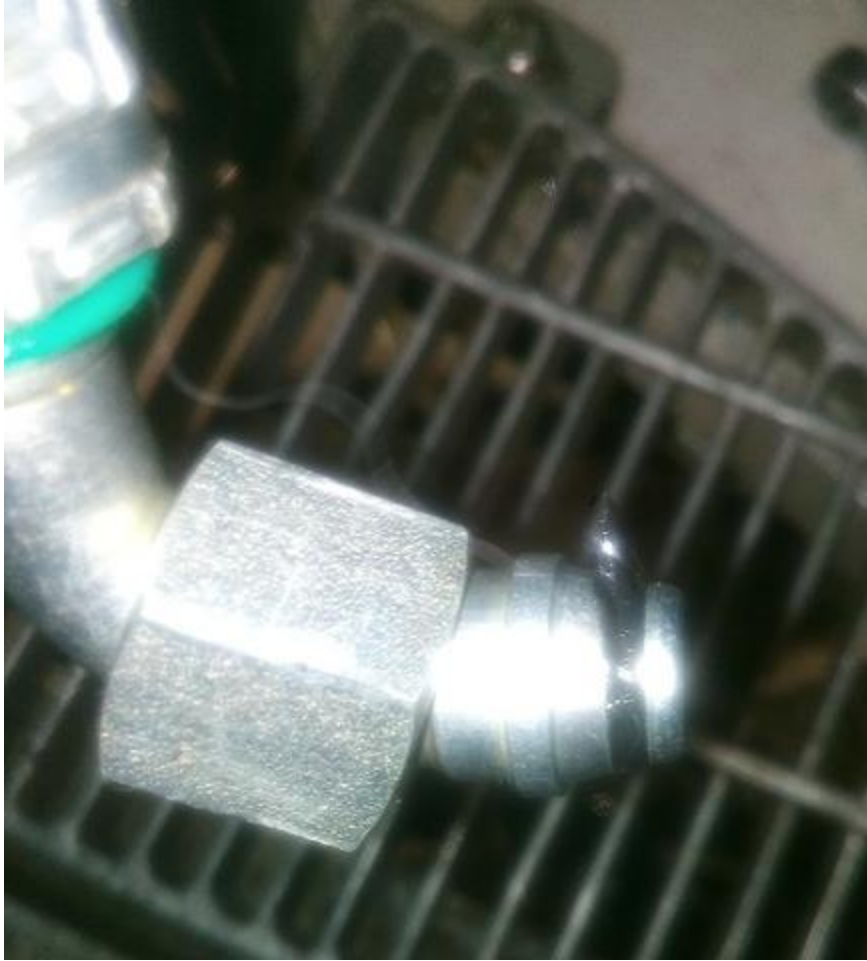
Oil seal/ O-ring damage in return hydraulic hose:

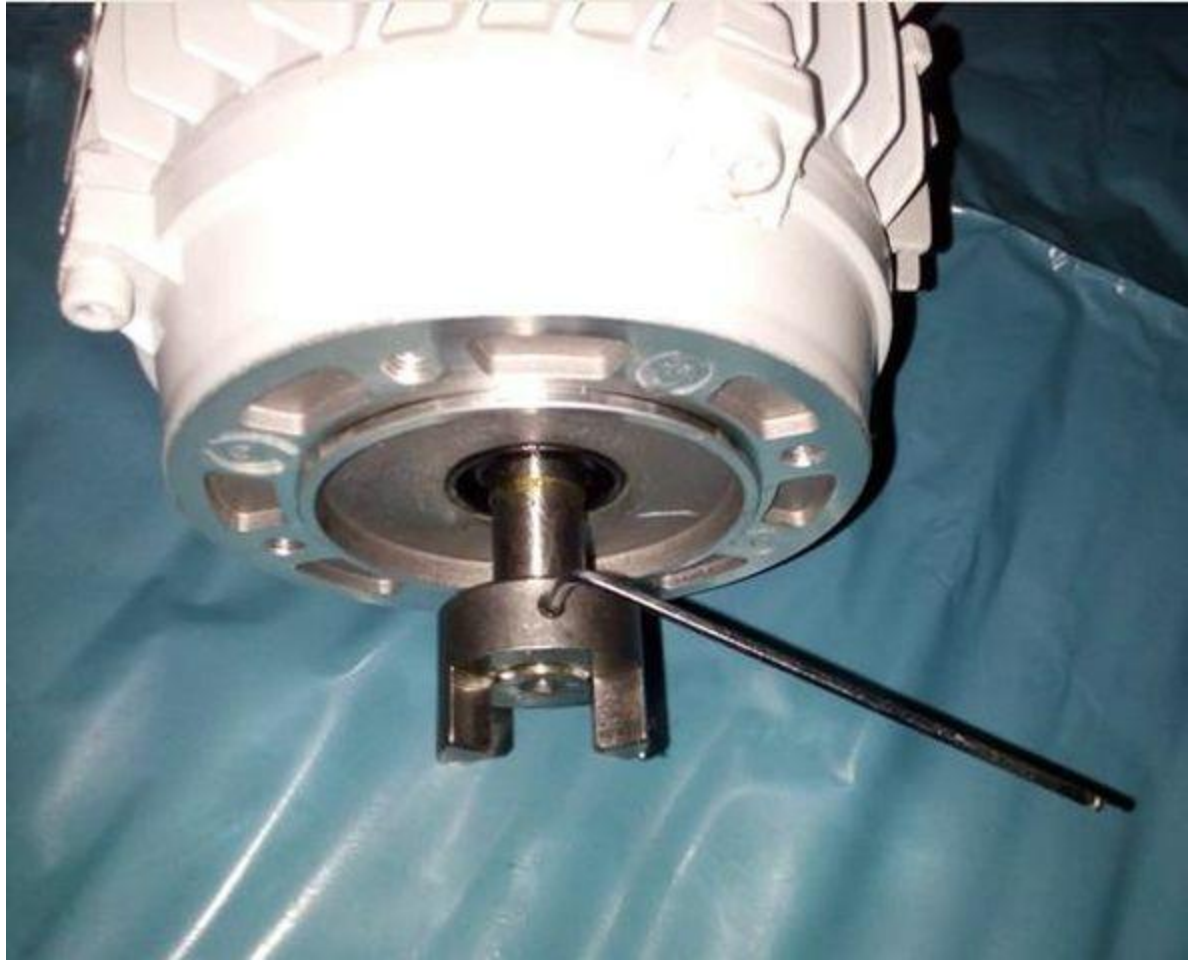
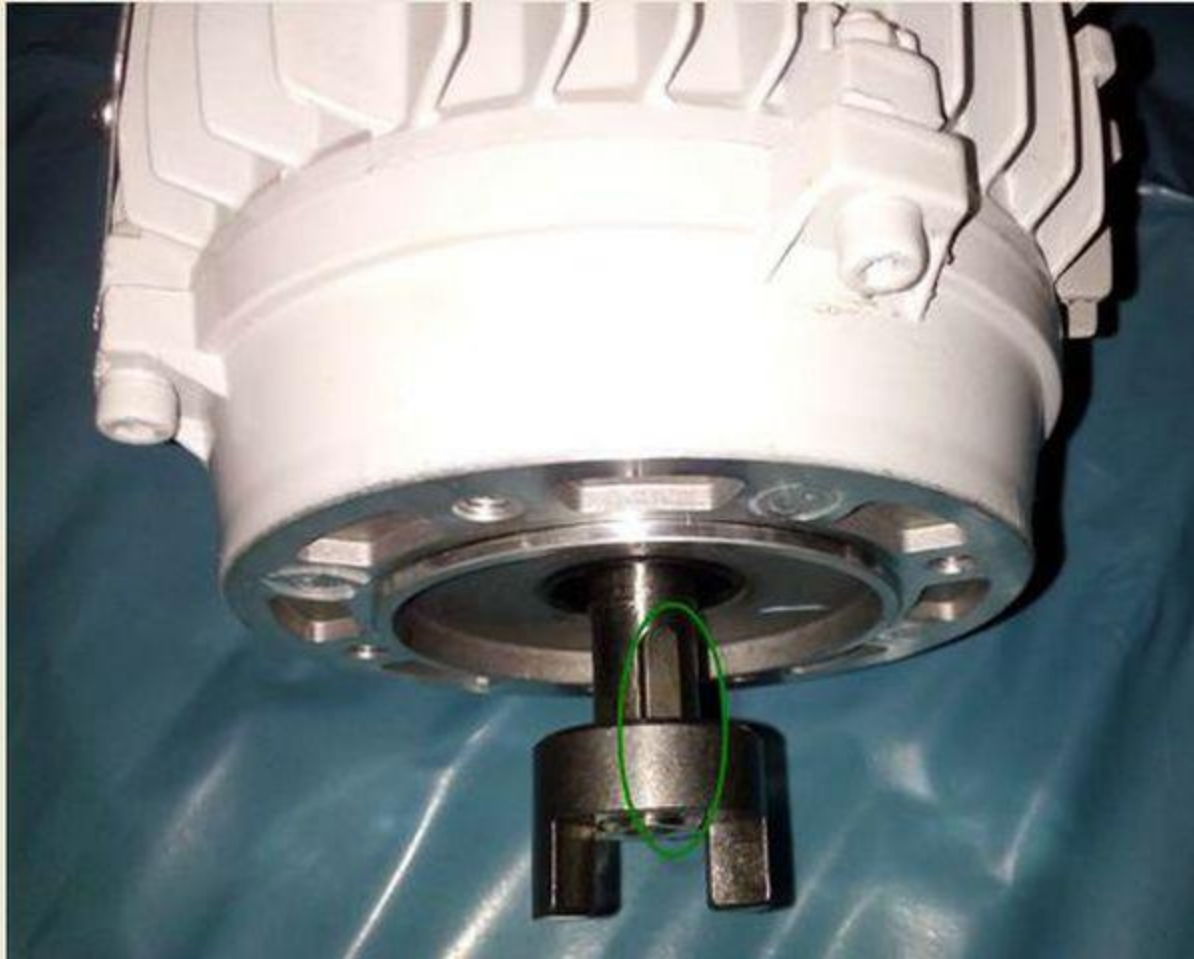
Check the motor-pump coupling for proper functioning, if the pressure is not developing while the pump is running. Then dismantle and check for proper engagement of Pump-Motor coupling assembly. In few instances, 2mm Allen screw which holding the flange with the motor shaft key way has loosen and leading to run the pump freely. If pump runs freely, then align the flange by tighten Allen screw as shown below pictures;

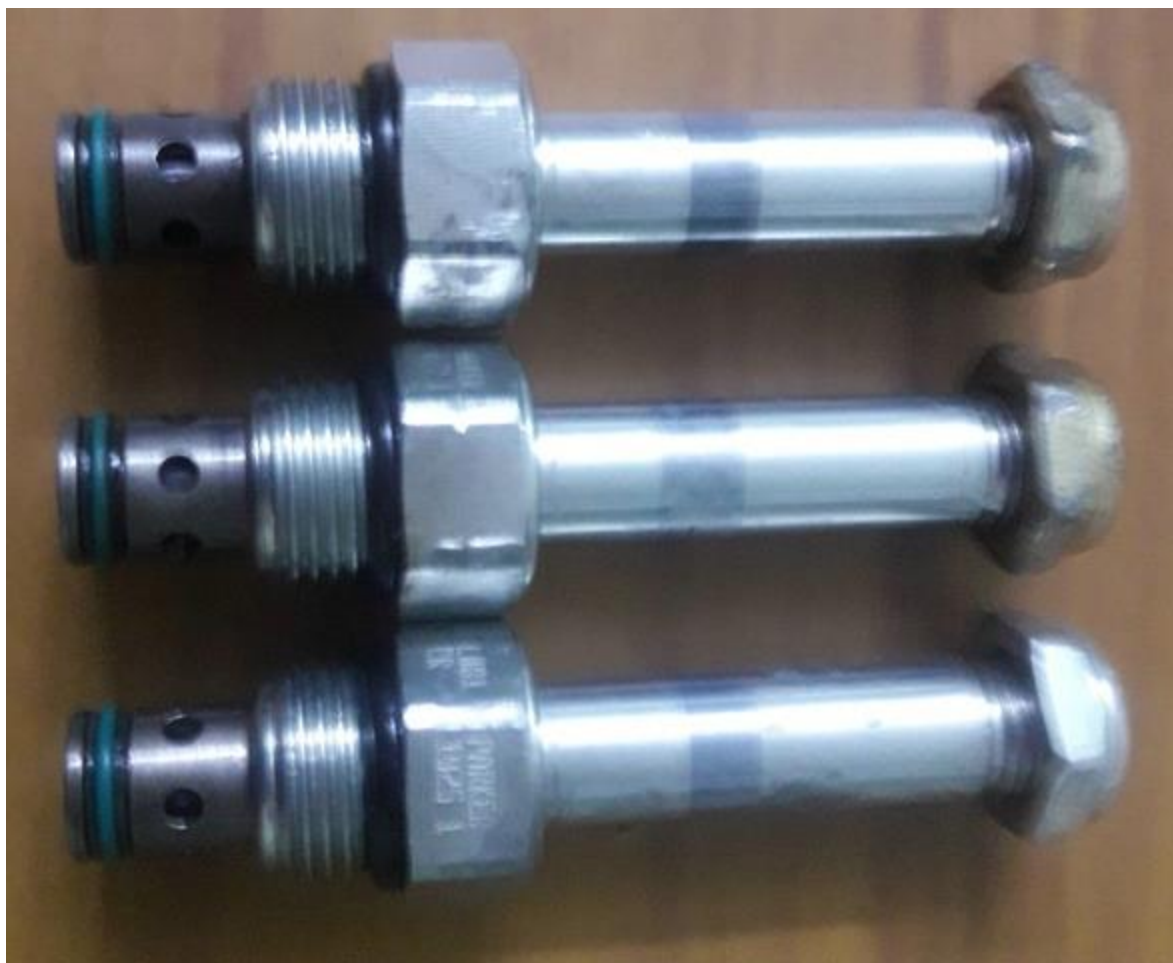
Check and replace the position 014,0.17 7 0.18 valves

Relevant spare parts		
Description	Item No.	Position
VALVE CHECK RHZ08ZLREDCF V82	60104016	06
DIRECT VALVE N.C. 2/2 DSL-08-1	60104031	0.14 & 0.17
VLV DIRECT NO 2/2 DSL-08-1-CR	60104034	0.18

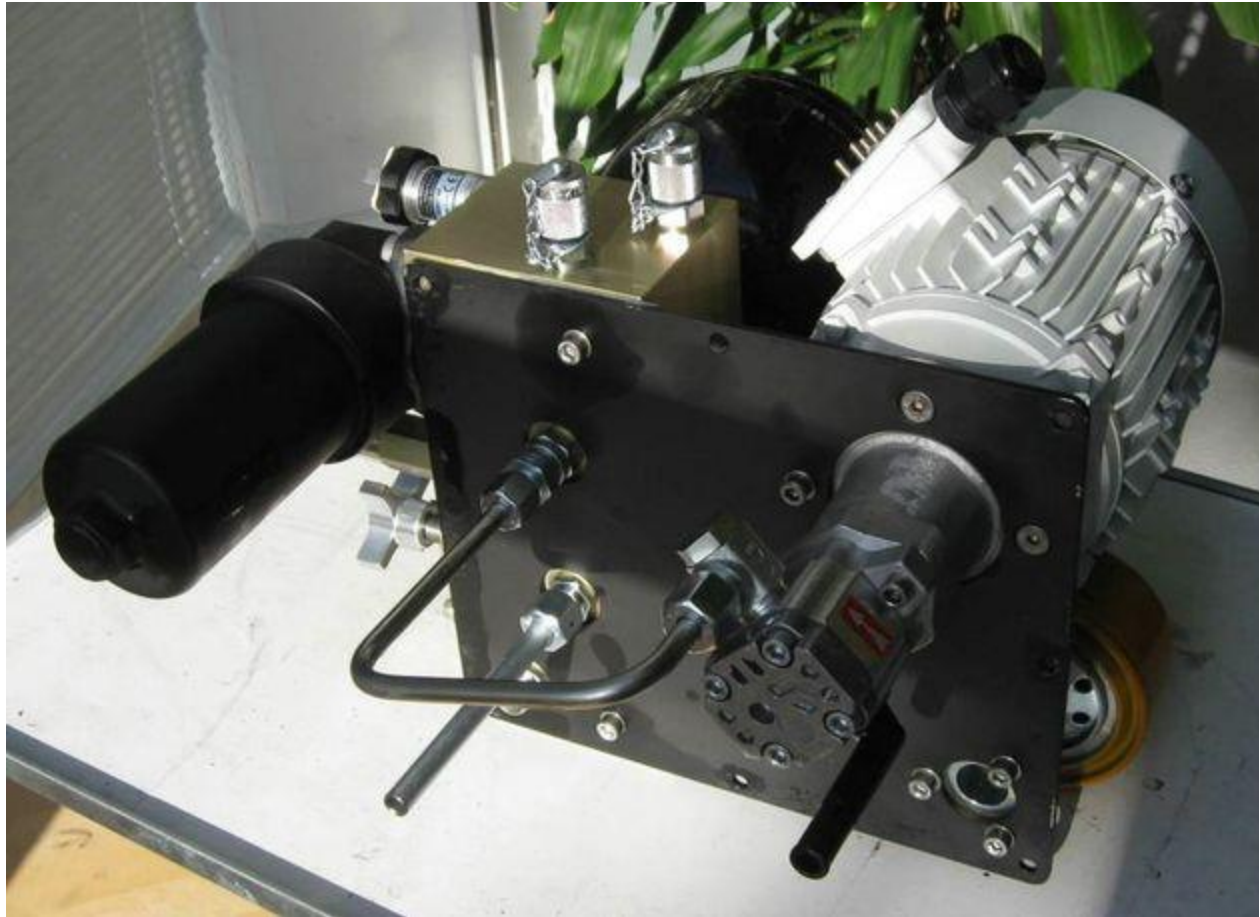
For Evo II turbines with Parker hydraulic units (e.g. mk.2 or higher):
Check if the hydraulic unit needs CIM1106 upgrade (replacement of coils and pump).

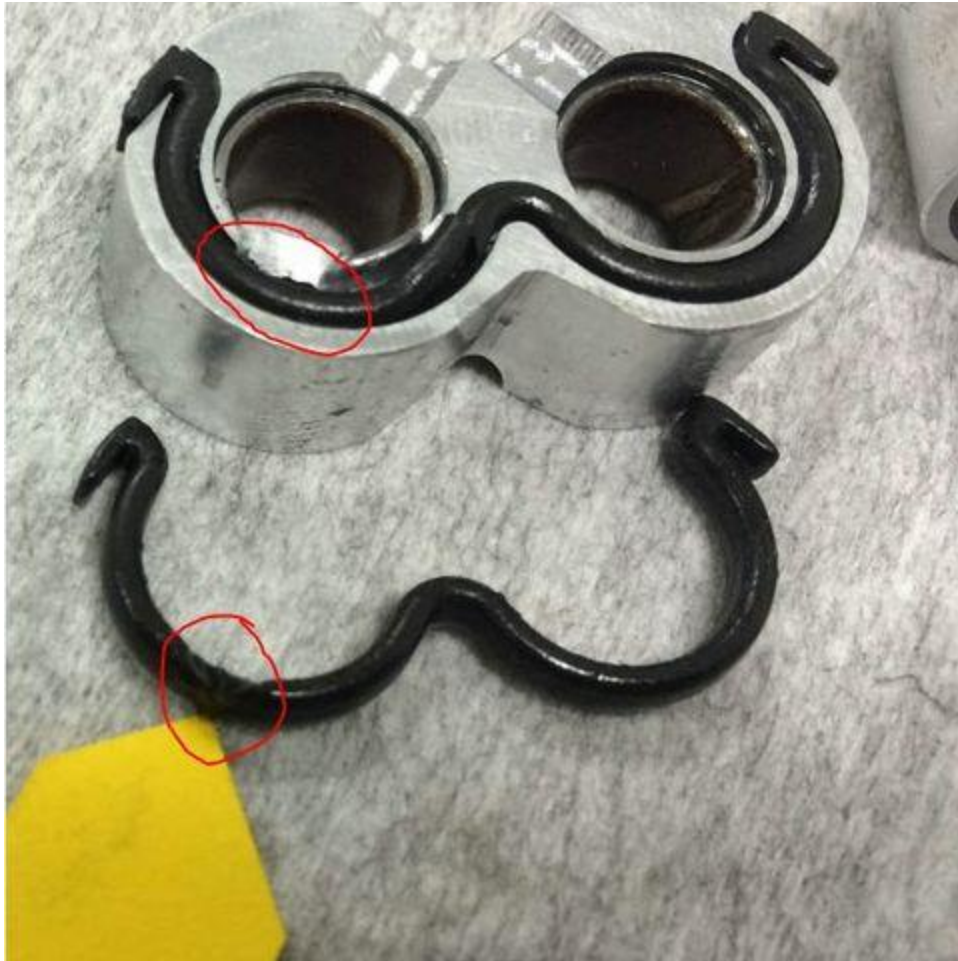
If new style pumps is installed check for internal seal failure.

Description	Item No.
Gear Pump P1 AAn 0050 FL 20-B0	60103470
