## Replace the defect valves

Check the hydraulic circuit diagram.

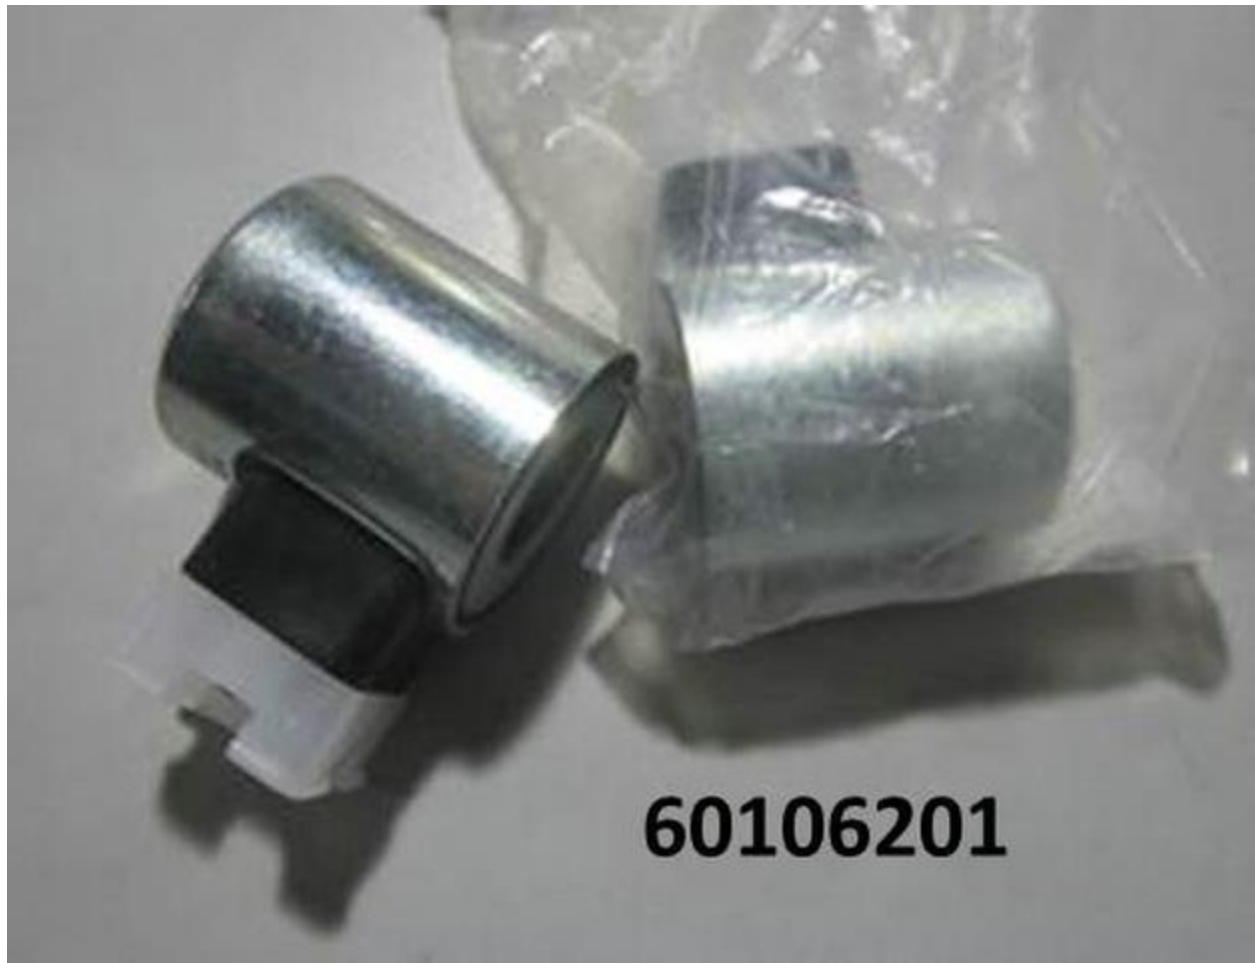
(Rexroth) Valve/Solenoid

The part No.60096475 is phased out and henceforth replaced by 109795 & 60106201.

Pos. 210 & 215

The part No.60096475 is phased out and henceforth replaced by 109795 & 60106201.

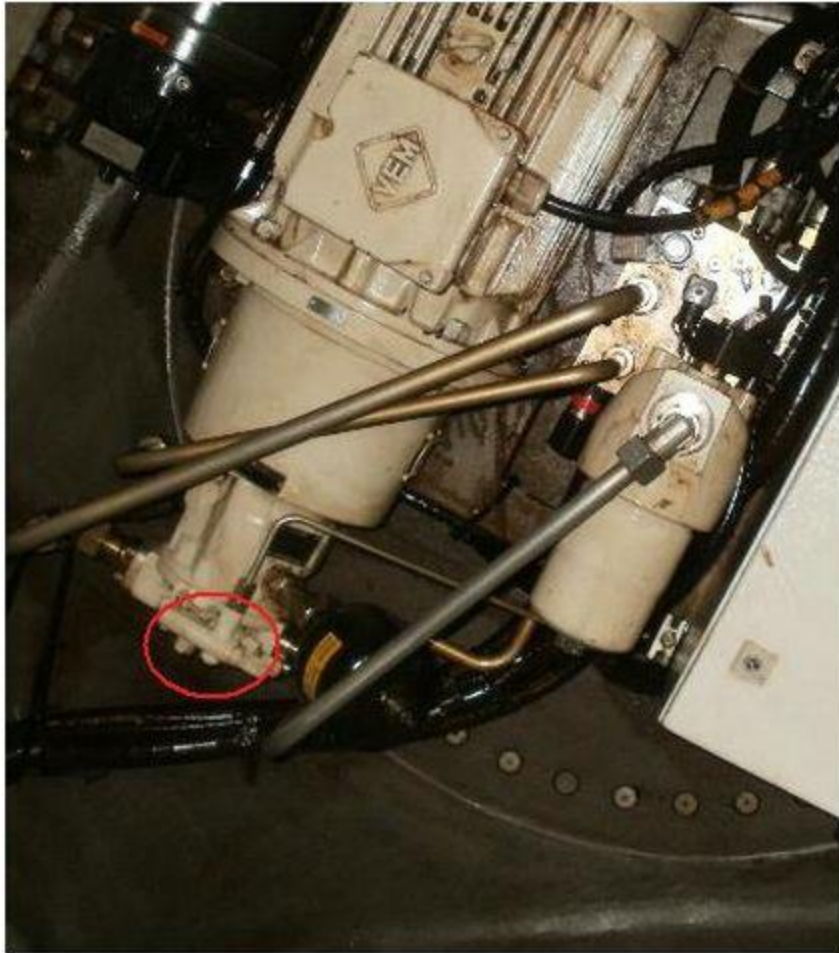
Part number for Rexroth compensator valve:

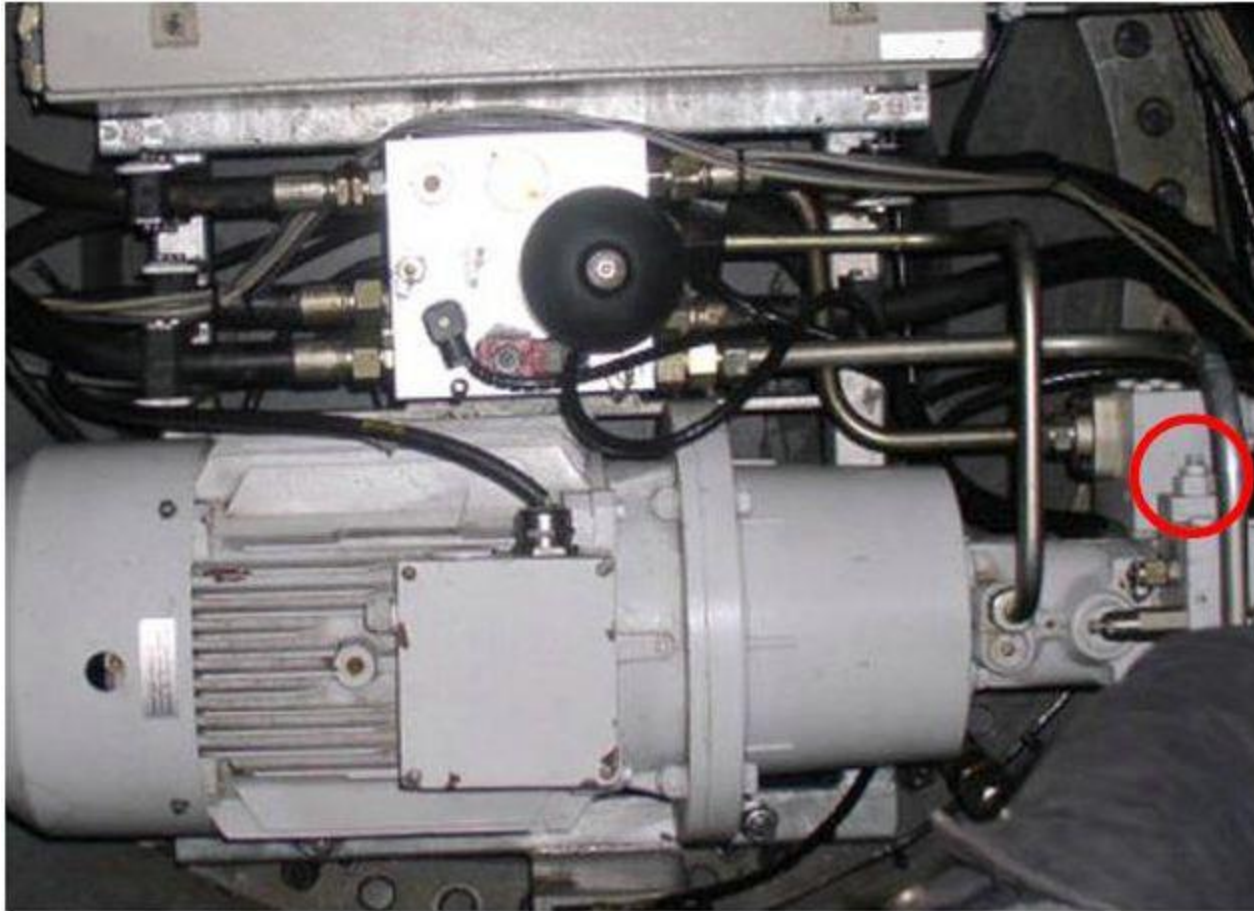
In parker hydraulic system have two different type of compensator valve,  
Ensure the valve type before replacing new valve.

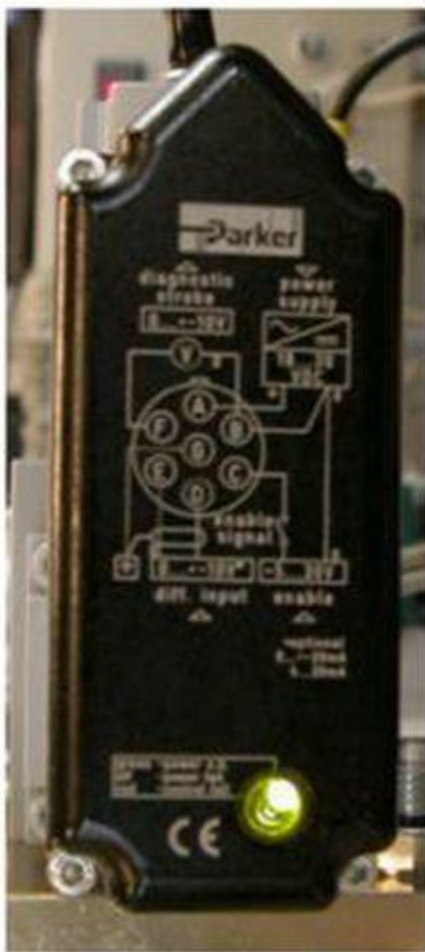
The LED should be green with the pitch system pressurized.

If it is red and there is pressure verified on test port MP, then the valve may also be defective.

<b>Display Color</b>	<b>Indicates</b>
Green	Normal operation
Off	Supply voltage outside permissible range of 18 to 30 VDC
Red	Spool position error / Low pilot pressure

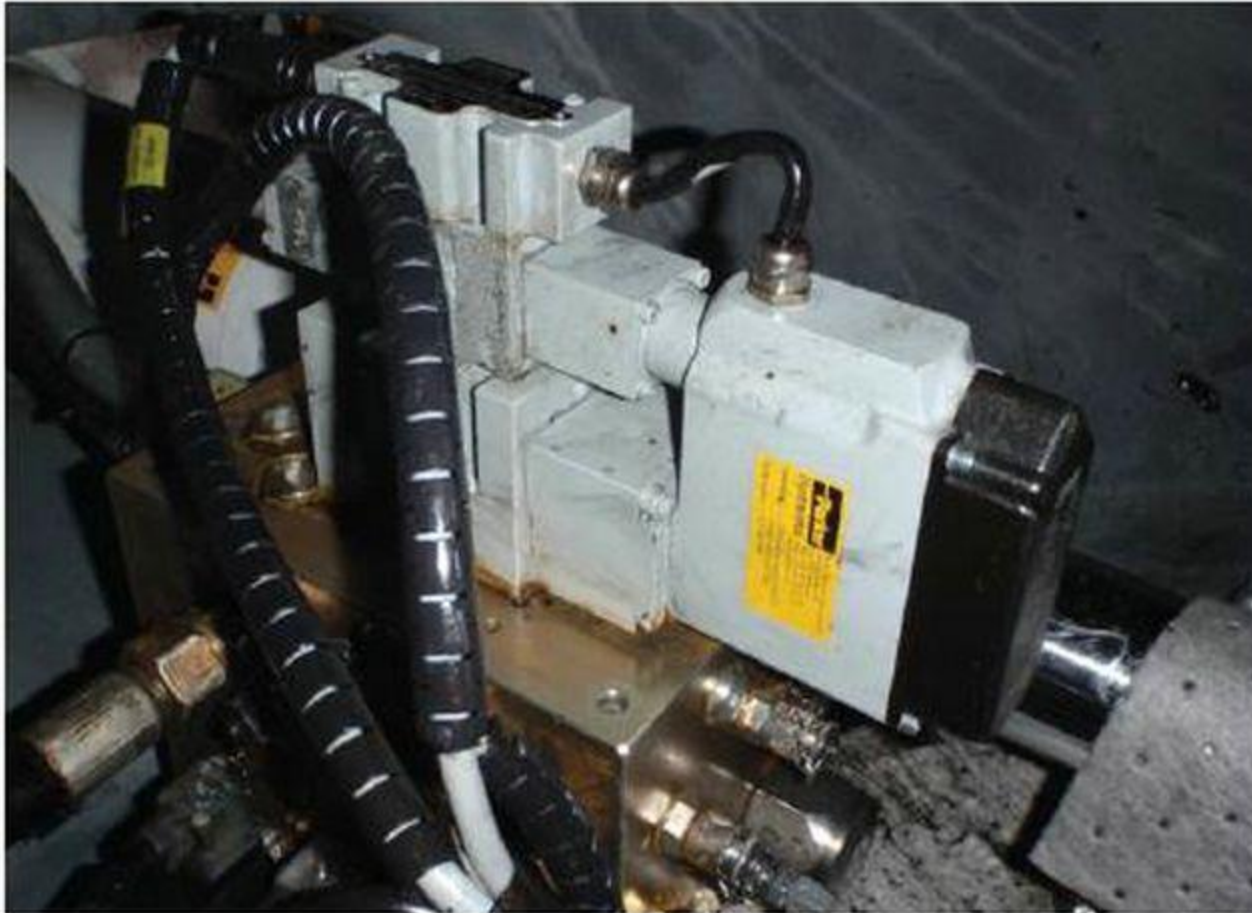
**Proportional Valve Item numbers:**

If the alarm follows the valve to the other blade, the proportional valve is defective.

If it does not, the proportional valve is likely not the cause.

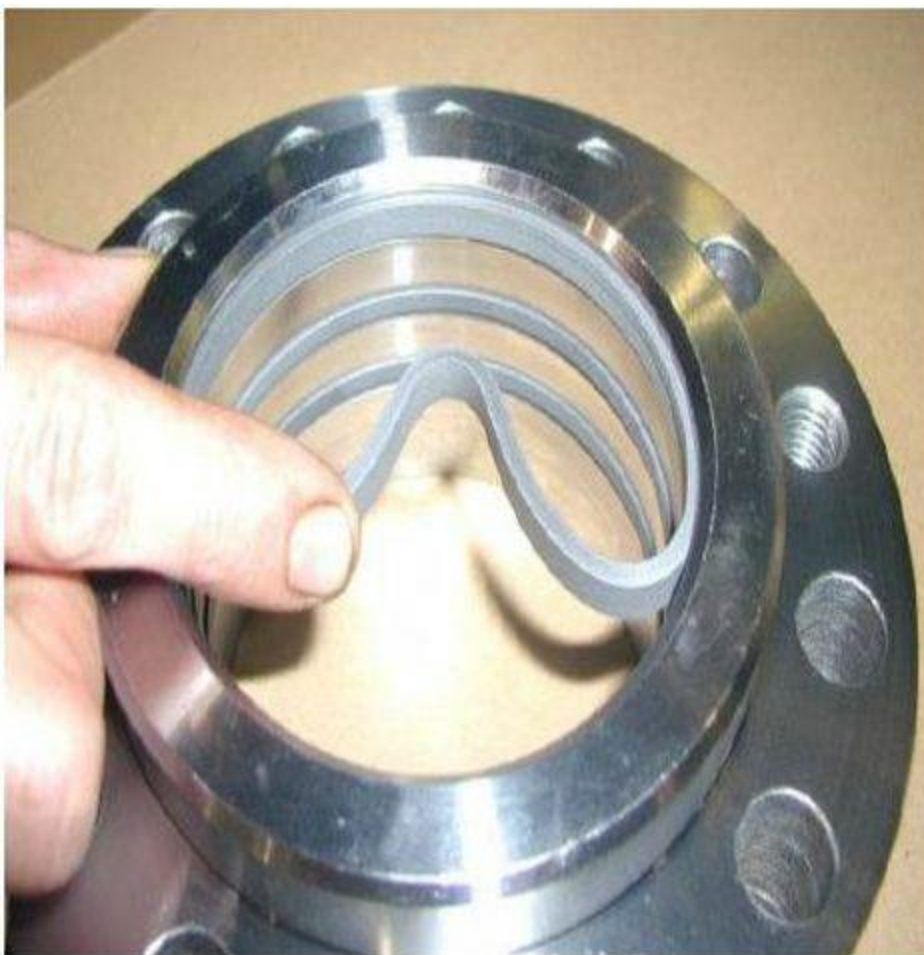
**PARKER System:**

Relevant spare parts		
Description	Item No.	
HYDR CYL 125/90x884 COMPLETE	<a href="#">60120439</a>	Actuator with manifold
HYDR CYL BUSHING W. SEALS ø90	<a href="#">60114033</a>	Seal with Bush

Check the Actuator rod surface thoroughly if any punch mark or damage.

Check the actuator seal if any damage or seal parts come out from push,

If found actuator seal failure replace with new seal kit.

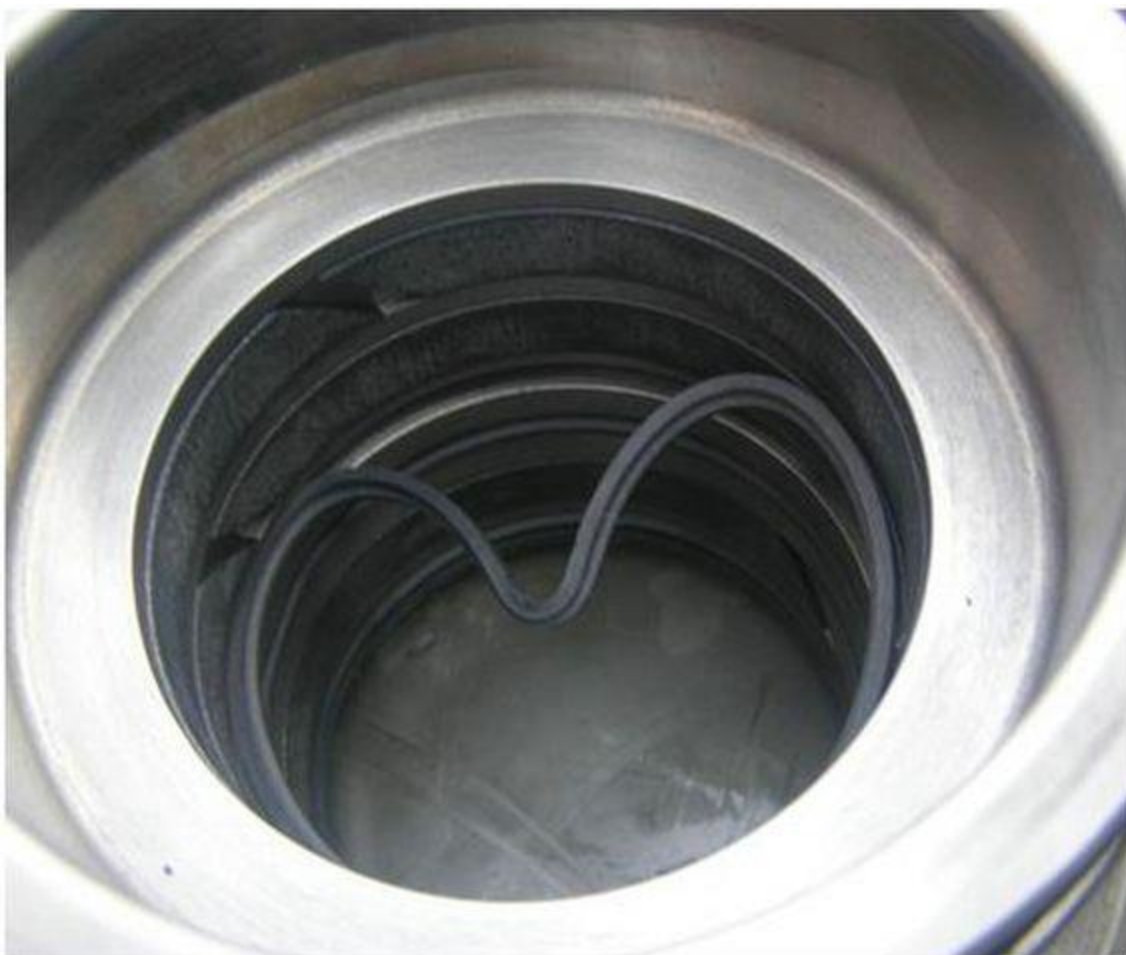
**REXROTH System:**

Relevant spare parts		
Description	Item No.	
ACTUATOR Ø140 WITH Ø100 TRUN.	<a href="#">60096442</a>	Actuator with manifold
ACTUATOR SEAL KIT	<a href="#">60110956</a>	Seal kit alone

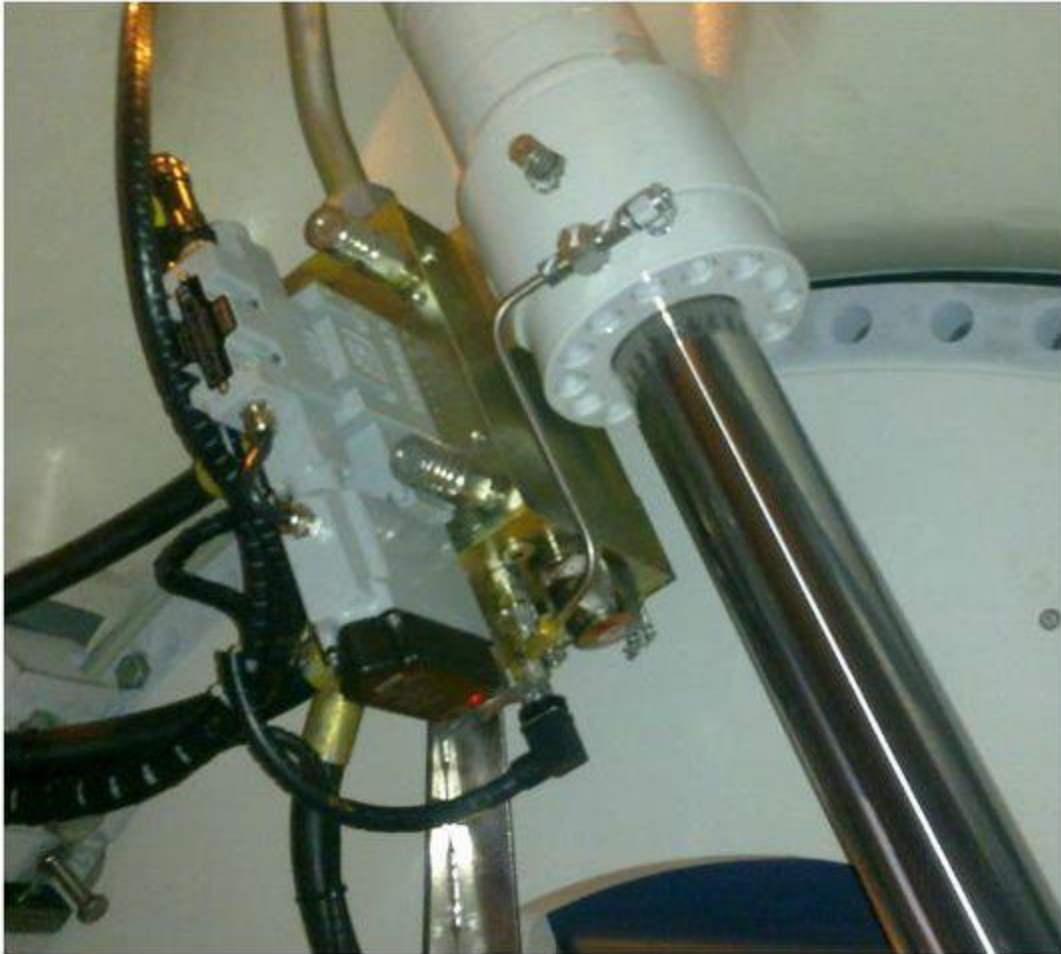
ITEM	TITLE
#1	Seal Bushing Assembly
#2	Non return valve - 3 bar opening pressure
#3	Swivel nut elbow
#4	Drain pipe assembly PH080236
#5	EO High pressure banjo tee
#6	EO Test Point with threaded connection M16x2 for cone

Ensure proper fixing and installation
