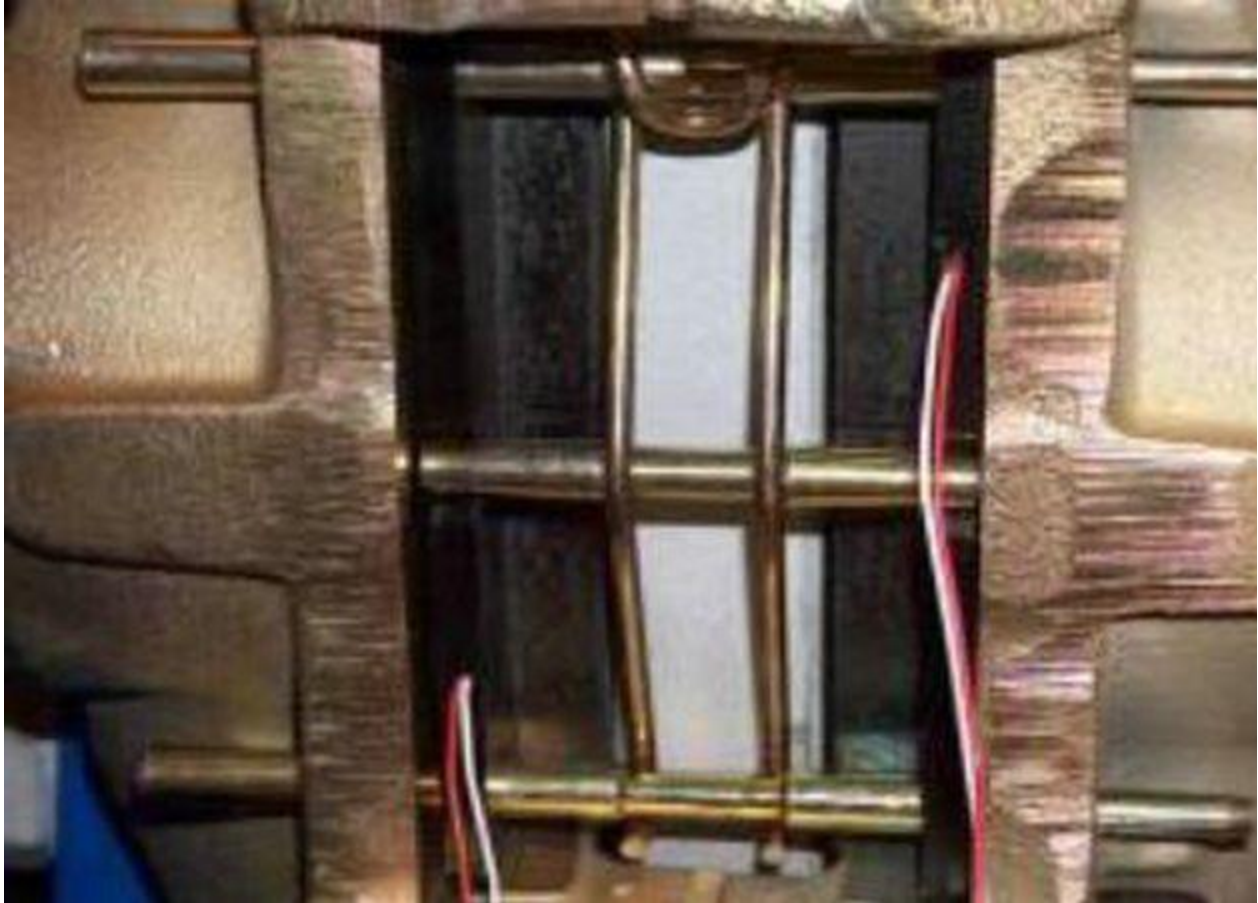
Check the condition of the brake pads. If they have worn down too much, the thermistor may be starting to wear on the disc surface.

Generally, the pad should be thicker than two millimetres but as always, refer to I&S data for current min/max specifications.

Investigate the root cause of the pad wearing prematurely before returning the turbine to operation.

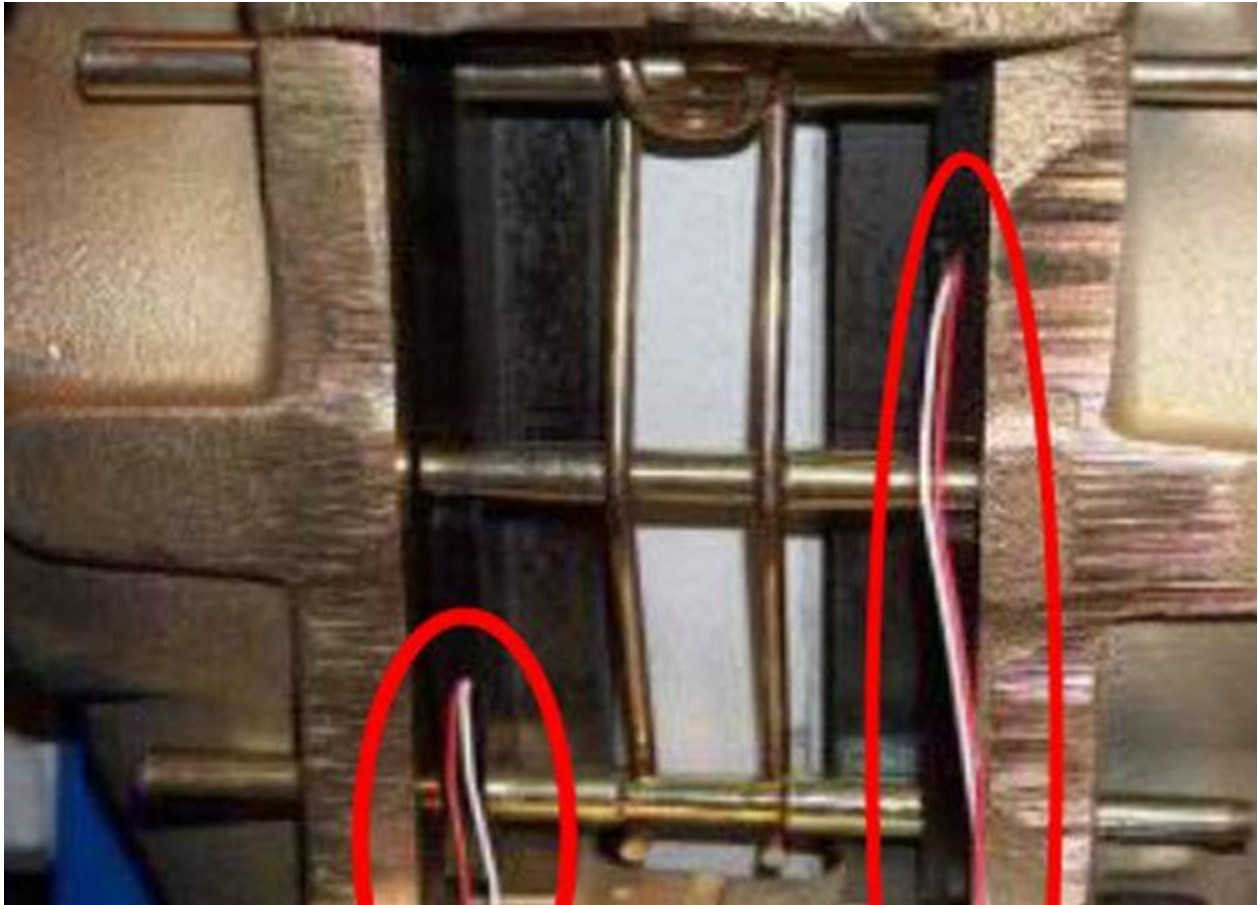
The thermistors are imbedded in the brake pads. If the pads are worn below two millimetres, then they should just be replaced.
