**Check the circuit and replace the defective components**

- **Explanation**  
**IN THE +AT2 PANEL:**

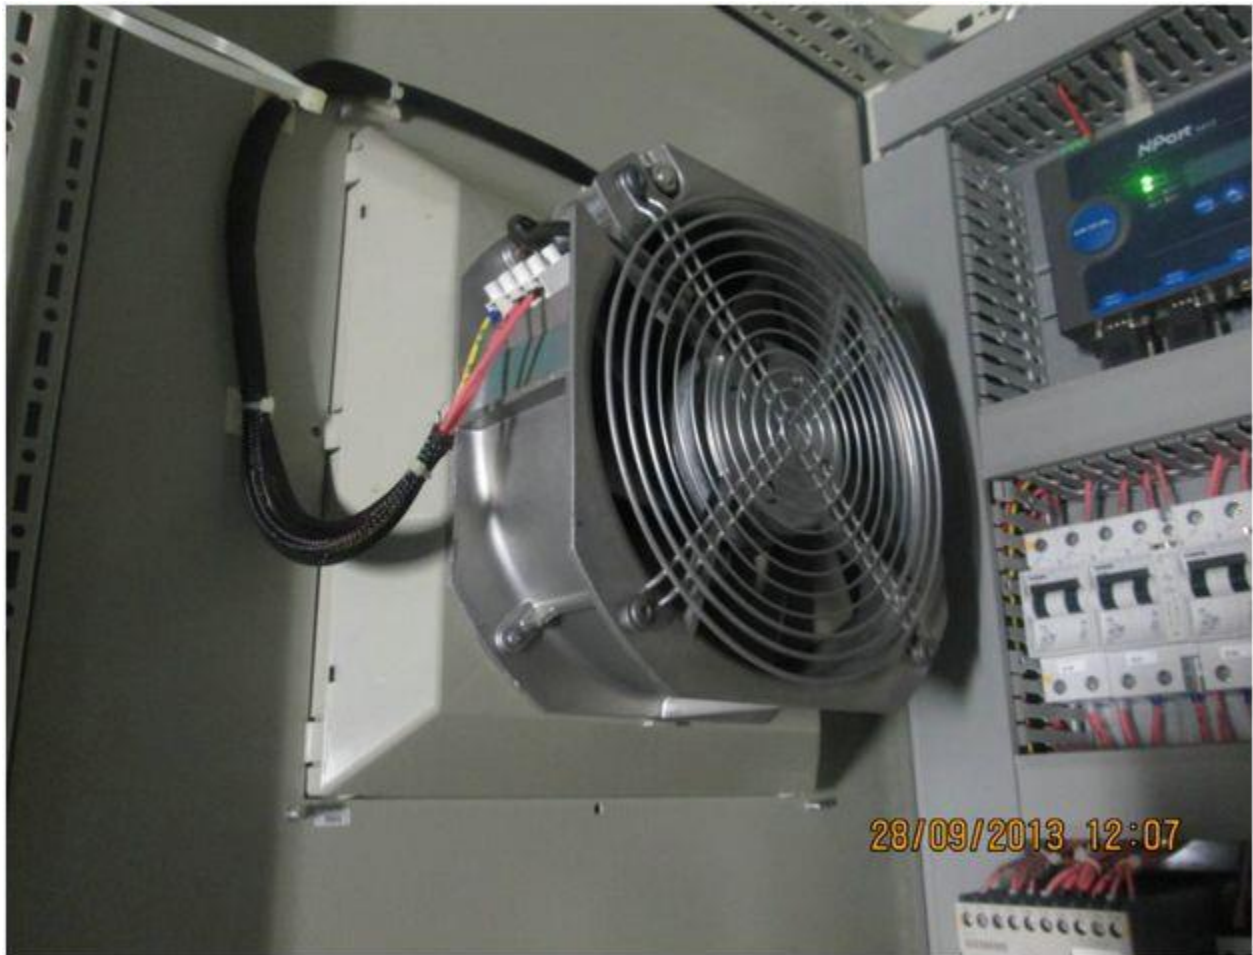
Check the control panel cooling Fan/capacitor, if defective replace the cooling fan/capacitor

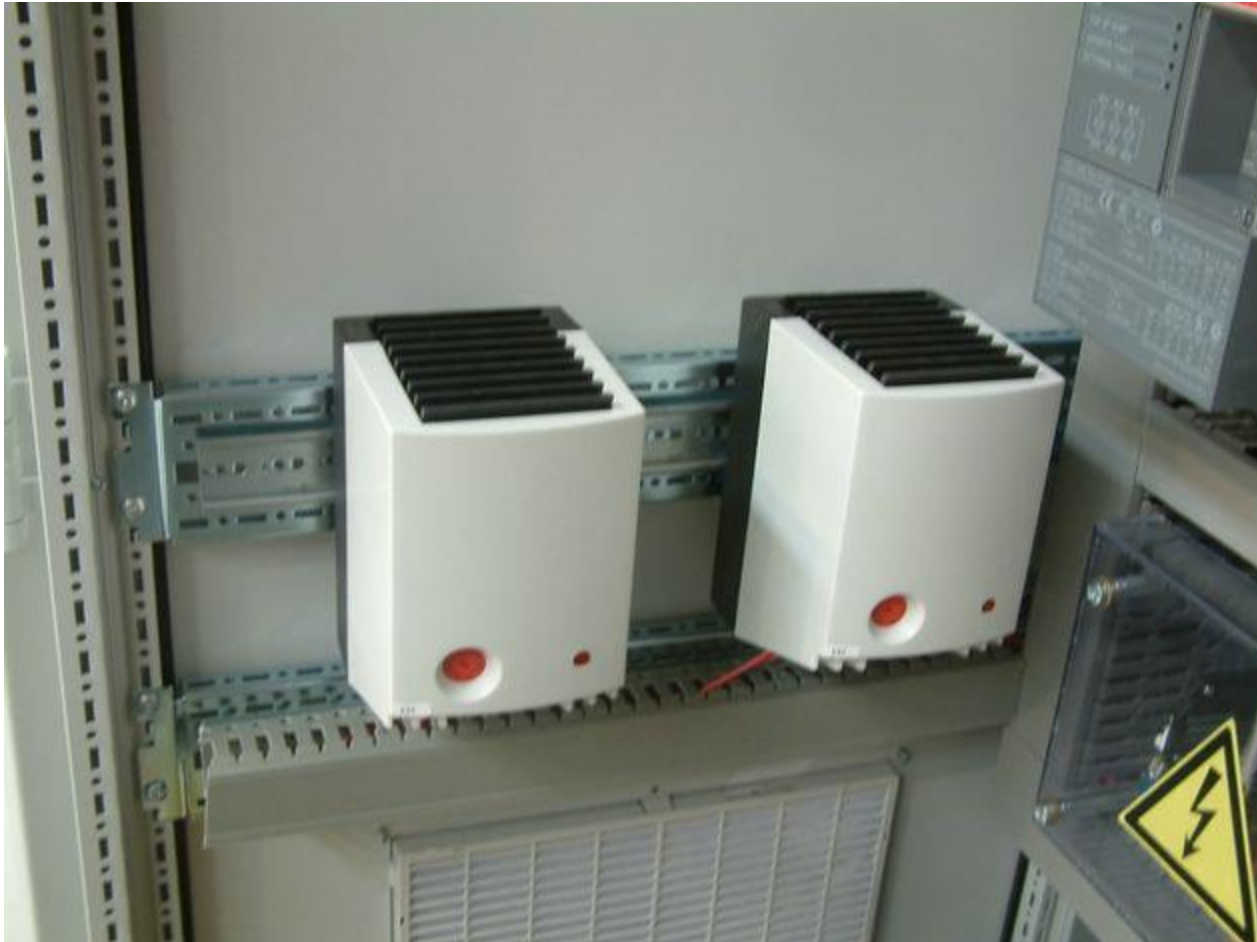
Check the control panel heaters, if defective replace the heater.

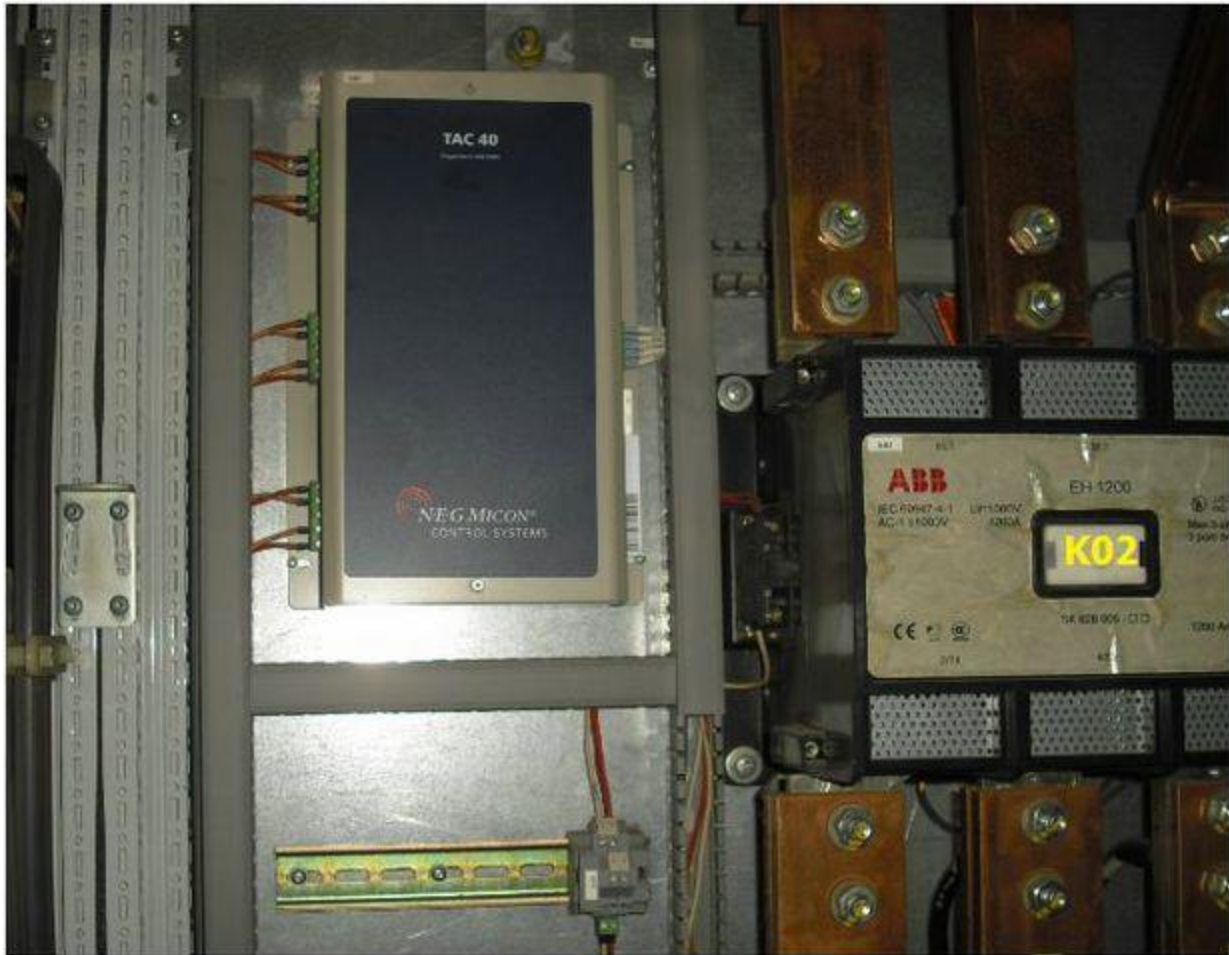
Check the by-pass contactor supply coil for short circuit.

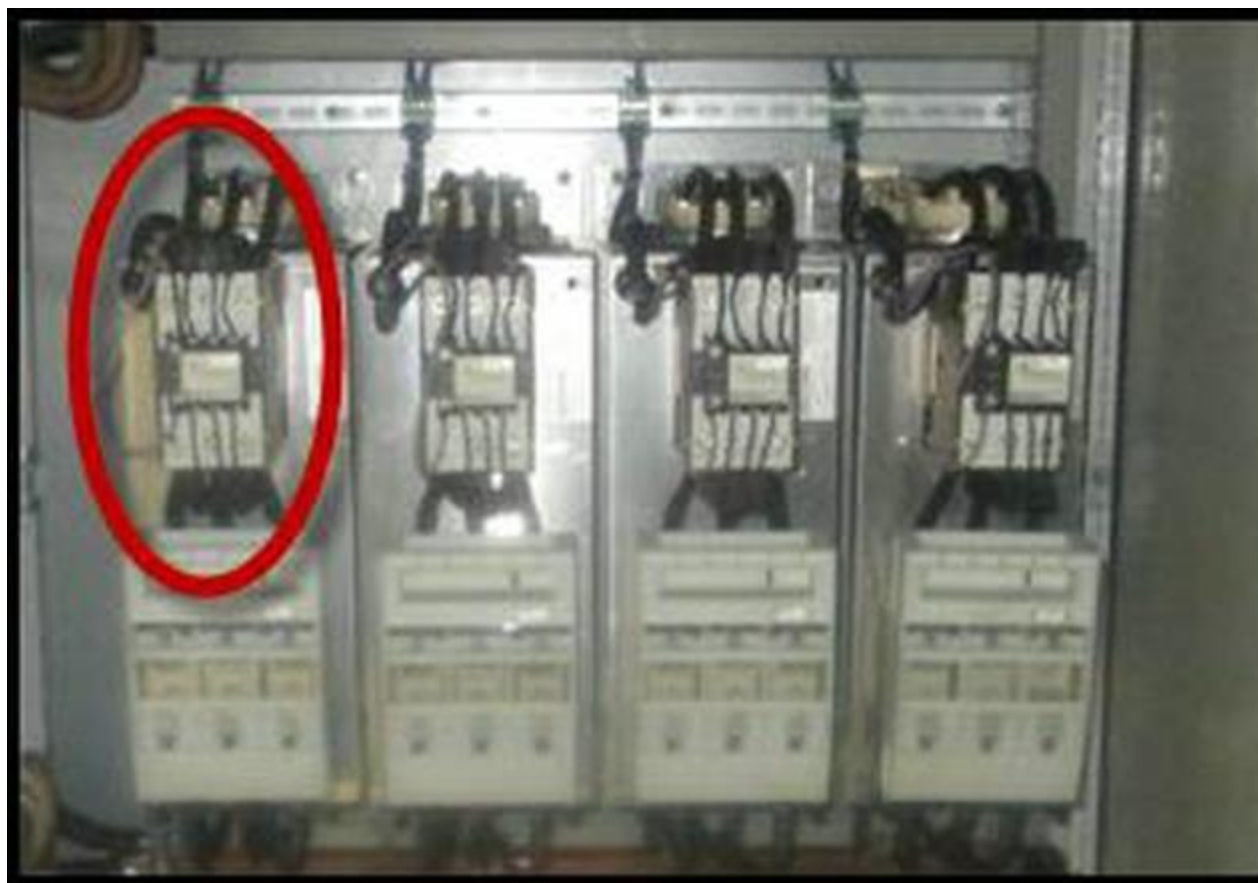
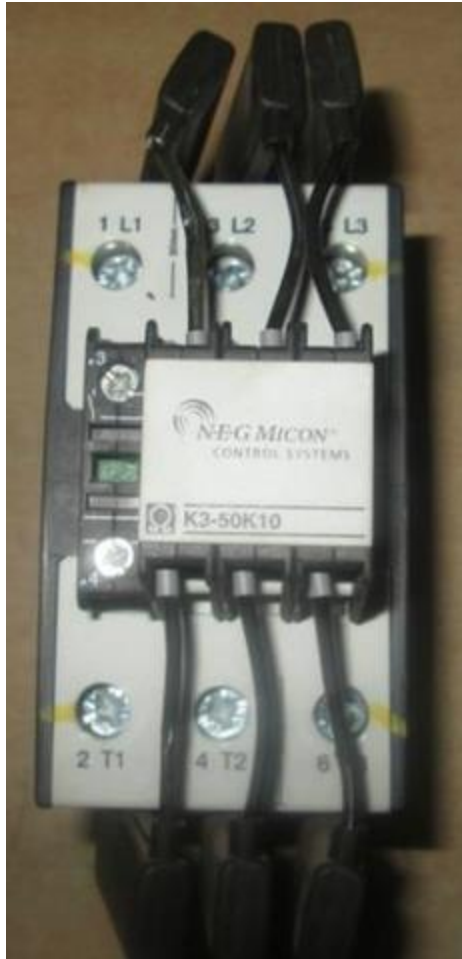
Check all capacitor Contactor coil for short circuit.

The contactor starts from number K01 to K12

These contactor coil supply feed through the F33 breaker.

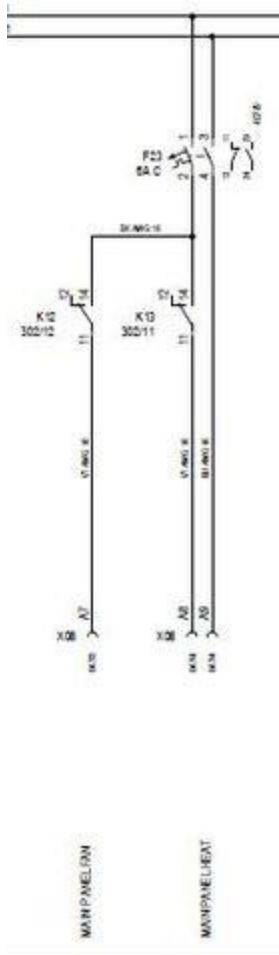
60Hz:

Part number for F37/F23 CB

Relevant spare parts - 60Hz(F23)	
Description	Item No.
MCB 5SX22067 6.0A C 2P	<a href="#">60005157</a>
AUX CONTACT 5SX9100	<a href="#">60005193</a>

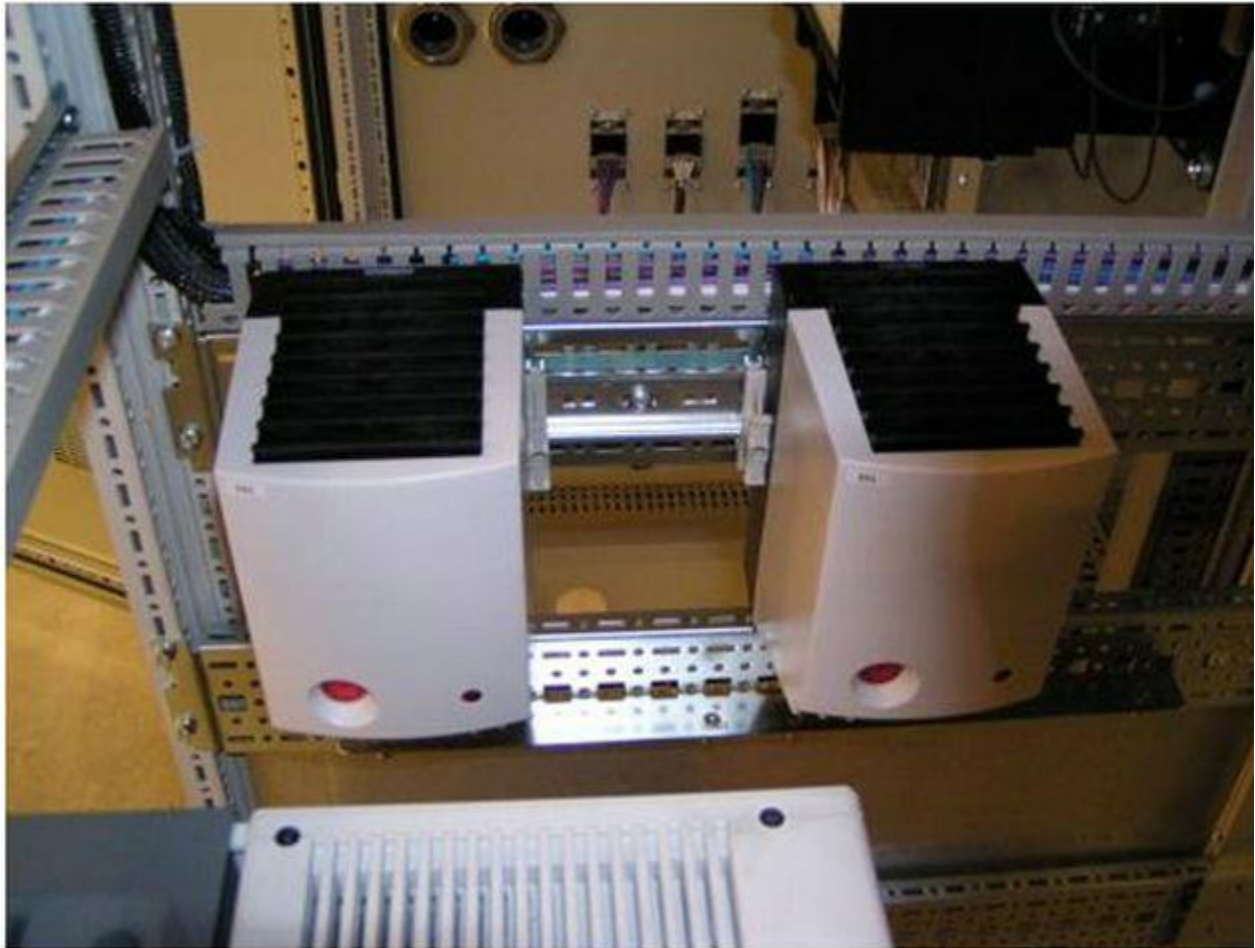
Check the main panel heaters, if defective replace the heater.

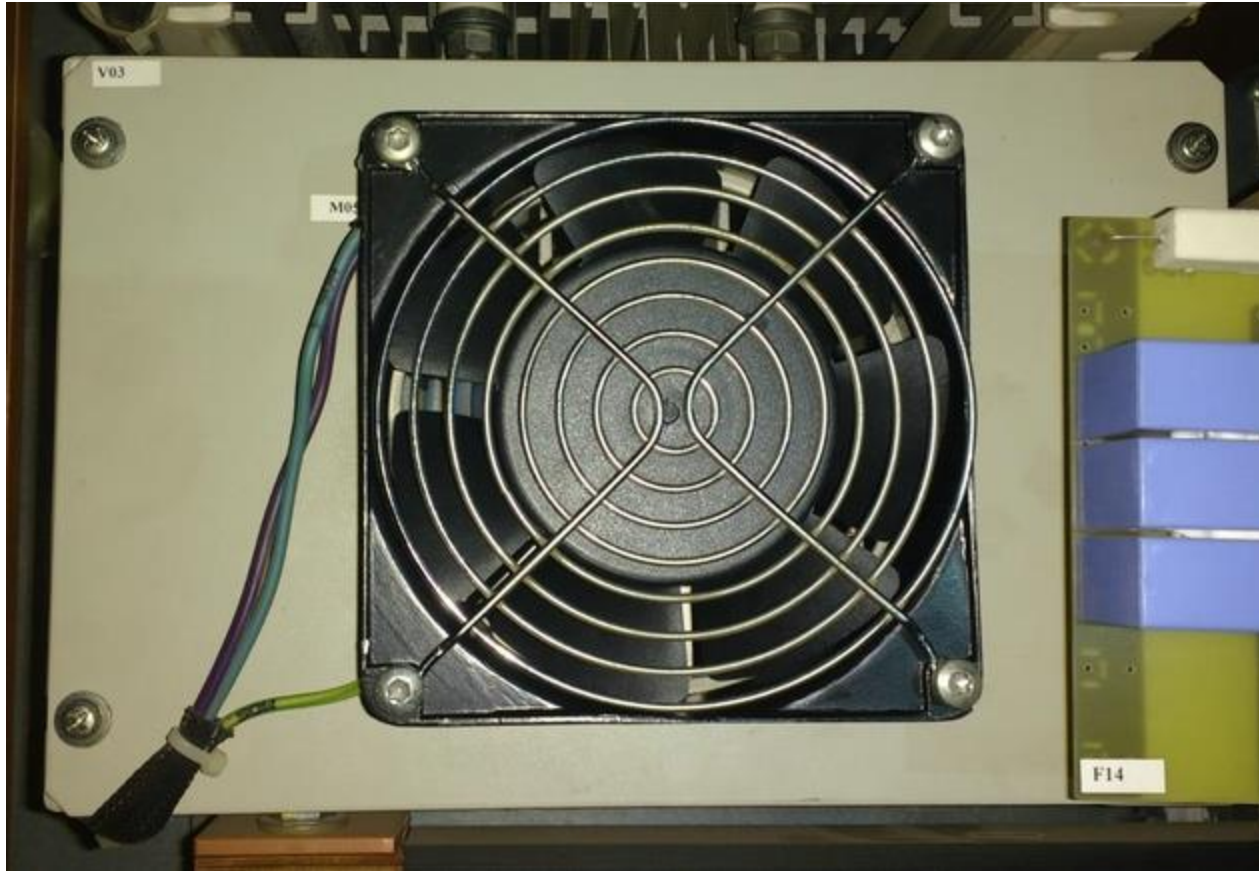
Check the thyristor cooling fan and replace, if defective.

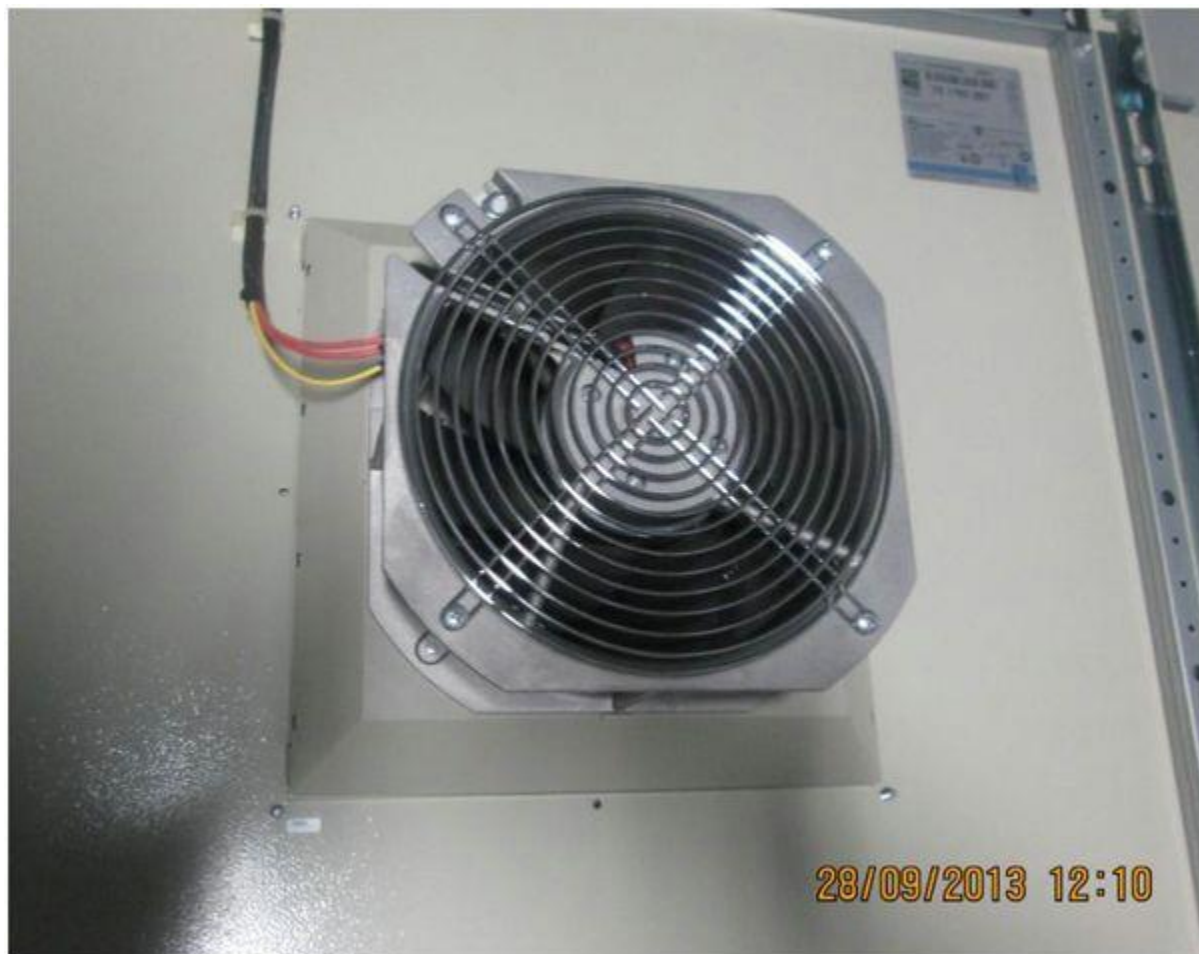
Check the PFC panel cooling Fanand capacitor, if defective replace the cooling fan/capacitor.

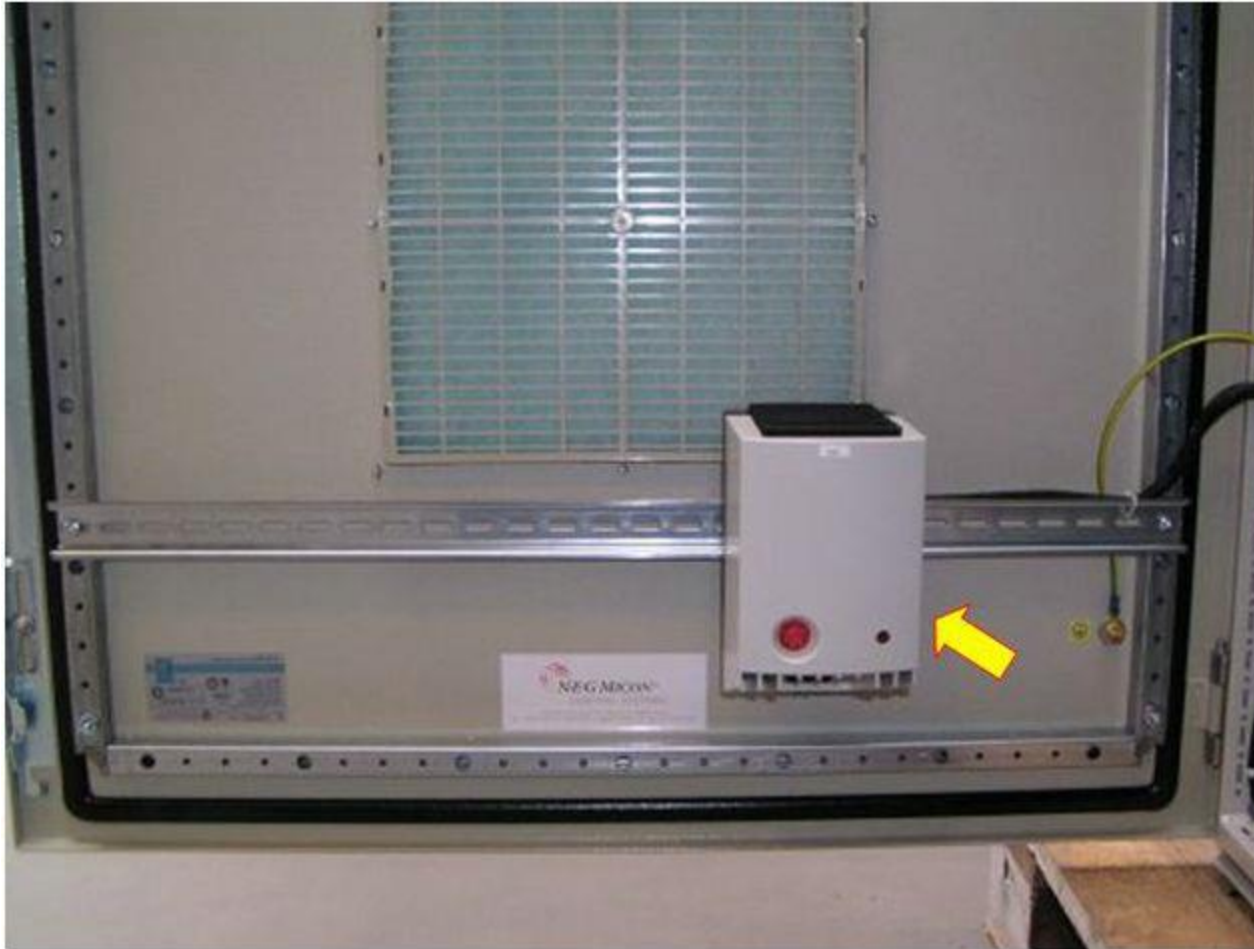
Check the PFC panel heaters, if defective replace the heater.

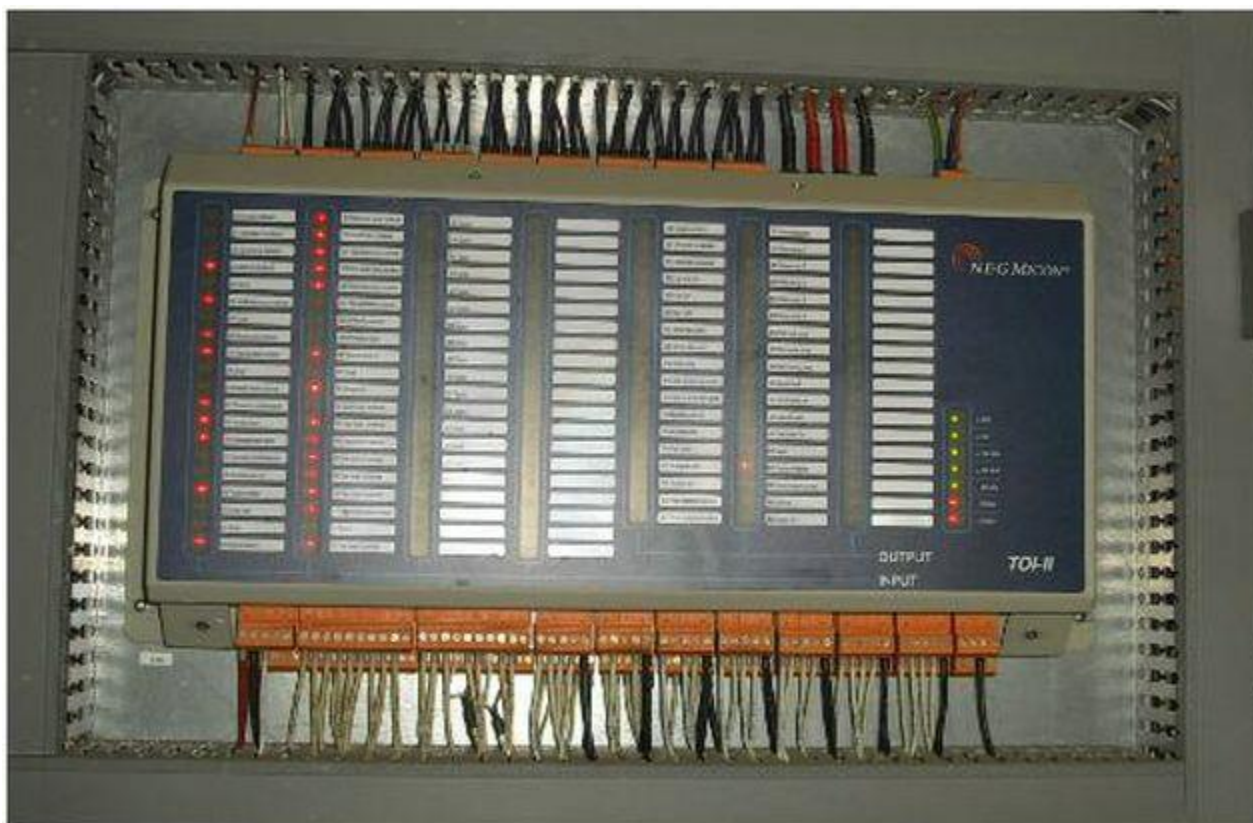
Check the 24V presence to TOI 516 terminal; if the signal is present the TOI will most likely be defective since the signal is reaching the TOI but the TOI is not recognizing it.

If no signal is present, there is a feedback circuit problem.

If any of the following circuit breakers are tripped, the alarm will be raised.

(50Hz-F33/F34 /F35 /F36 /F37) (60Hz-F23/F24/F25/F26/F27).
