## Replace the auxiliary contact

#### IN THE AT1 CABINET:

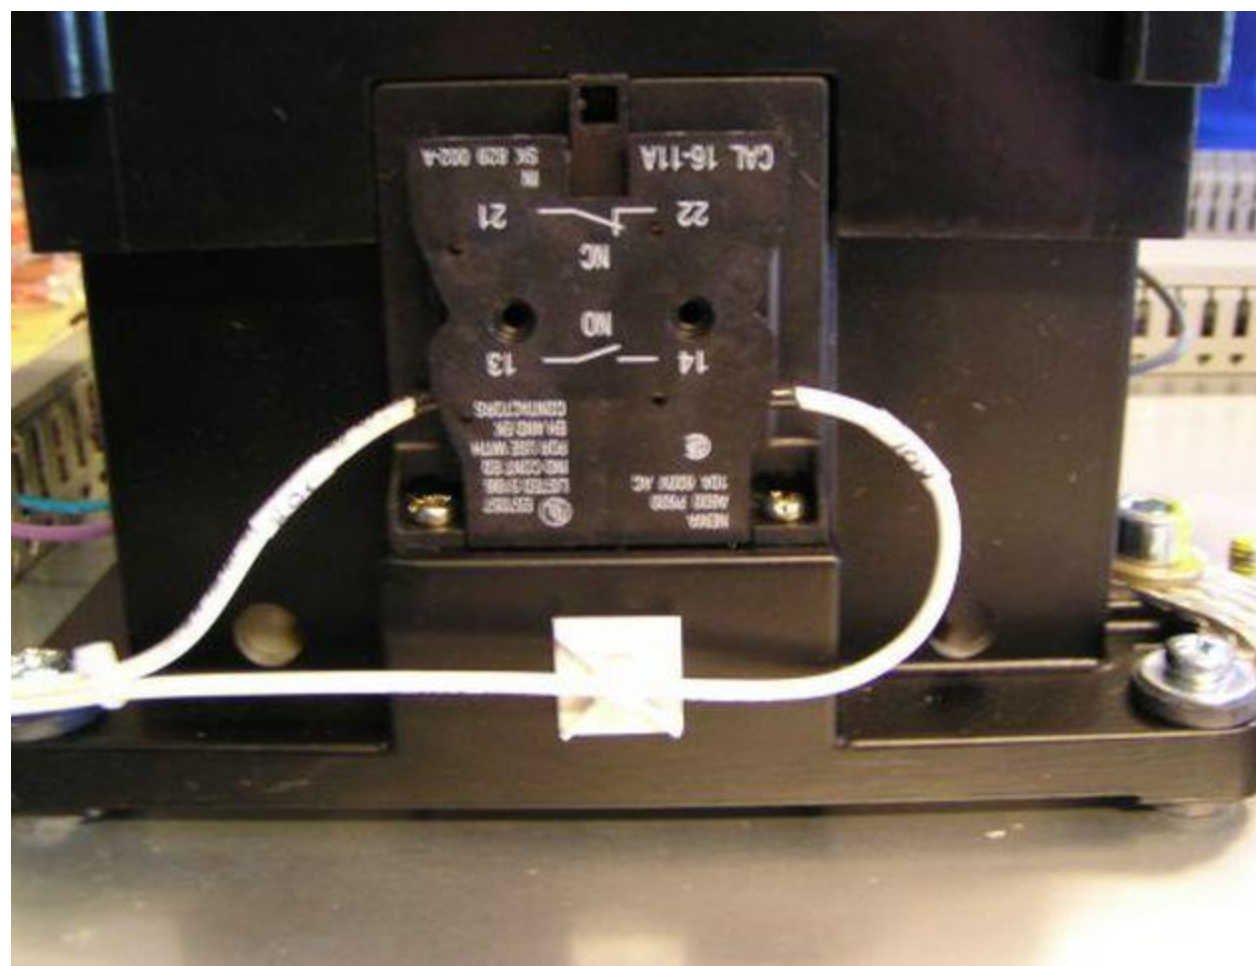
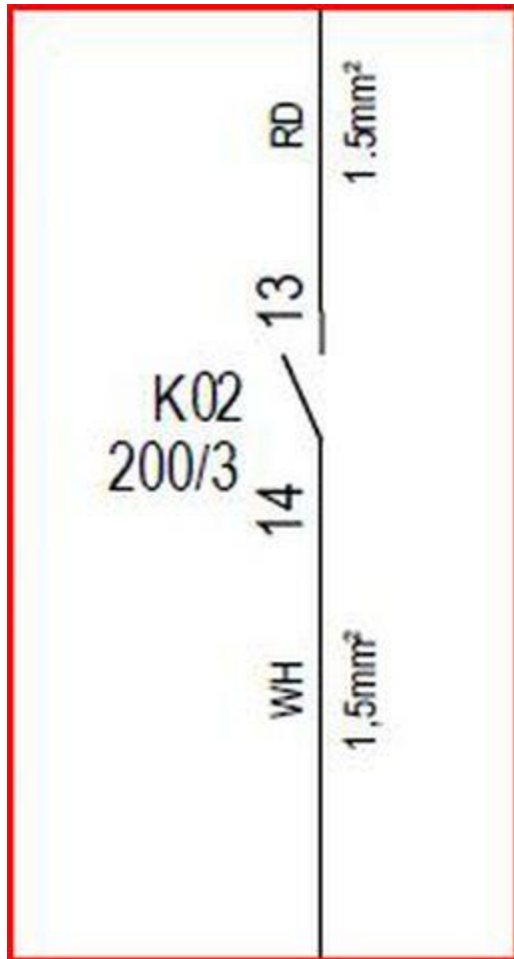
Check the contact fixing positions.

Check the contact function.

Check the feedback signal wire terminations and tighten if necessary,

If defective replace the relay ( **Item number: 60004318- AUX CONTACT CAL16-11A**)

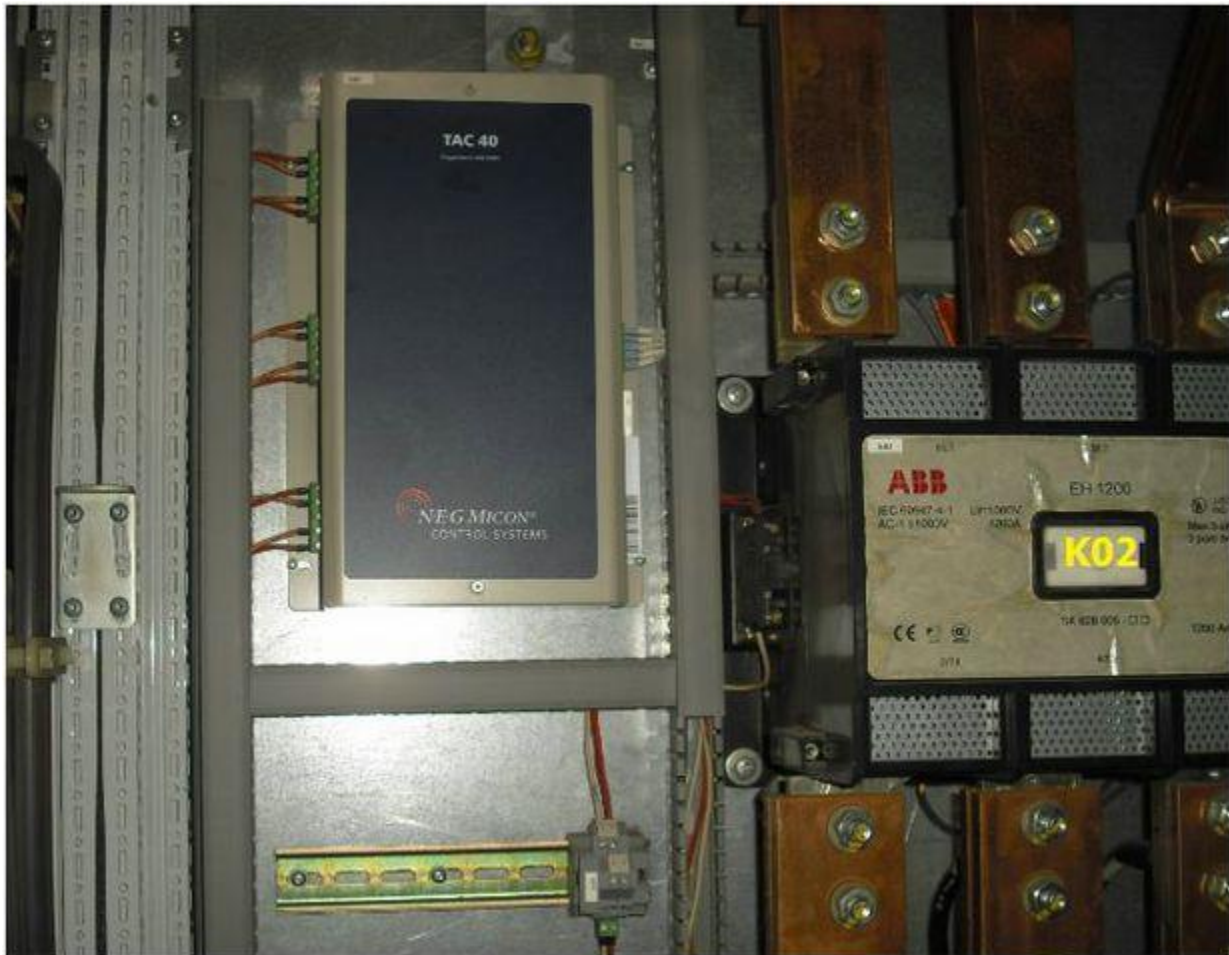
Check the contactor function K02.

Check the contactor input supply.

If defective replace the contactor:

(Item number: 60004316 CONT EH1200 240V 50/60Hz)

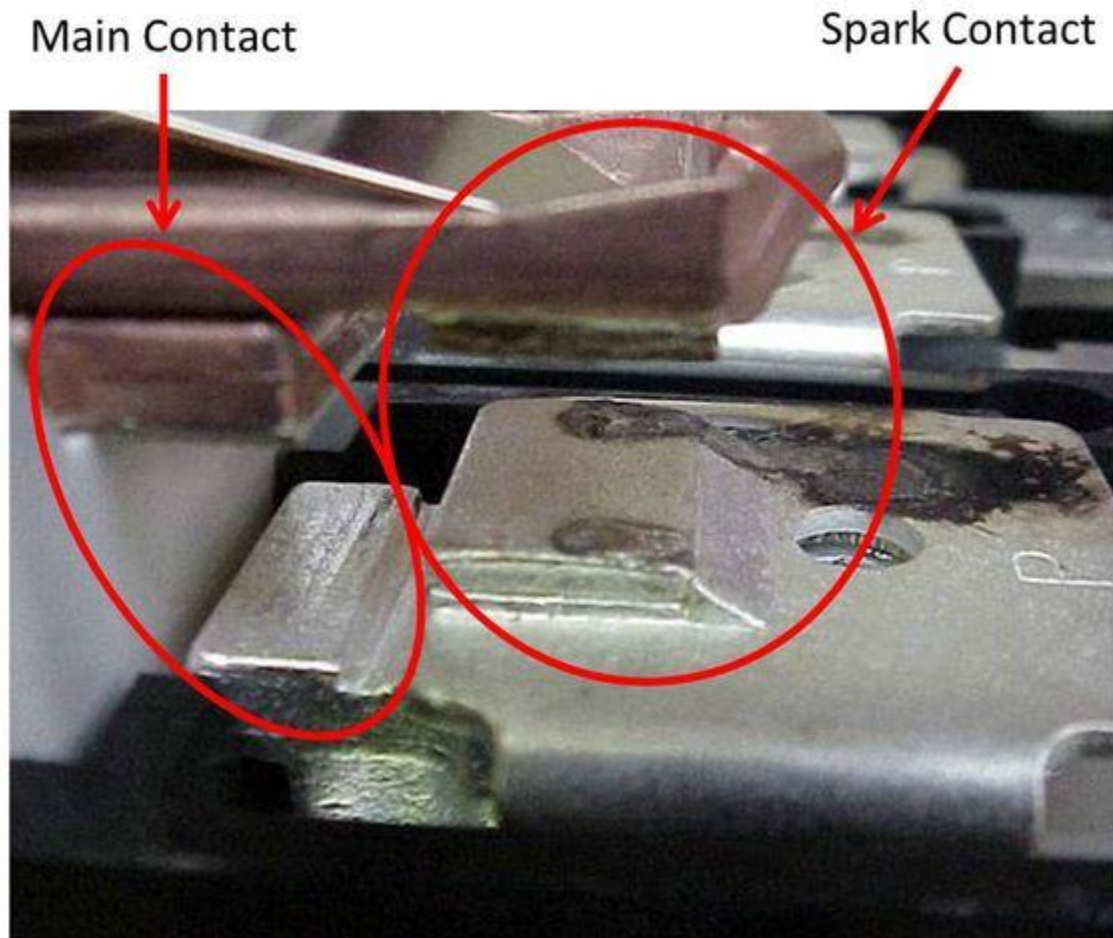
Picture 1.

There is 2 contact set for each phase.

A Main contact and a spark contact (See picture 1 below)

The main contact set must be in a good looking condition. This is where the full load is to be transferred through the contactor.

The Spark contact is designed to handle the unavoidable sparks and arcs that will be developed when opening and closing this amount of energy. (Up to 2-3MW). So burn marks on the spark contact set is not only allowed, it is expected.

A complete melt down of the spark contact set is of course not allowed, but most important is it to make sure that the main contact set is not burned.

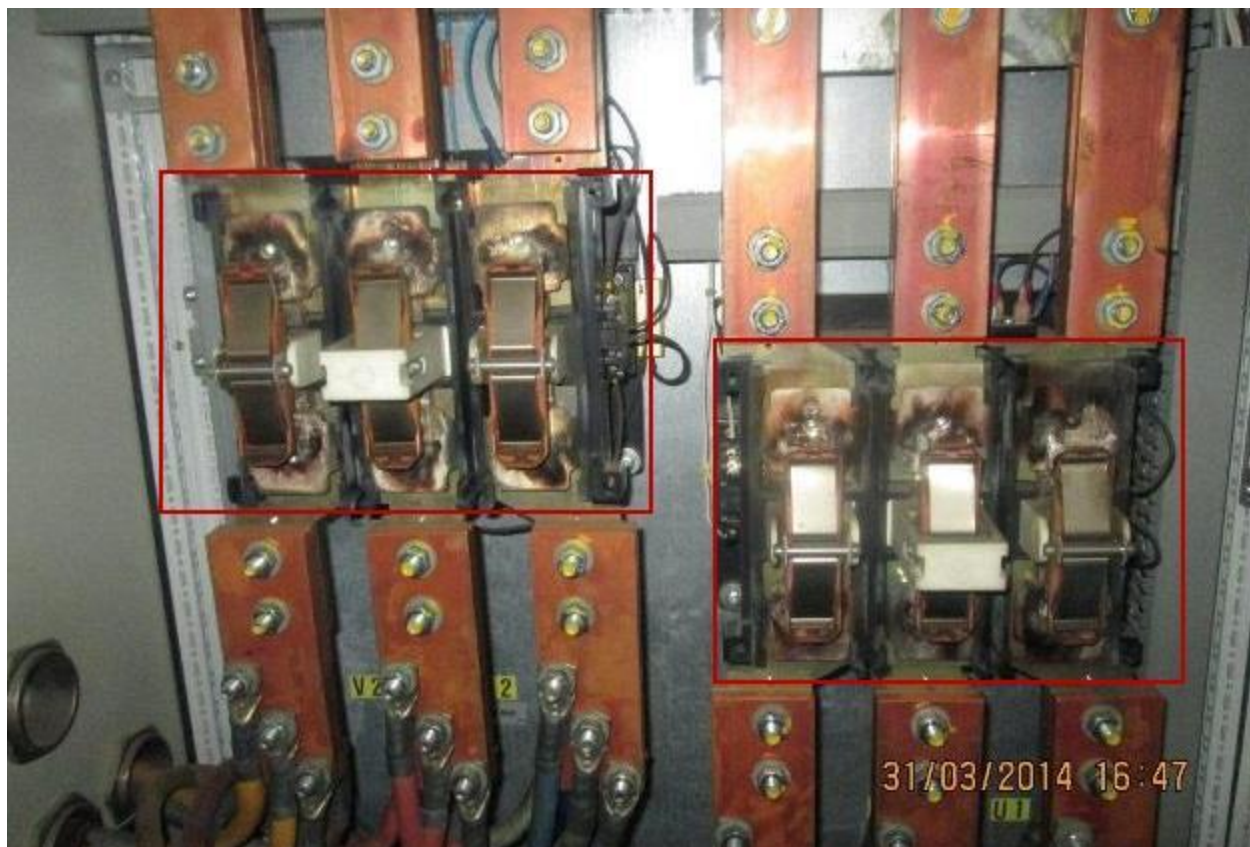
The contactors below show clearly burn marks, but all burn marks that can be seen from this view are placed on the **Spark contact set** where it is supposed to be like this.

Only a closer look from the side of the contactor will show if the **Main contact set** is damaged.

If the **spark contact set** has suffered a complete melt down or have extreme burn damage making the spark contact fall apart, then a replacement is required.

If the **main contact set** has burn marks making the surface un-even, then a replacement is required.

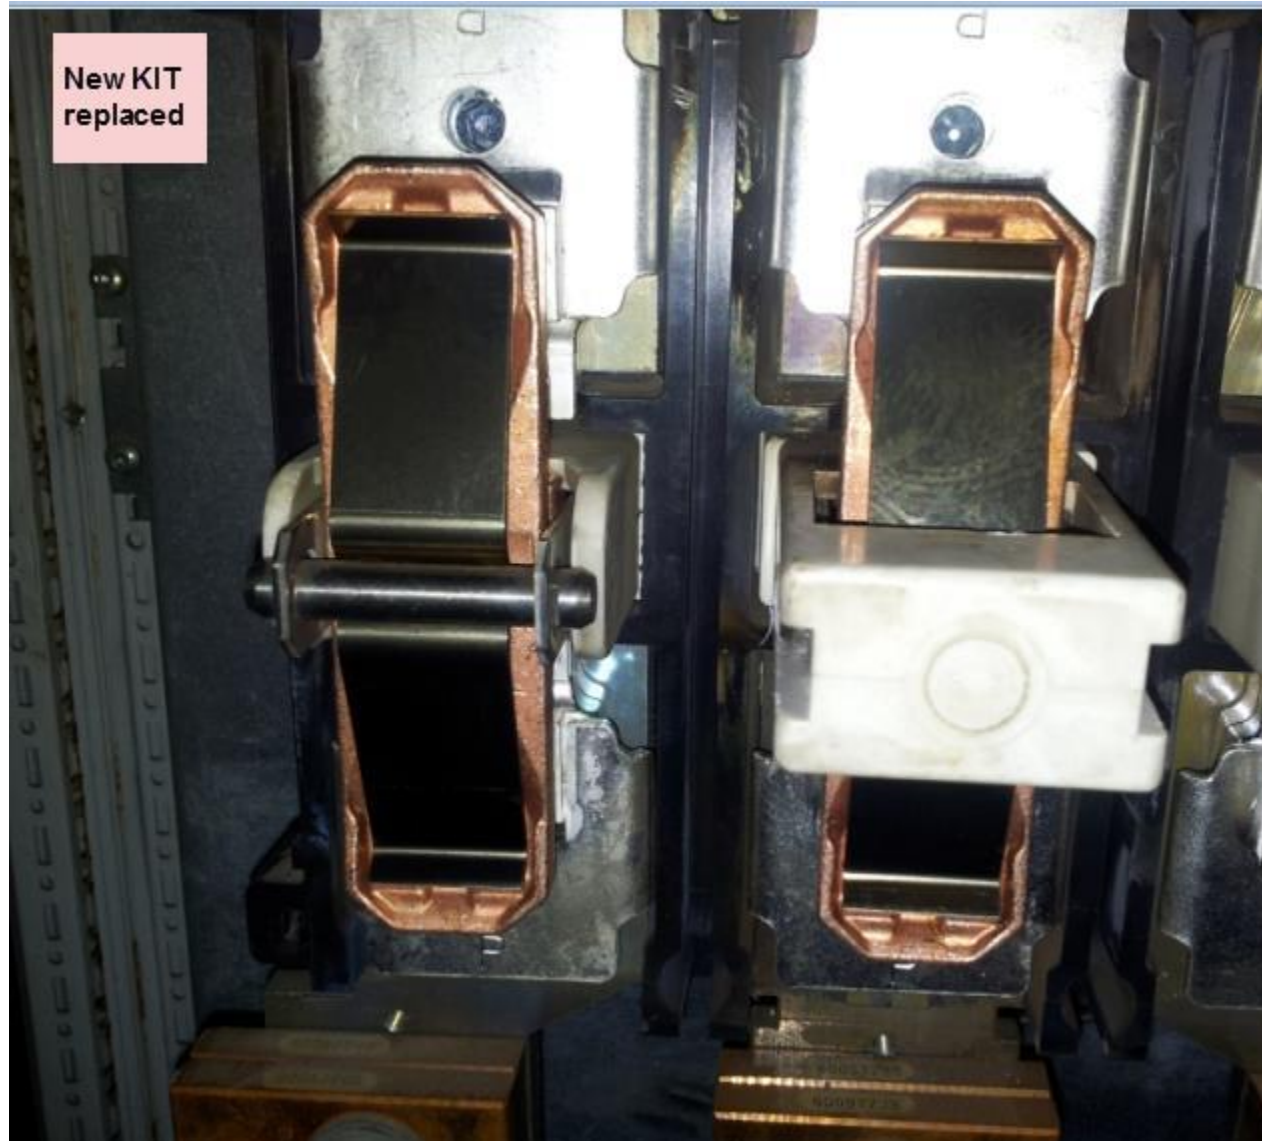
The picture below show a EK1200 contactor, where a new contact set (repair kit) have been mounted.

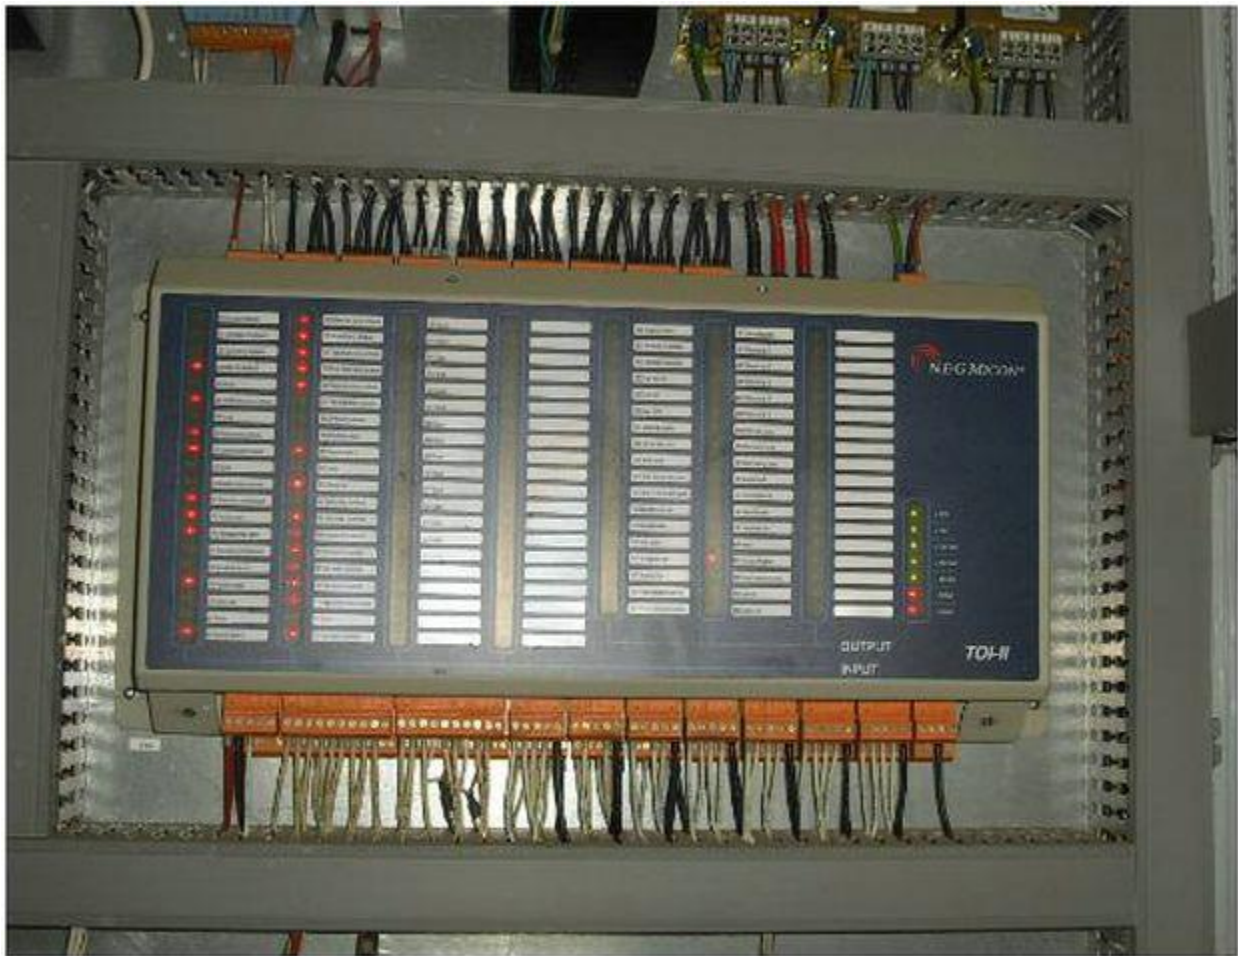
Check the TOI Output (RELAY OUTPUT 800 -803)

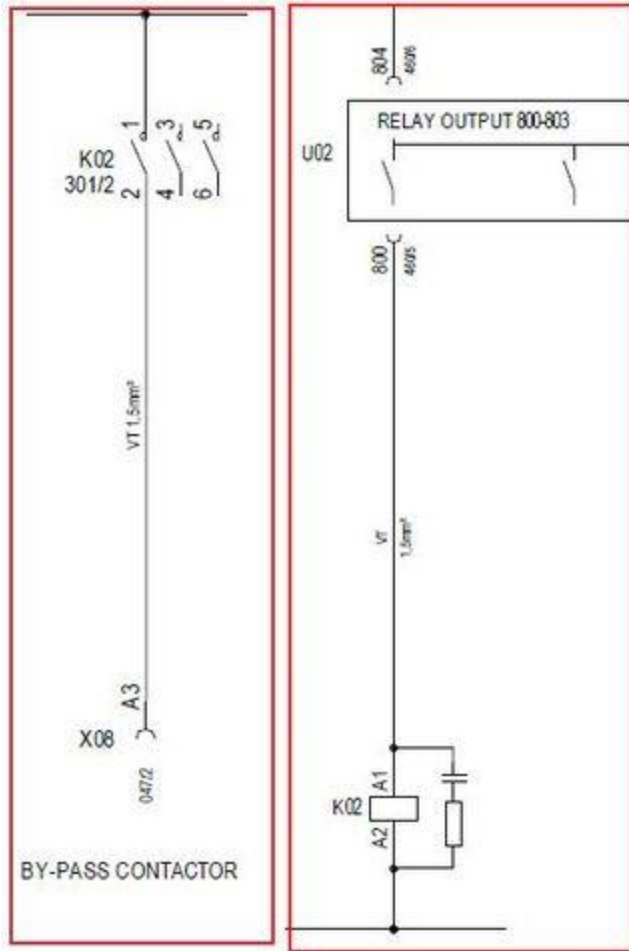
50 Hz

Check the K02/K25 relay operation.

Check for loose connections at the feedback signal terminations.

**(50Hz) 60004394 CONT 3RT10161AP02 230V 50/60Hz**

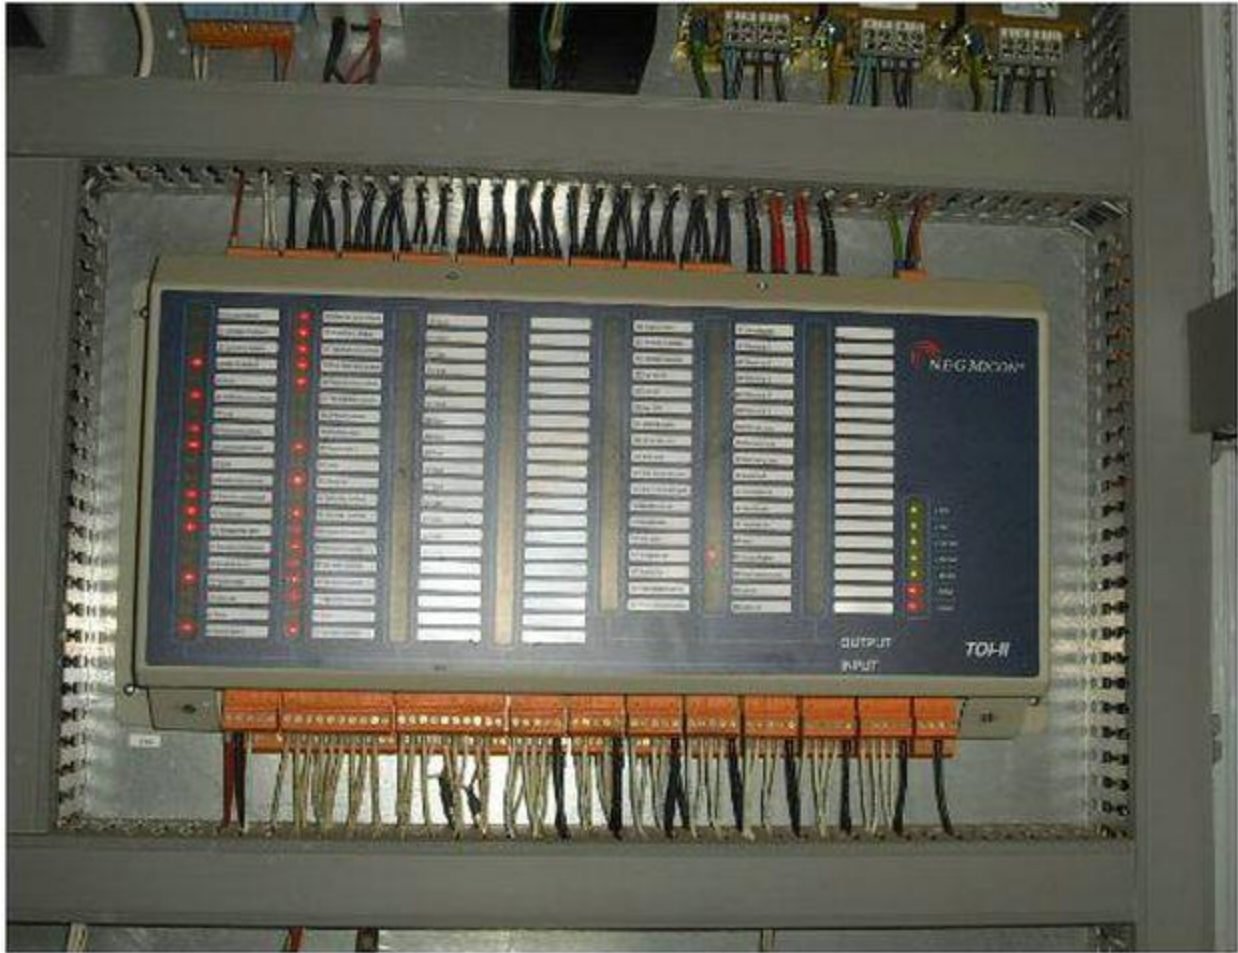
Check the TOI Input (DIGITAL INPUT 500 -504)

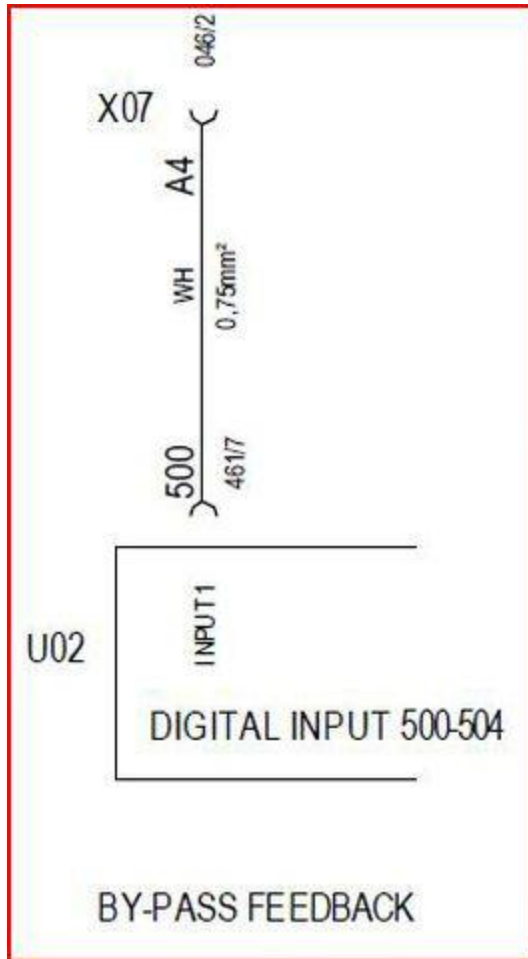
Check the signal presence in 500

Check LED indication is 'ON' for bypass contactor signal
