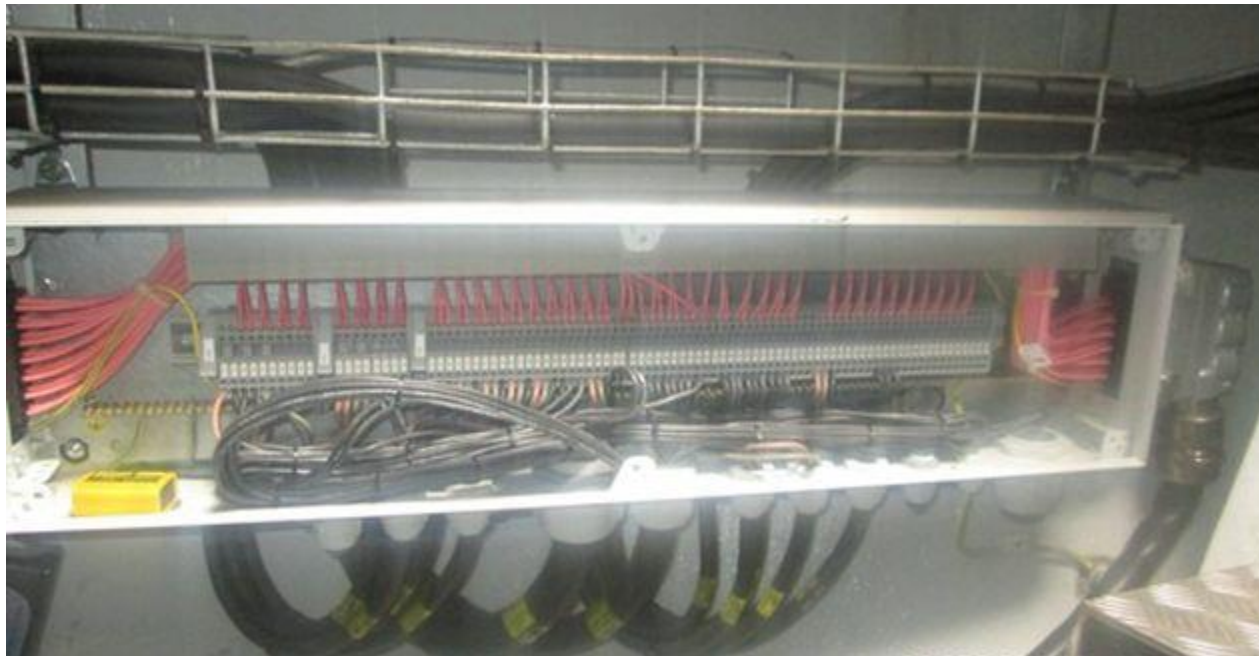
+AN4

Check the incoming cable connection and connectivity from Control panel (+AT2) to box (+AN4)

Connection terminal X01 (Pin no: 28,29,30)

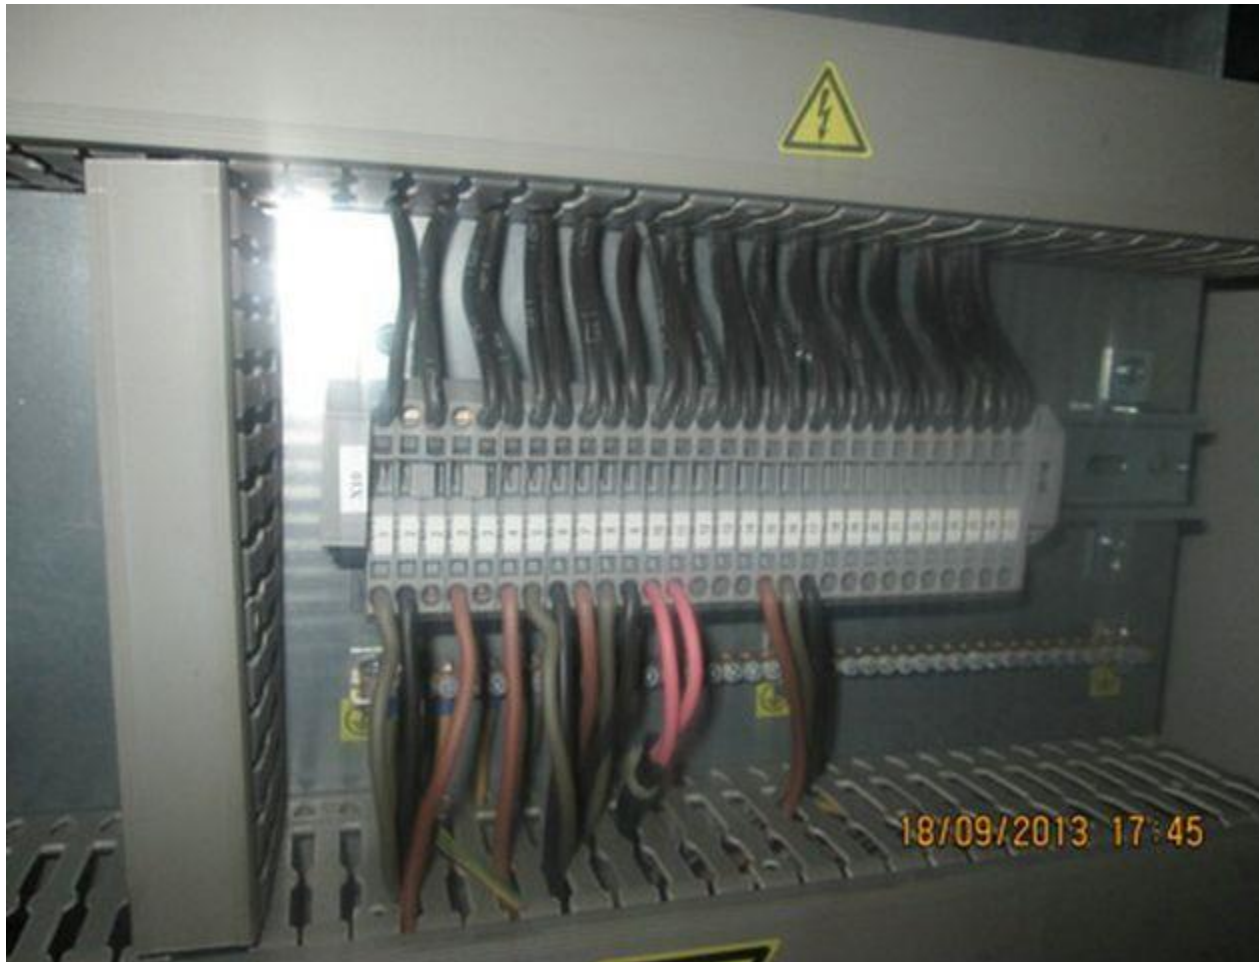
+AN1

Check the cable (W352) connection and connectivity box(+AN4) to Control panel box (+AN1)

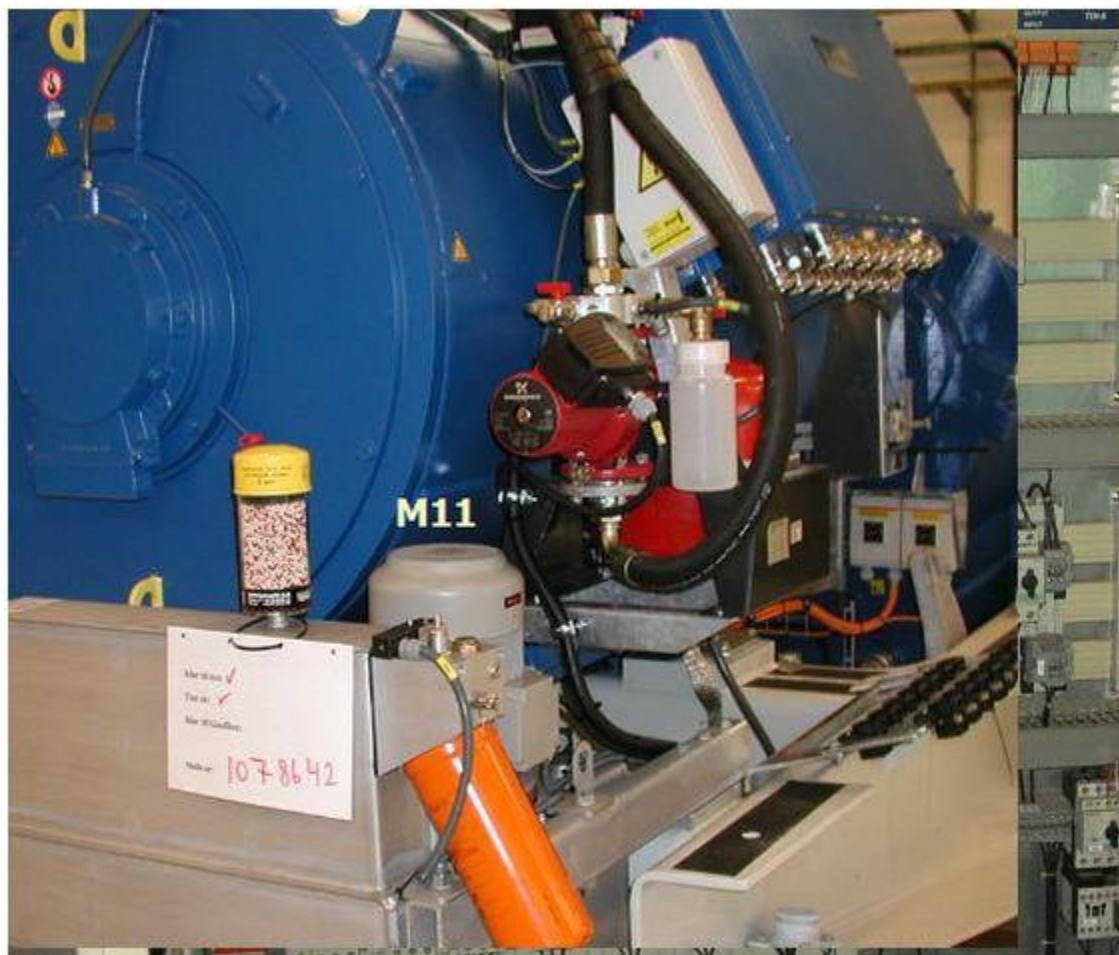
Check the input voltage.

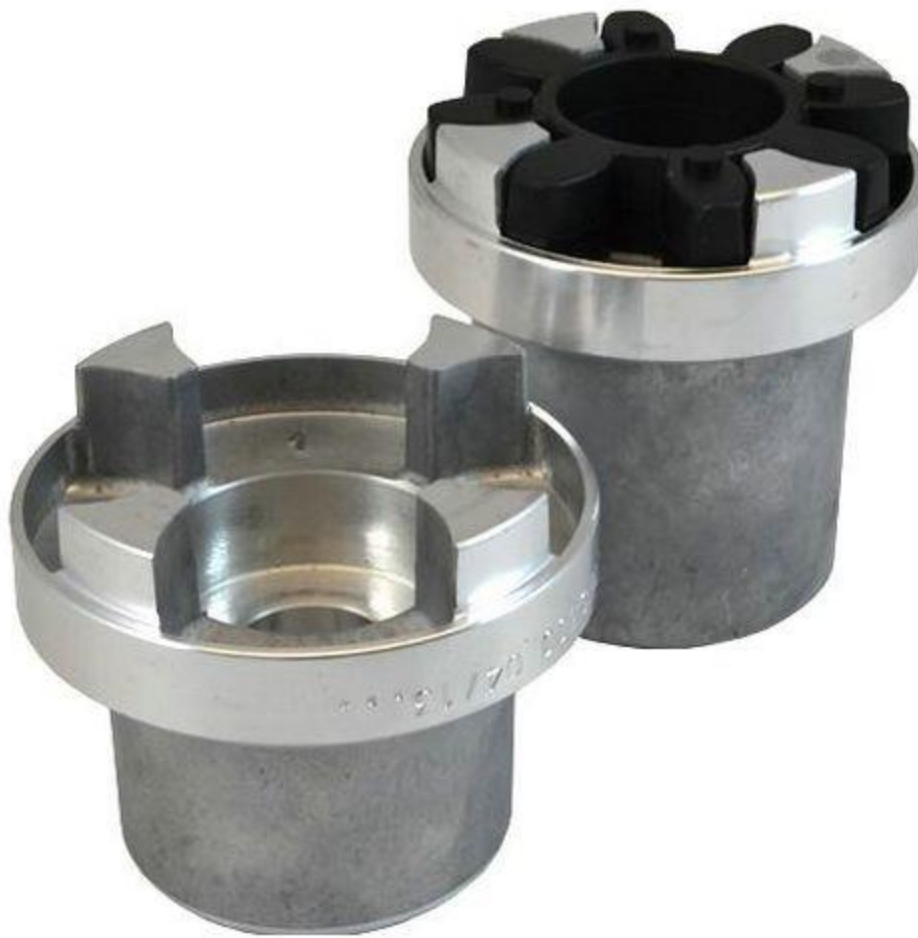
Visually inspect the coupling for any damage and that the rubber element is in good material condition.

Check for any debris stuck in the coupling.

If the coupling is found to be defective or shows signs of excessive wear, replace the coupling:

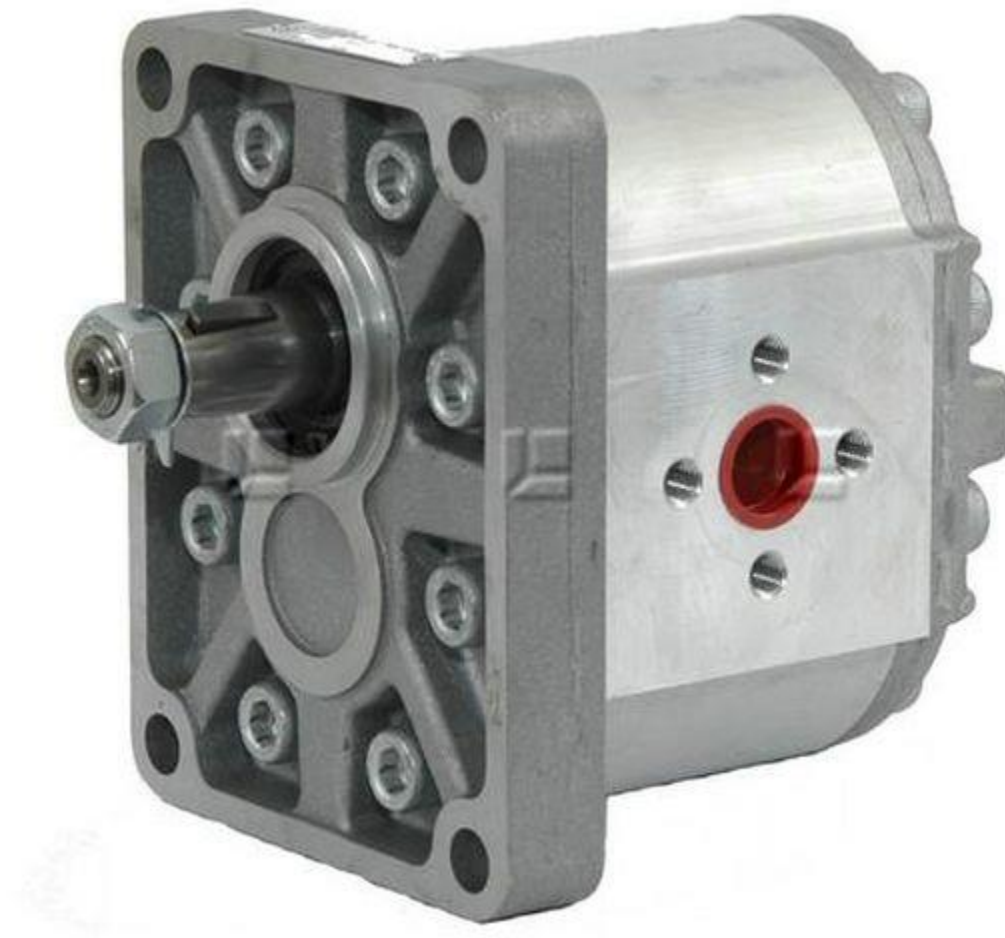
Check the pump out pressure through TAC-II

Operate the pump and listen for faulty bearings or abnormal noise of any kind.

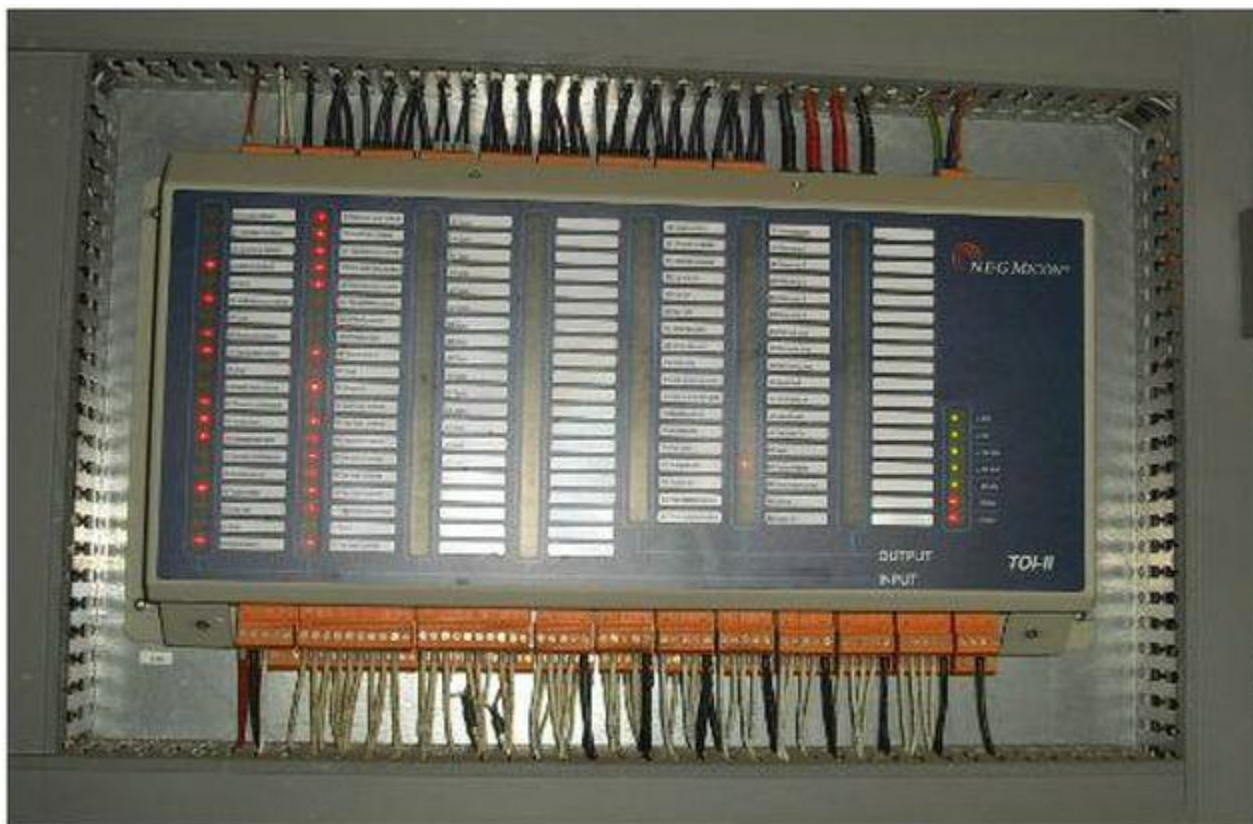
Check the TOI output (RELAY OUTPUT 830 -833)
