Replace the auxiliary contact

- **Explanation**
IN THE AT1 CABINET:

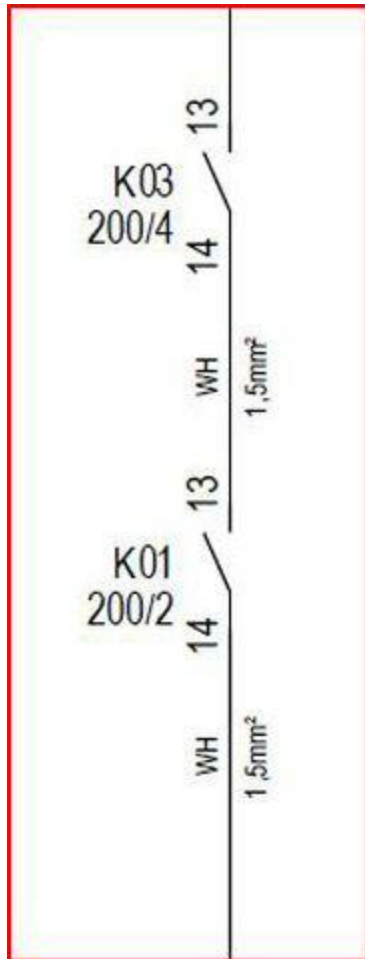
Check that the contact fasteners are tight.

Check that the contact functions freely.

Check for any loose connections at the feedback wire terminations.

Relevant spare parts	
Description	Item No.
AUX CONTACT CAL16-11A	60004318

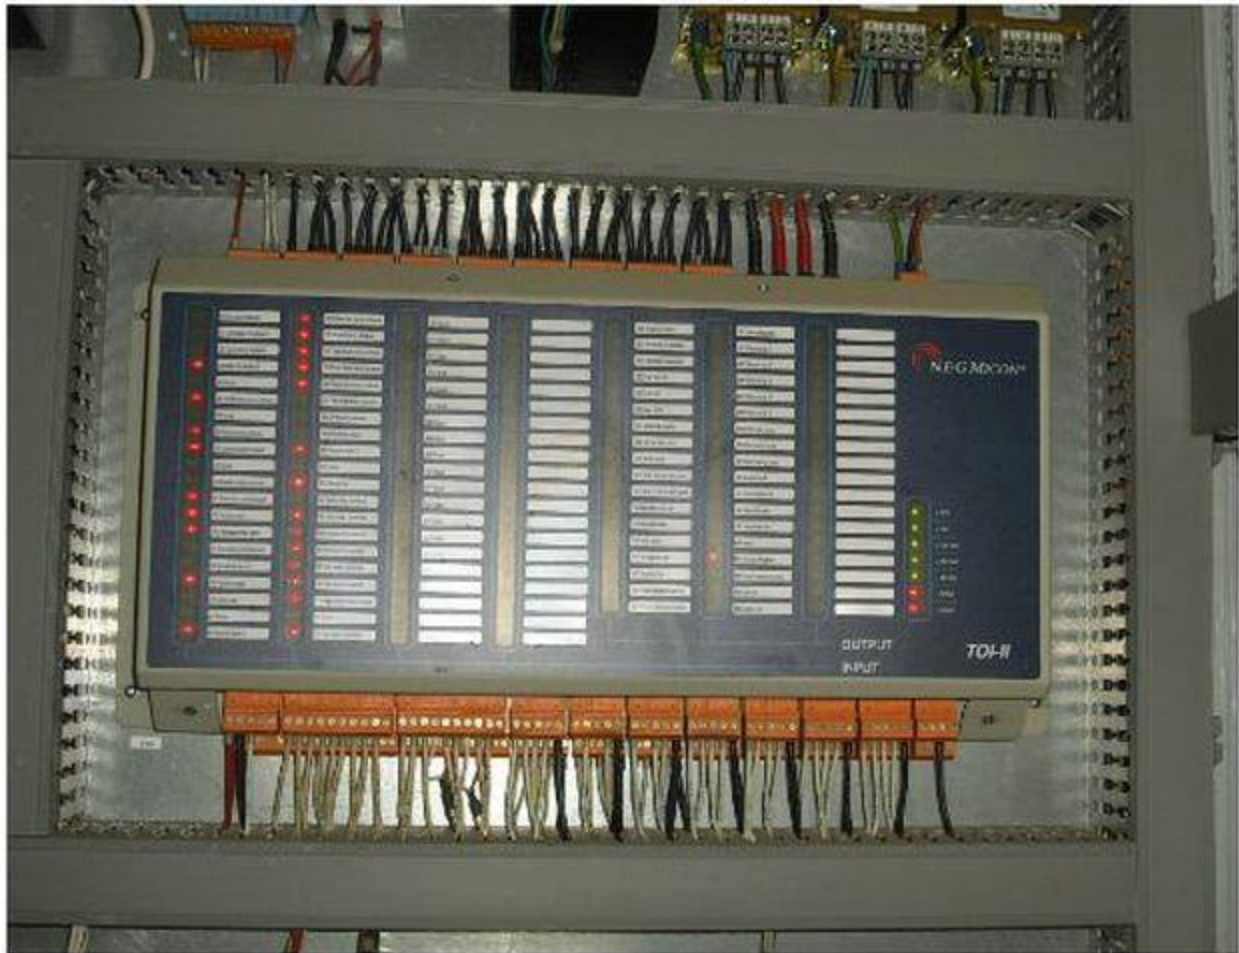
- Explanation**
IN THE AT2 CABINET:

Check the TOI Output (RELAY OUTPUT 800 -803)

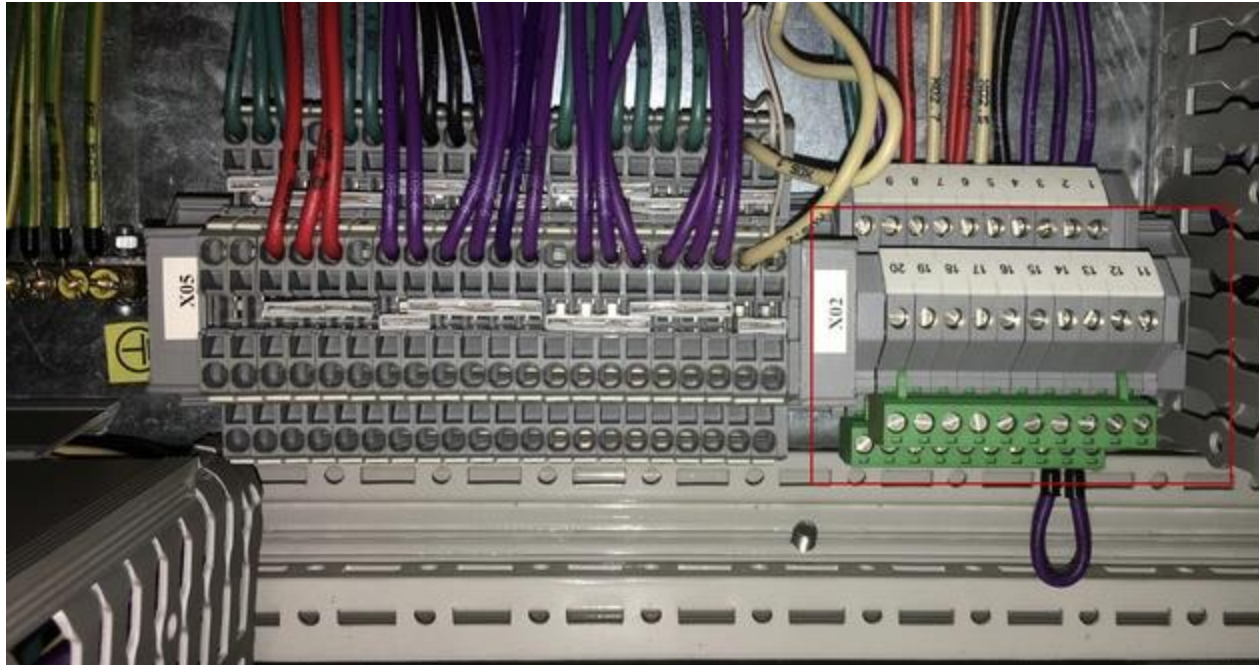
Loose wires in X02 will cause this alarm 530, When the contactor K01 in cabinet +AT1 cut in, the vibration caused a short interruption of contact

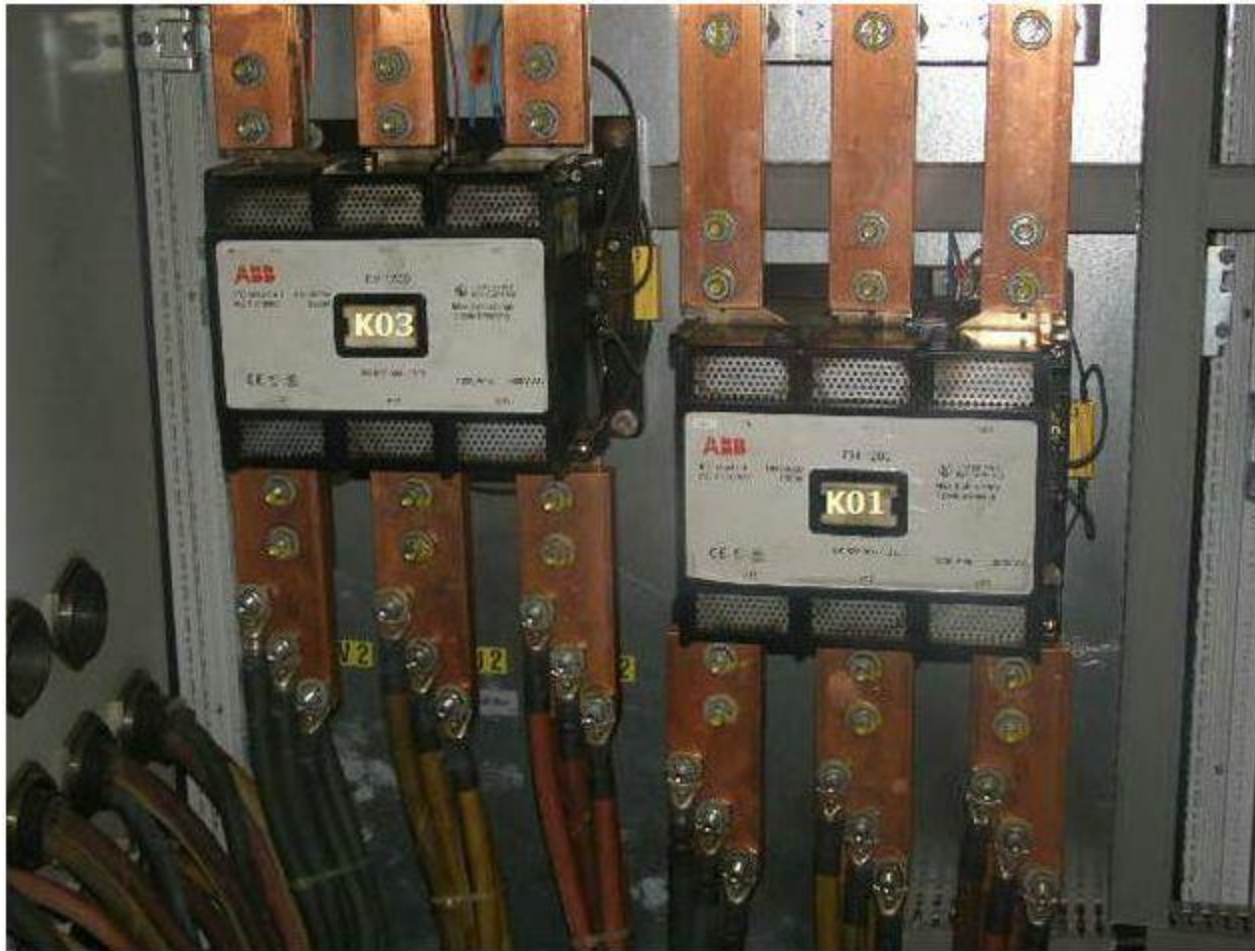
- **Explanation**
IN THE AT2 CABINET:

Check the contactor function K01 & K03.

Check the contactor input supply.

If defective replace the contactor:

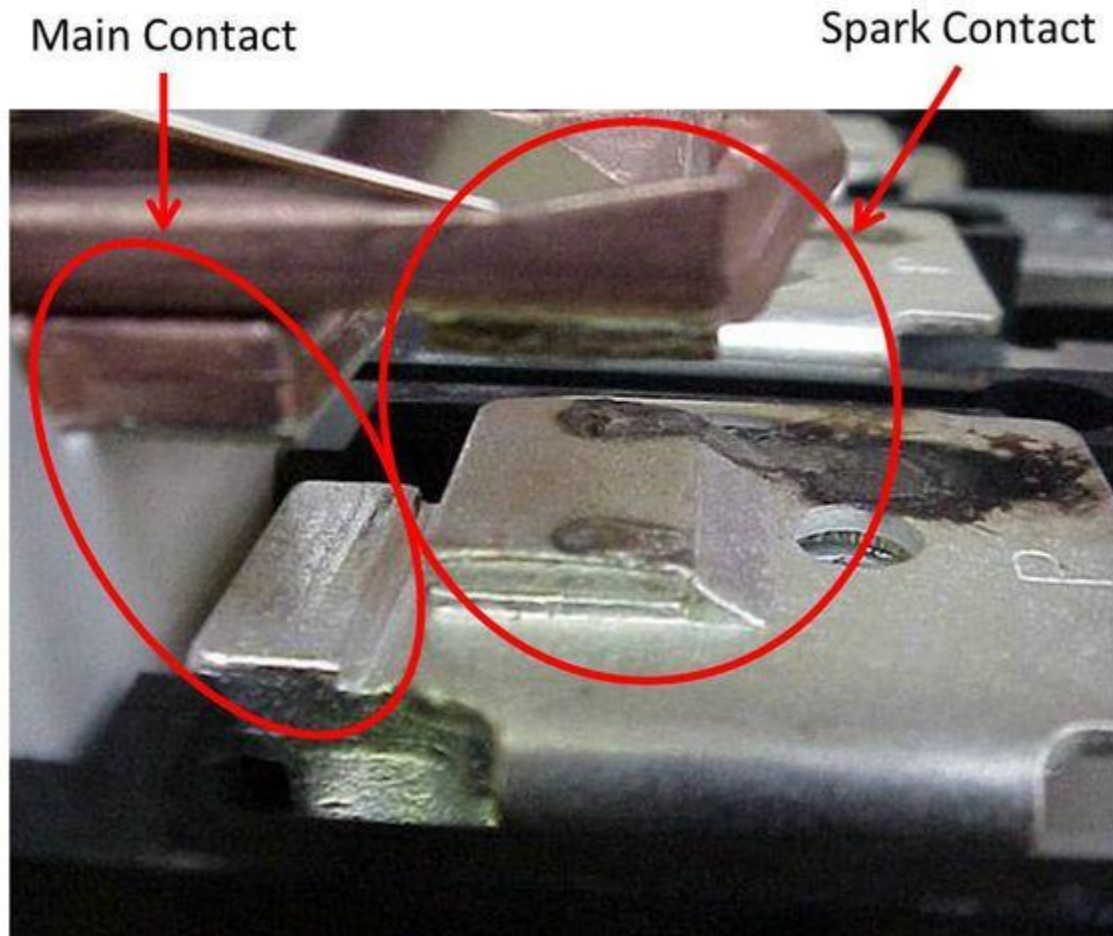
Picture 1.

There is 2 contact set for each phase.

A Main contact and a spark contact (See picture 1 below)

The main contact set must be in a good looking condition. This is where the full load is to be transferred through the contactor.

The Spark contact is designed to handle the unavoidable sparks and arcs that will be developed when opening and closing this amount of energy. (Up to 2-3MW). So burn marks on the spark contact set is not only allowed, it is expected.

A complete melt down of the spark contact set is of course not allowed, but most important is it to make sure that the

main contact set is not burned.

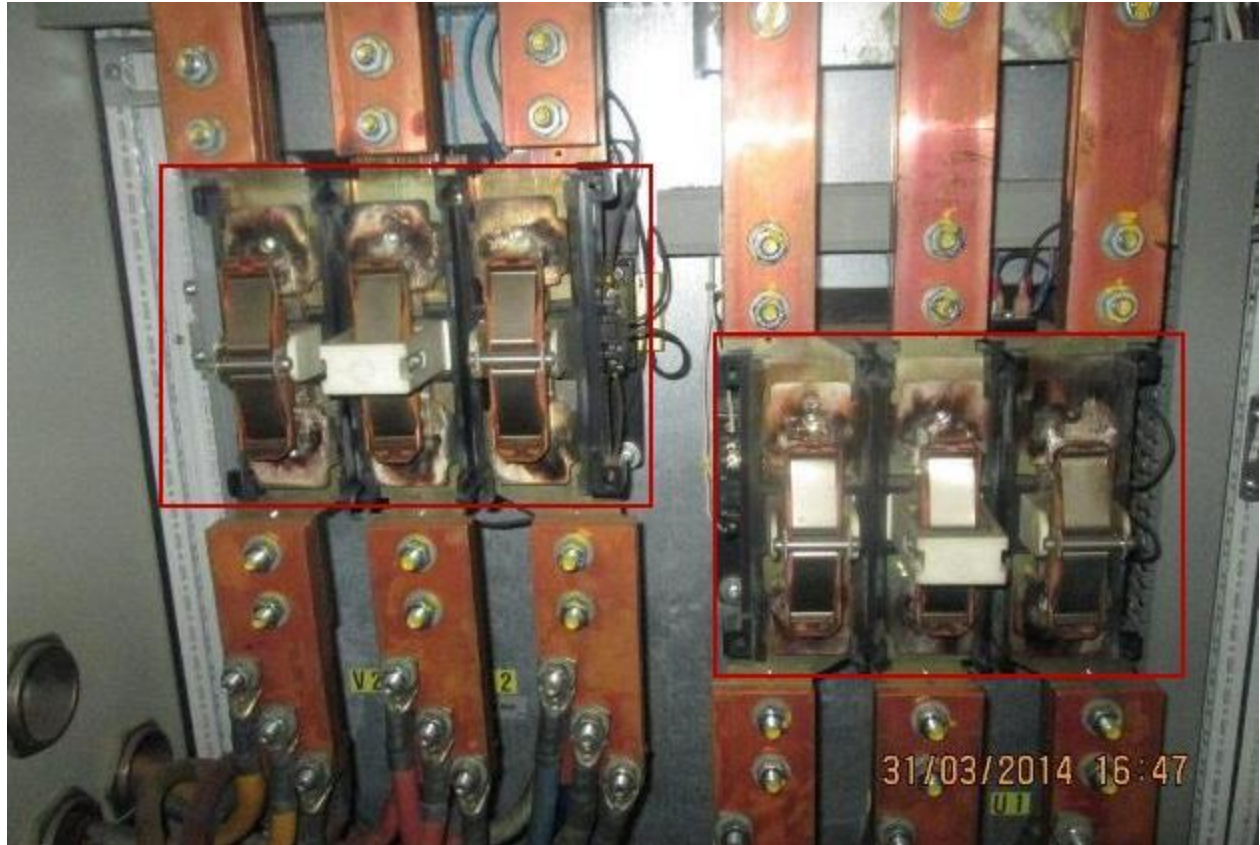
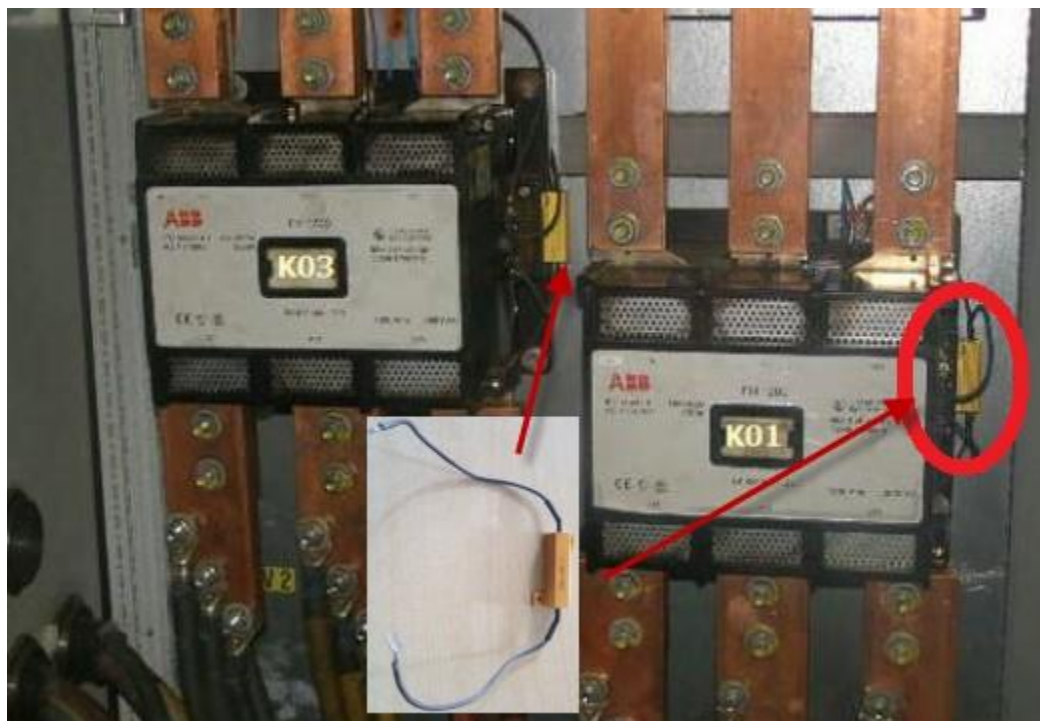
The contactors below show clearly burn marks, but all burn marks that can be seen from this view are placed on the **Spark contact set** where it is supposed to be like this.

Only a closer look from the side of the contactor will show if the **Main contact set** is damaged.

Solution:

If the **spark contact set** has suffered a complete melt down or have extreme burn damage making the spark contact fall apart, then a replacement is required.

If the **main contact set** has burn marks making the surface un-even, then a replacement is required.

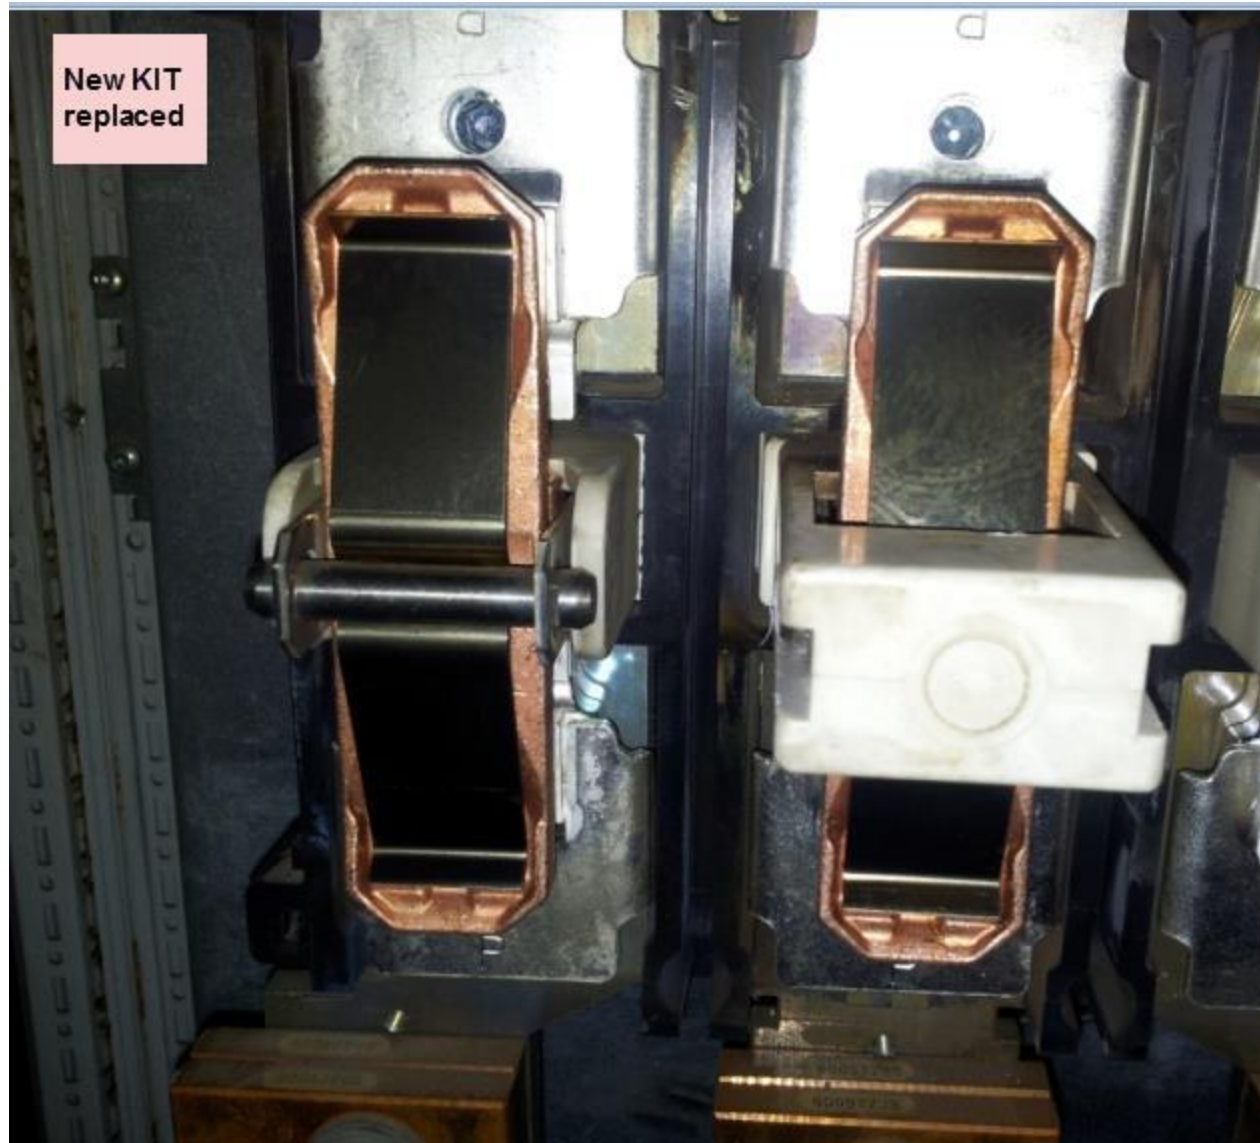
The picture below show a EK1200 contactor, where a new contact set (repair kit) have been mounted.

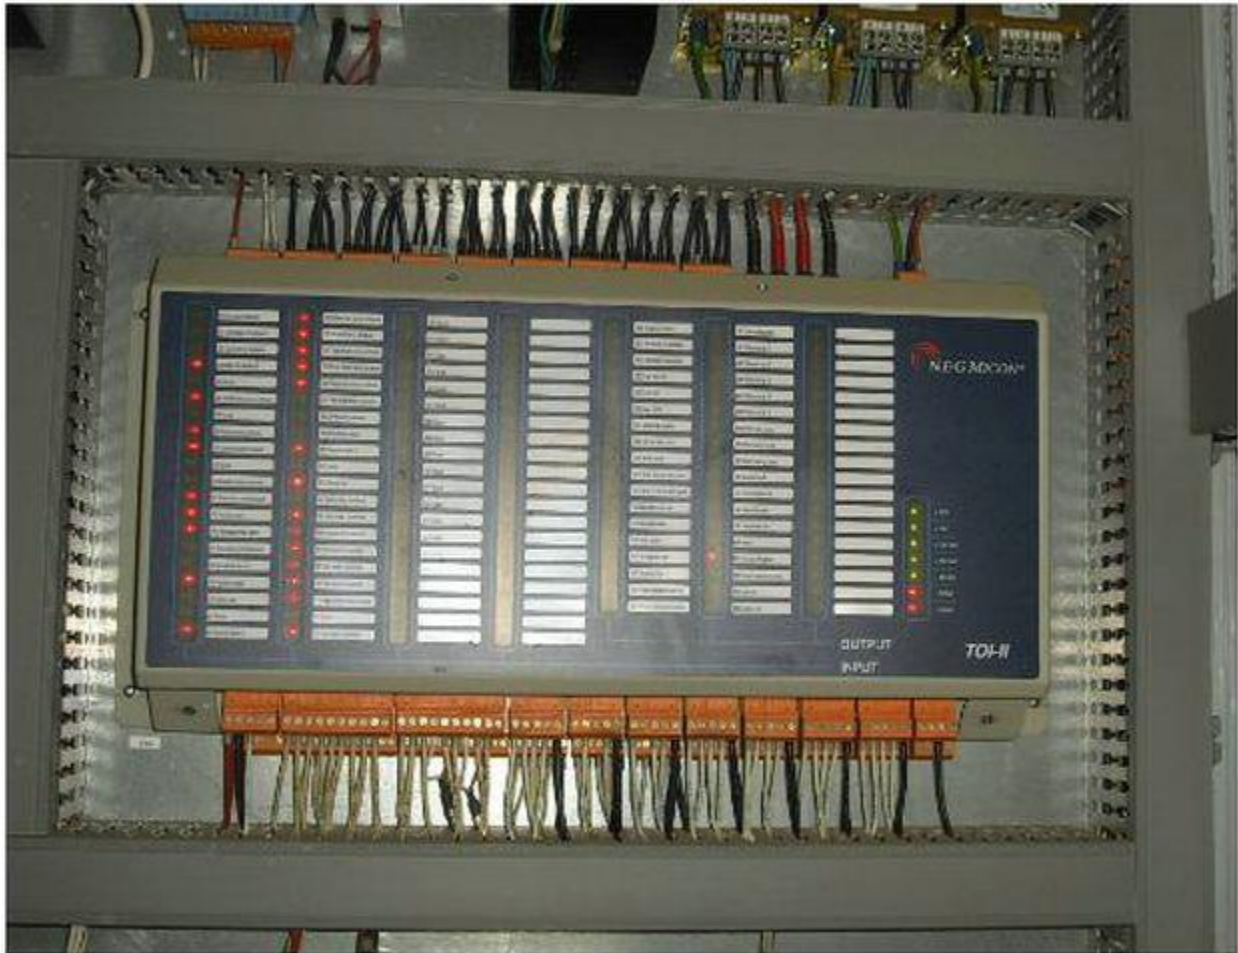
- **Explanation**
IN THE AT2 CABINET:

Check the TOI Input (DIGITAL INPUT 500 -504)

Check the signal presence in 501

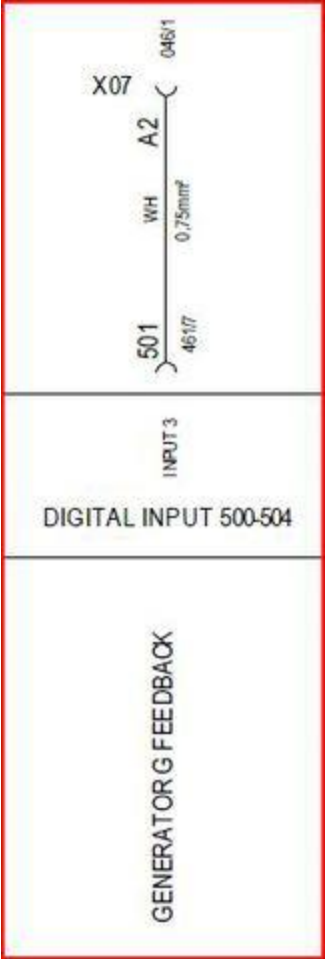
Check LED indication is 'ON' for Generator G Contactor signal
