Replace the defect Magnetic coil

- **Explanation**
IN THE Nacelle:

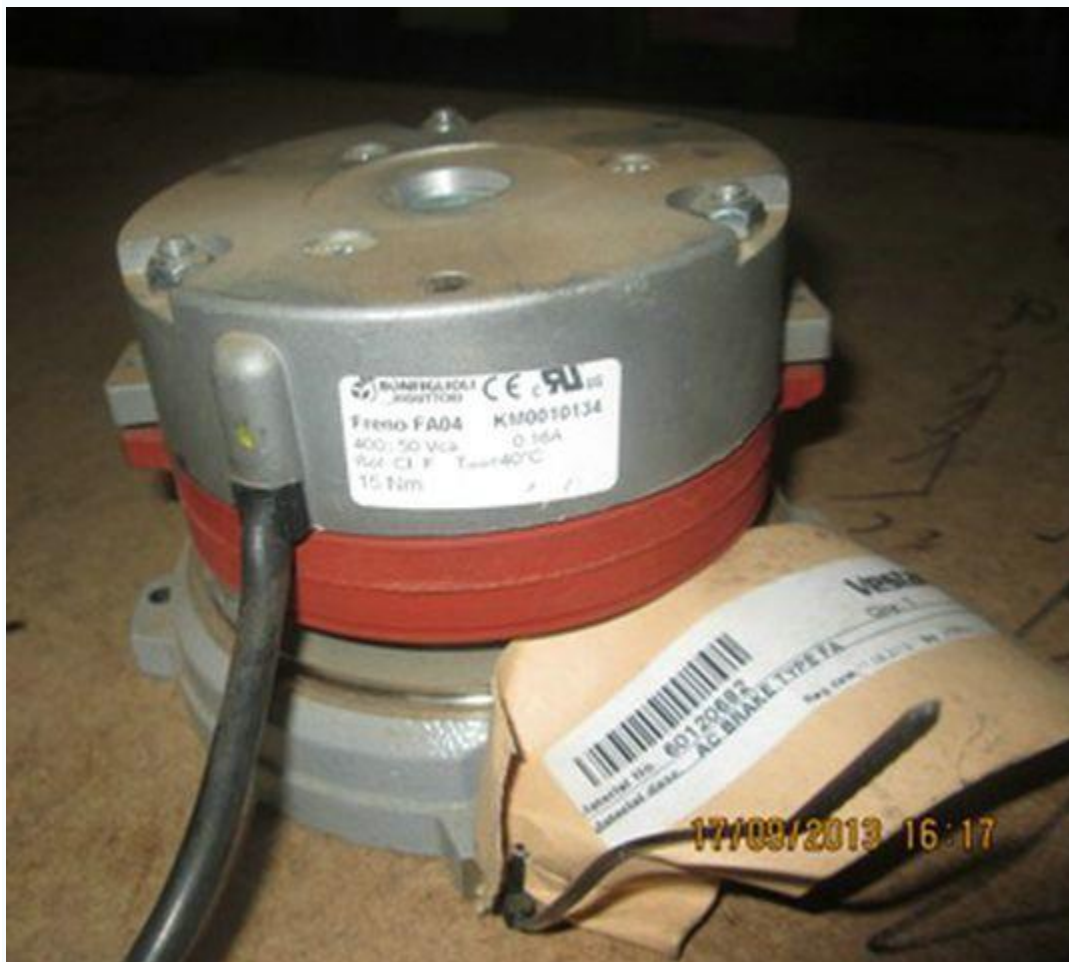
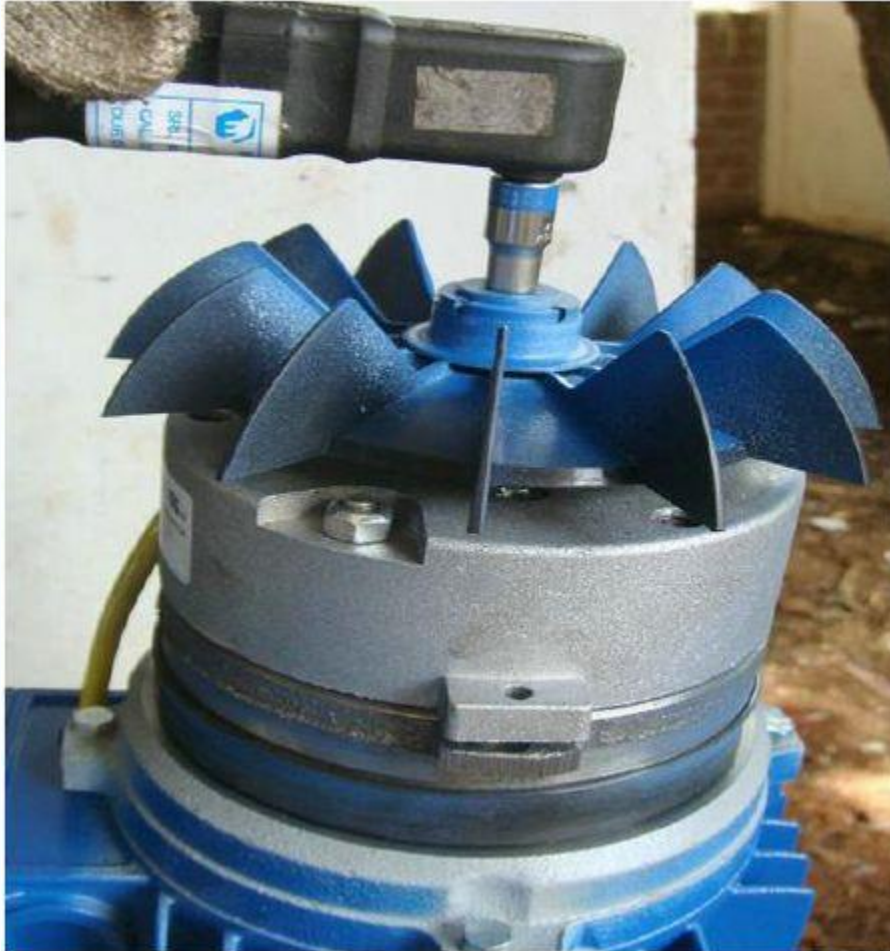
Item Number: [60120682](#) - AC BRAKE TYPE FA

If the Magnetic coil is found to be defective replace the magnetic coil

For details, refer to the service Instruction for Yaw System -[1000686](#)

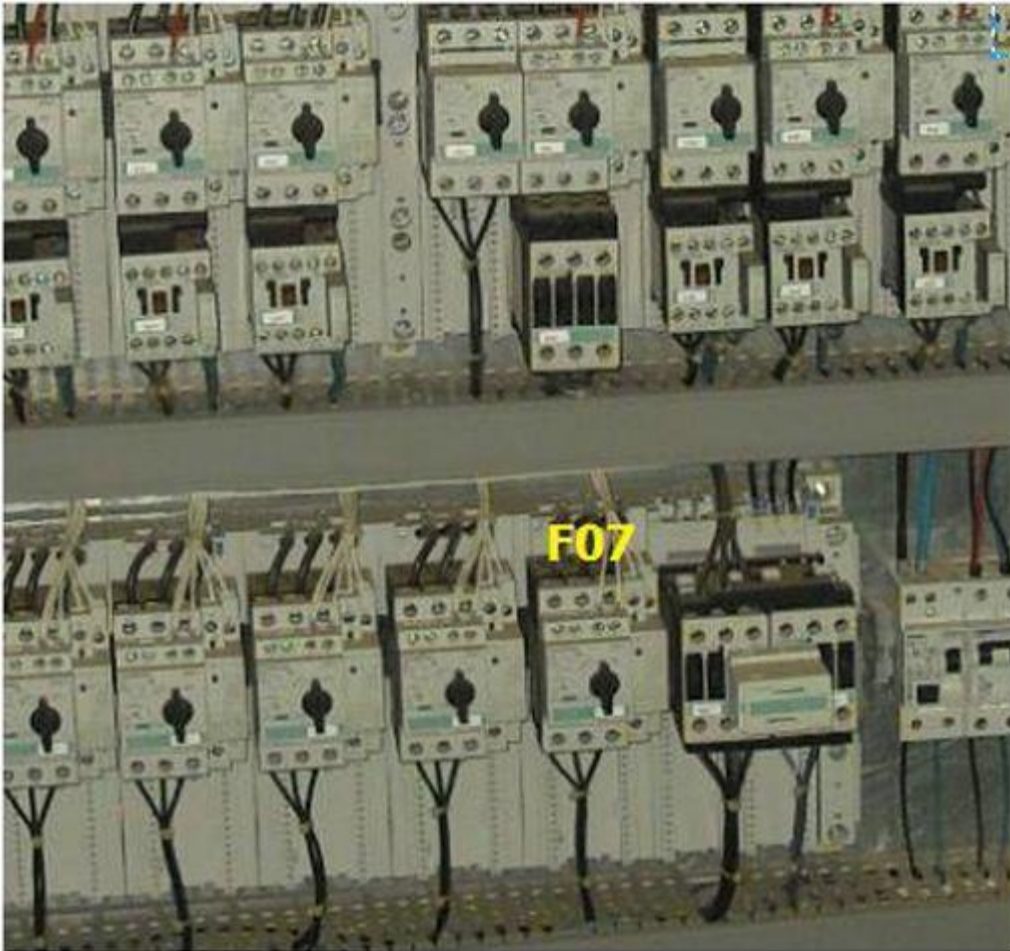
If defect replace the MCB (Item number – [60004746](#) 50 Hz 60004749 60 Hz)

If defect replace the Auxiliary relay (Item number – [60004778](#) 50 Hz/60Hz)

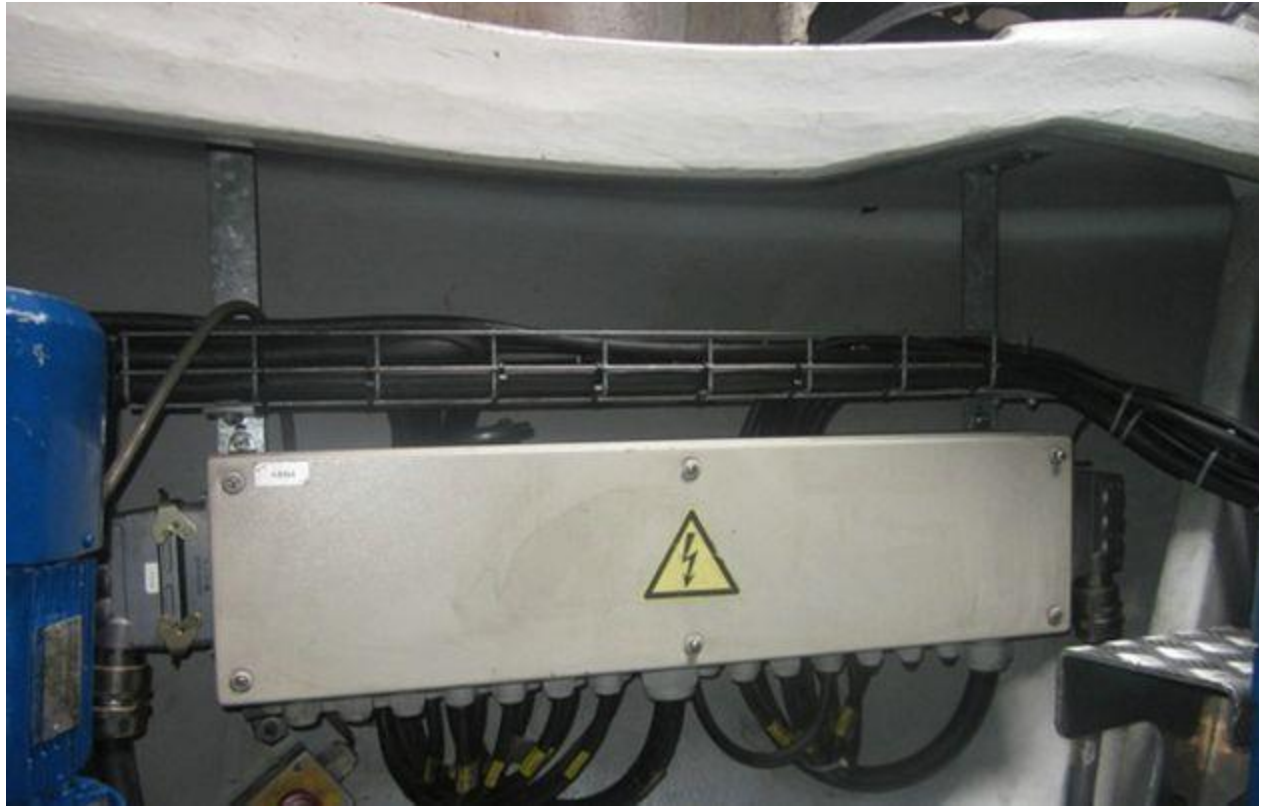
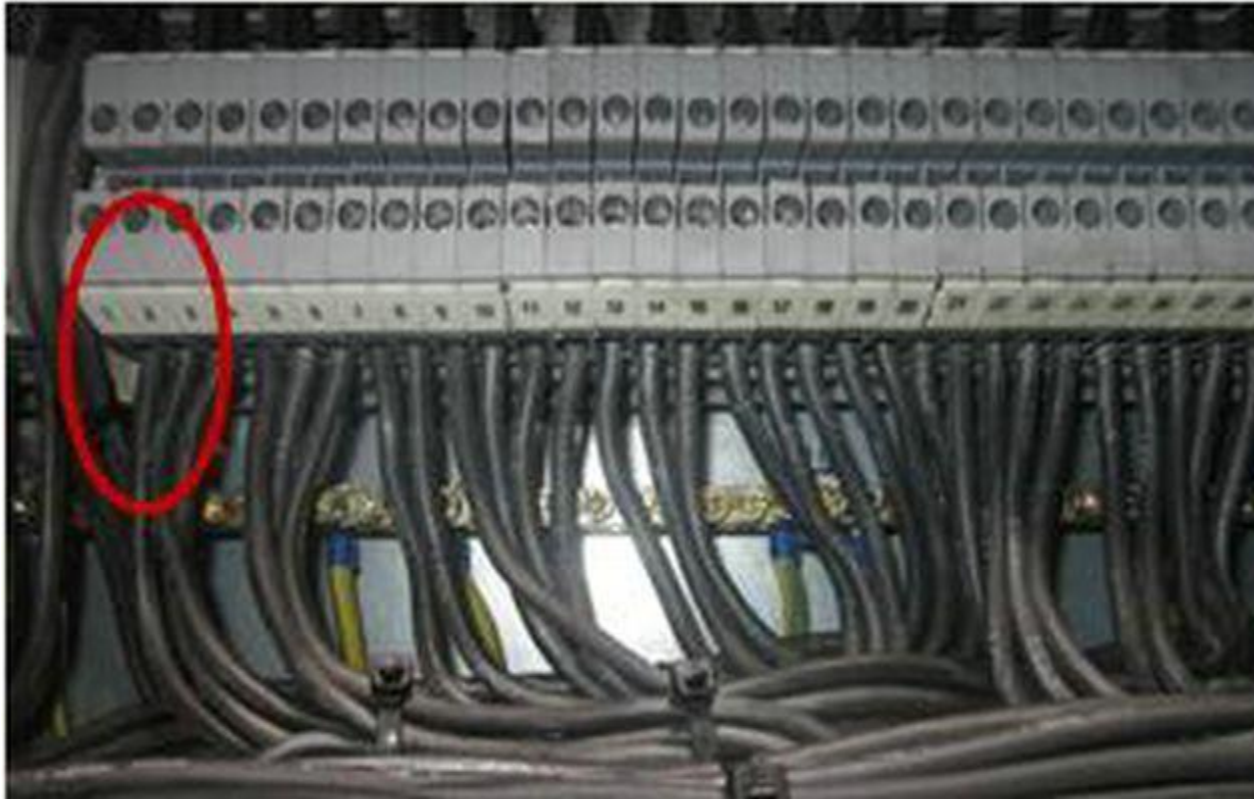
AT AN4 : Check the proper connection and connectivity between AN4 to motor terminal box cable (W339) and main cable from AT2 to AN4 (W310) connections and connectivity.

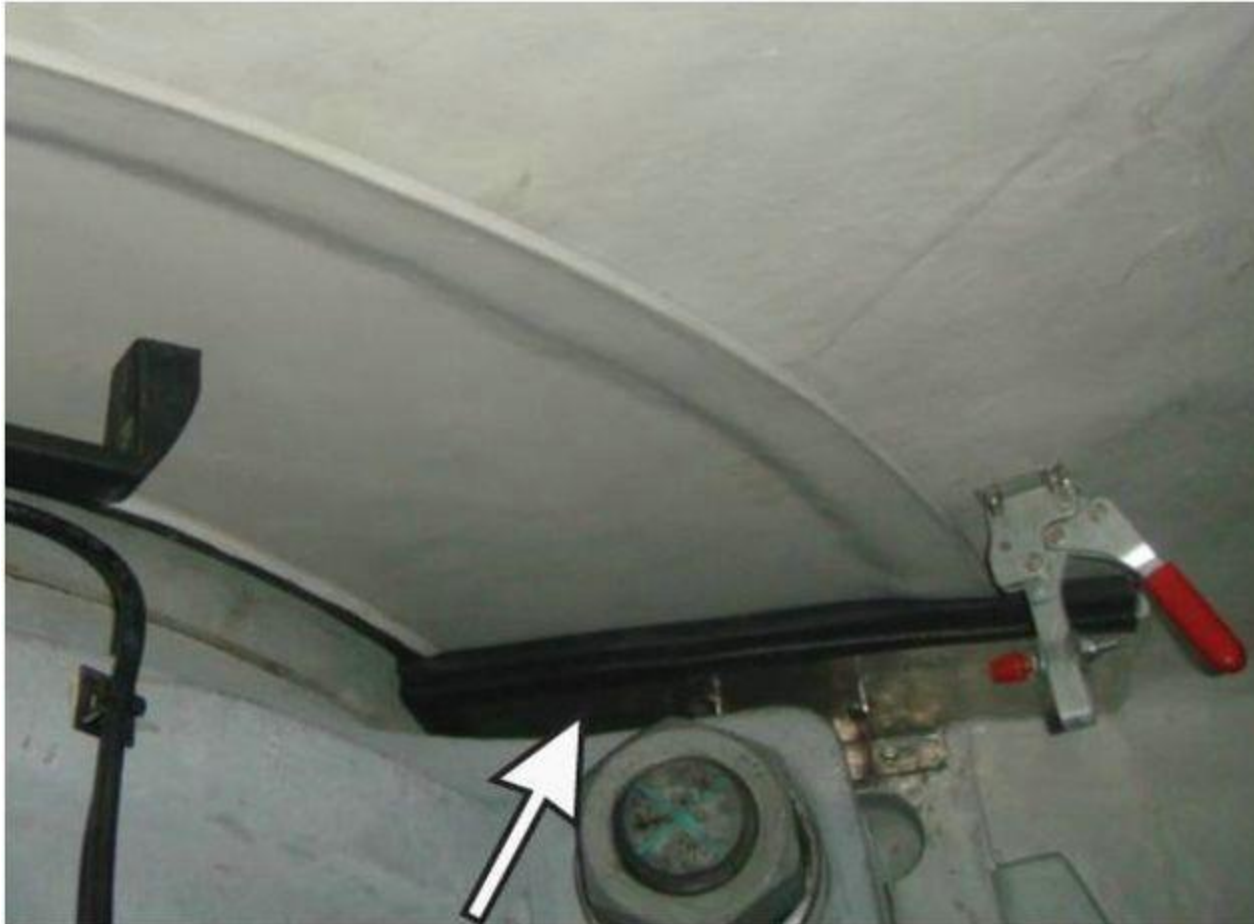
Sealing Nacelle Cover [0004-7508](#)

Ensure sealing on cover is fixed:

Relevant spare parts	
Description	Item No.
COVER PL. CPL. AT MAIN SHAFT V82 -LEFT	60111602
COVER PL CPL AT MAIL SHAFT V82 -RIGHT	60111603

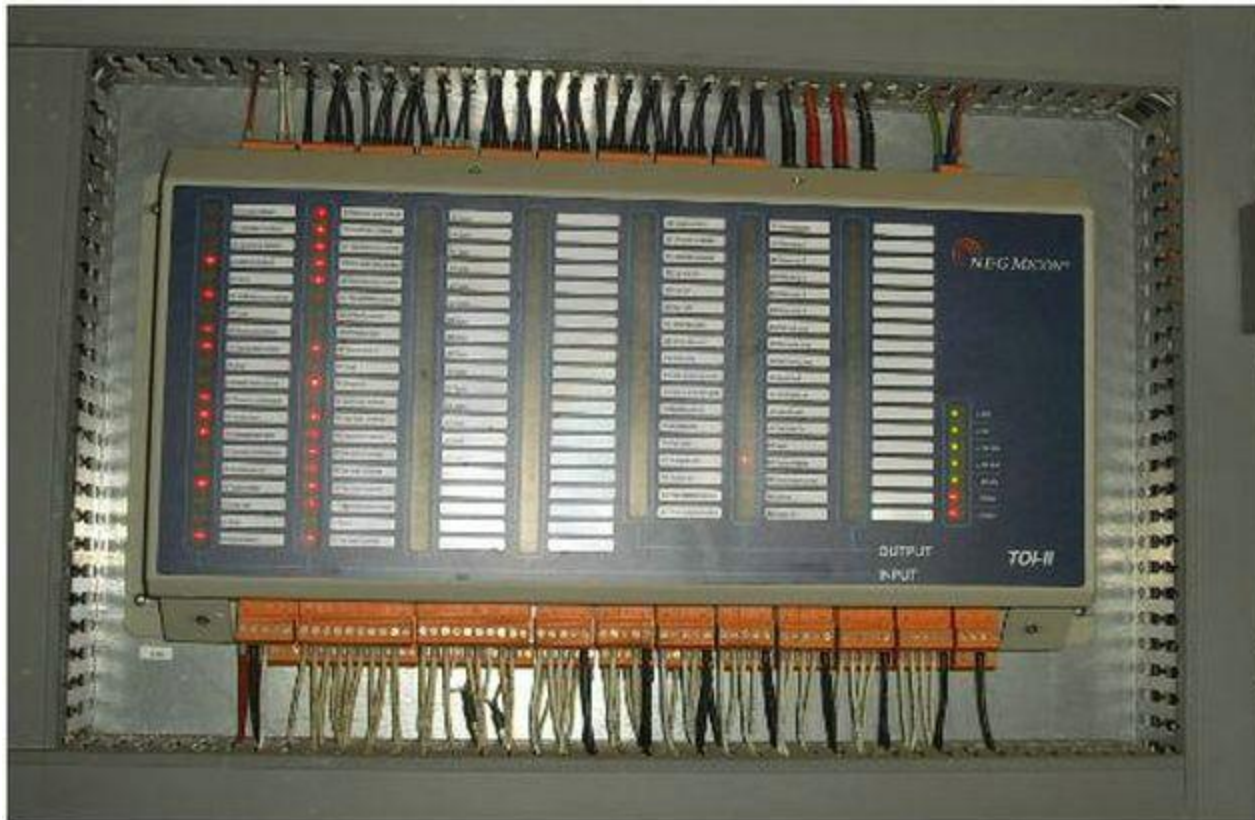
If defect, replace the TOI (Item Number [51701501](#))

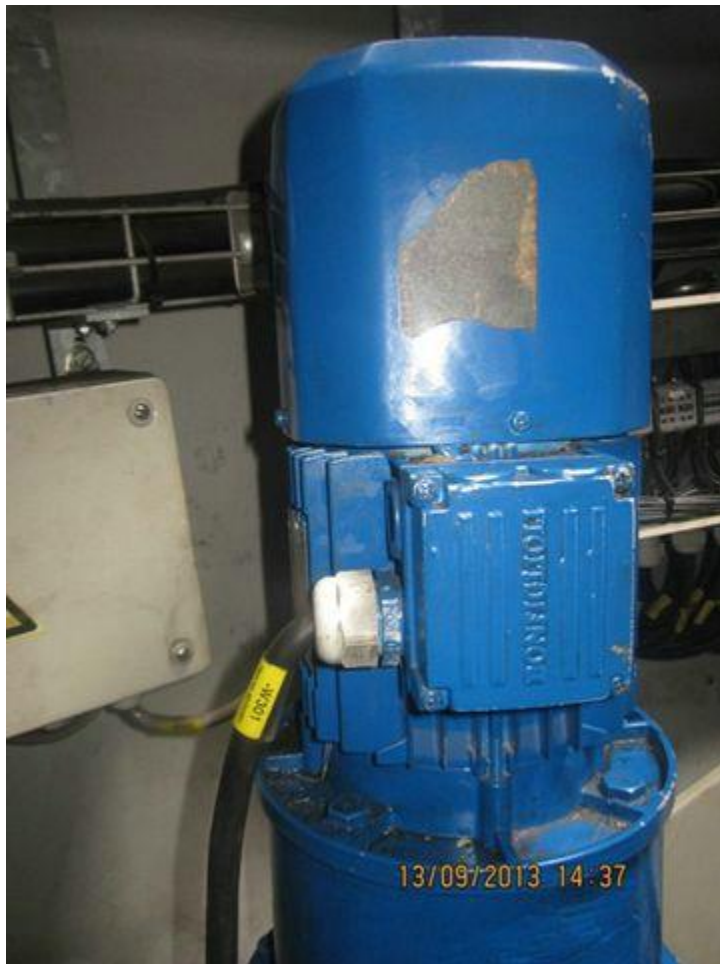
Operate the Motor and listen for faulty bearings or abnormal noise of any kind.

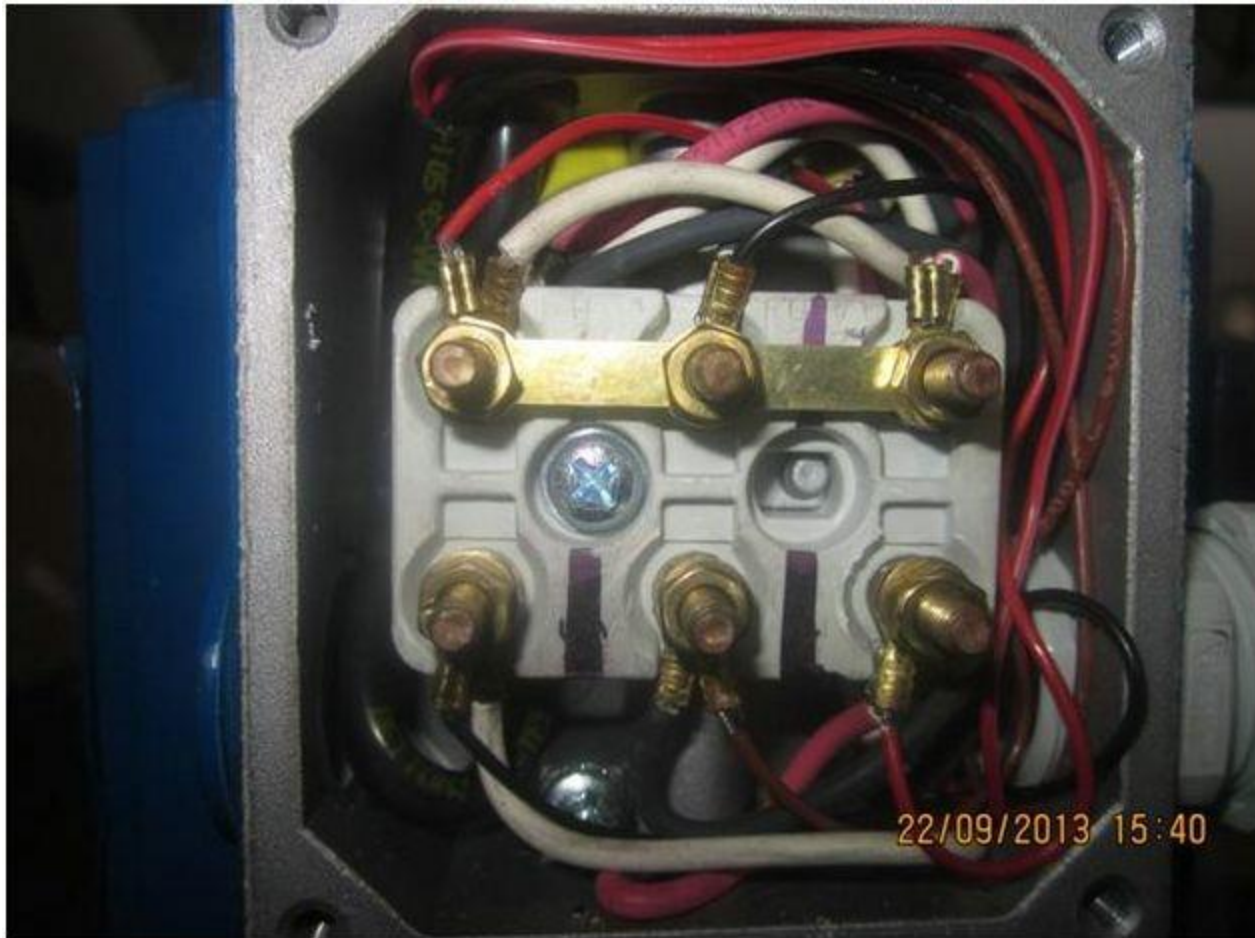
Check for any loose connection in the terminal box:

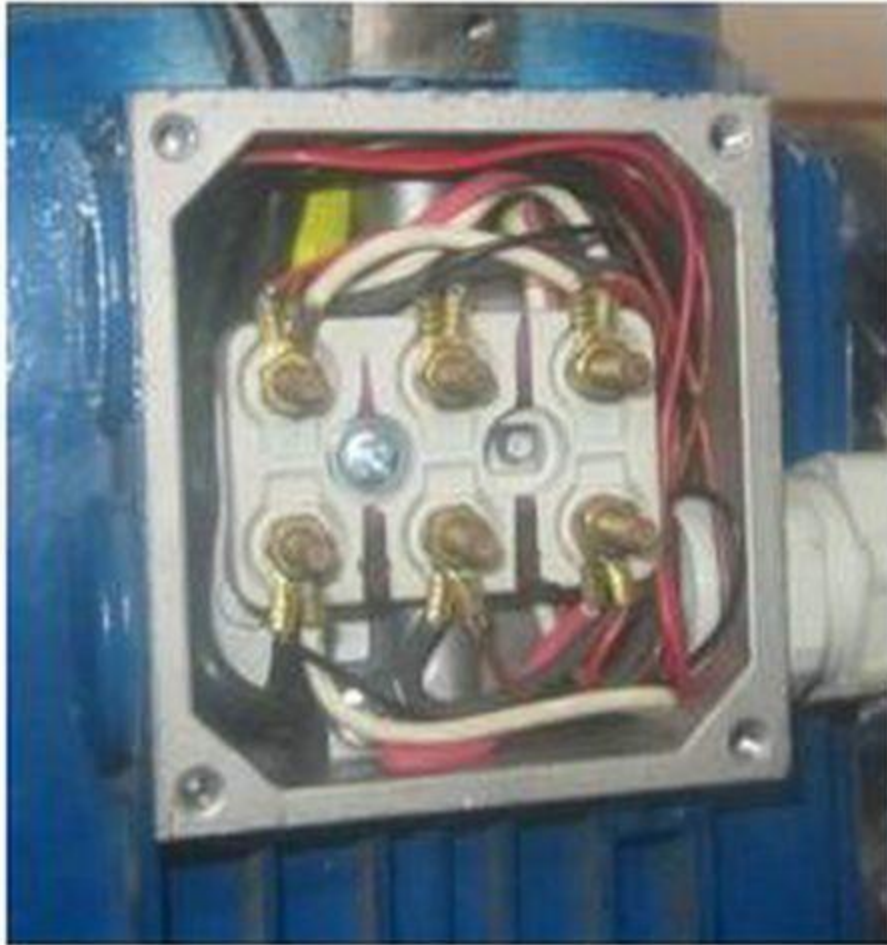
Remove the STAR/ DELTA connections.

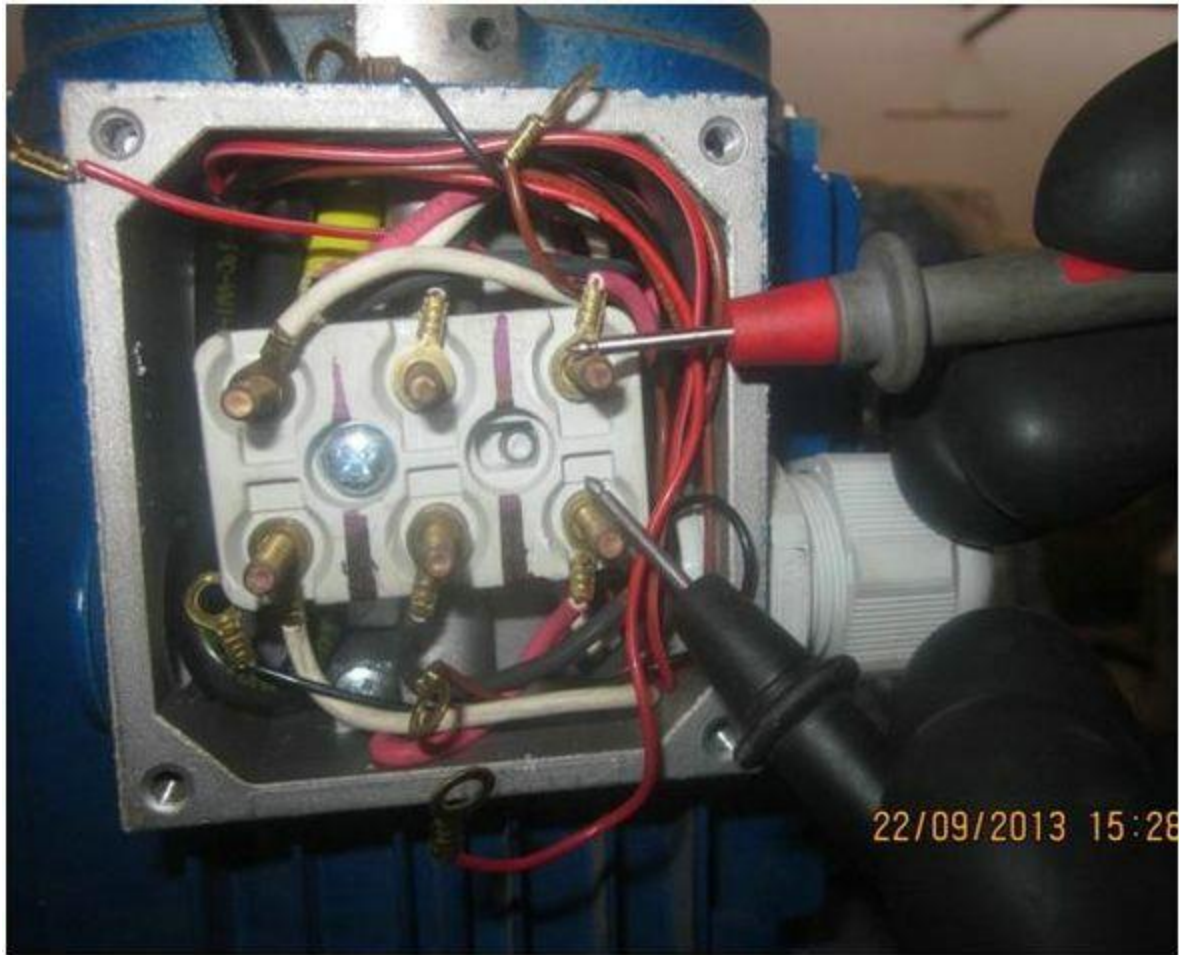
Remove the Yaw brake magnetic coil connection

Measure the resistance value of the motor windings and magnetic coil.

Measure phase to phase and phase to earth on all windings.

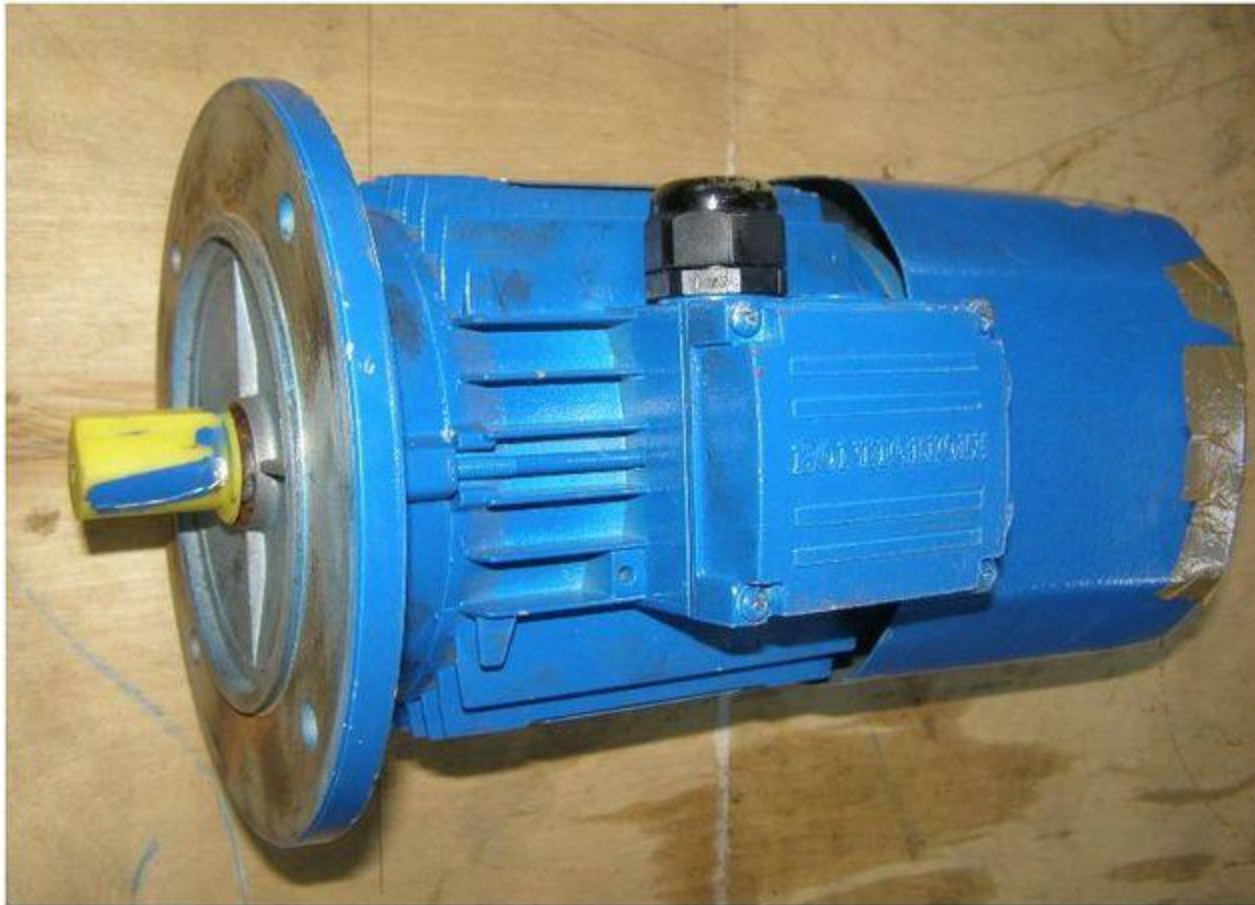
If the motor is found to be defective replace the motor with magnetic coil

(Item number: [60091176](#))

Yaw Motor replacement SWI - [0011-5166](#)

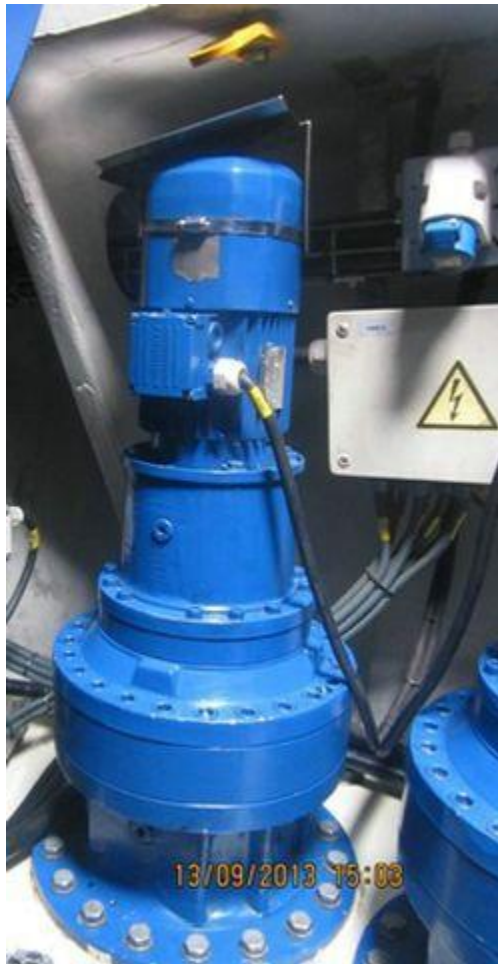
Check the oil level in the gear unit, top up the recommended oil If necessary.

Operate the yaw gear and observe any kind of abnormal sound.

If the yaw gear unit is found to be defective replace the gear unit and apply the torque value as per I & S data

Replacement of Yaw Gear Unit [0010-5073](#)

(Item number: [60103371](#) -Yaw gear Bonfiglioli 709T4F 0)

Refer Service Work Instruction for Yaw Lock - [0002-8965](#) before replacement of yaw gear unit, motor and magnetic coil.
