Check and replace defective valves

Replace the brake calliper defect or brake pad worn-out

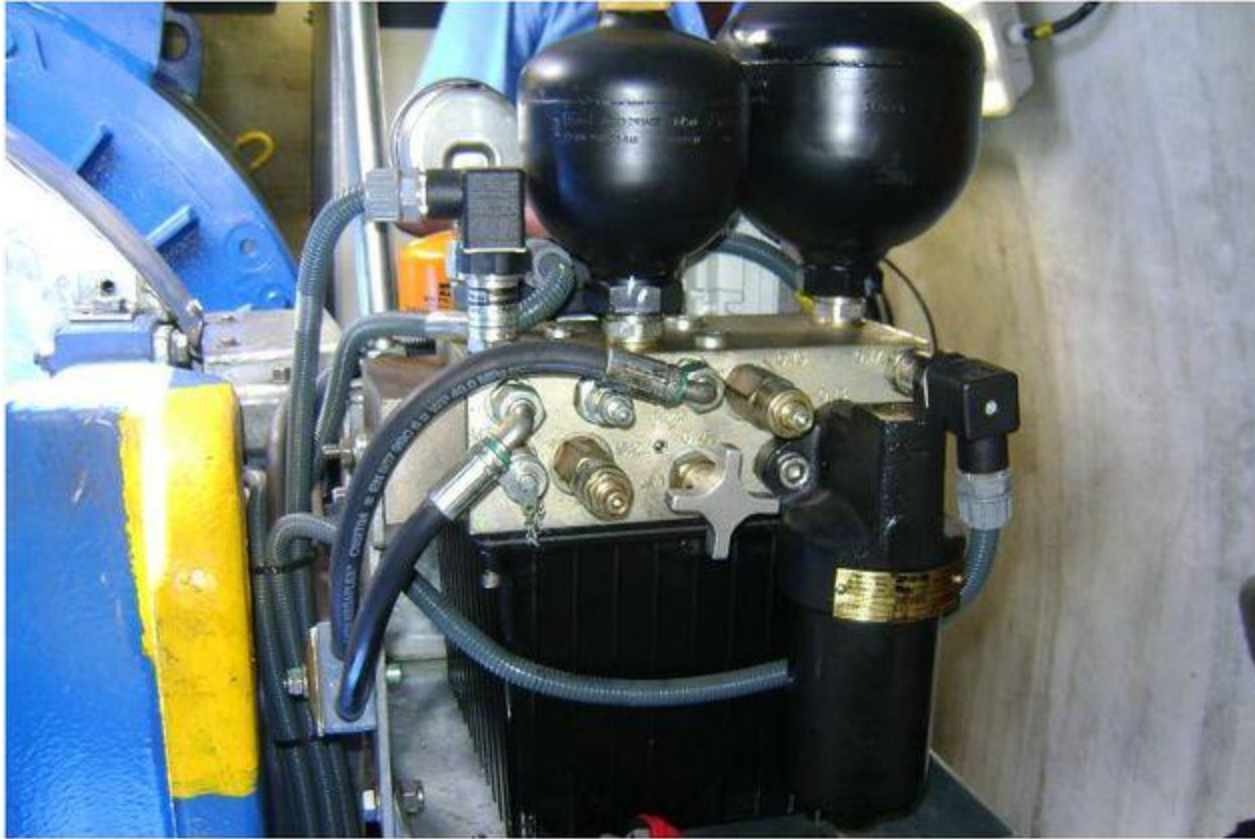
Check the solenoid valve **POS 0.20(NO), 0.21(NC)**

Item number for solenoid valve:	
60104031	DIRECT VALVE N.C. 2/2 DSL-08-1
60104034	VLV DIRECT NO 2/2 DSL-08-1-CR

If solenoid valve is found to be defective, replace it with new.

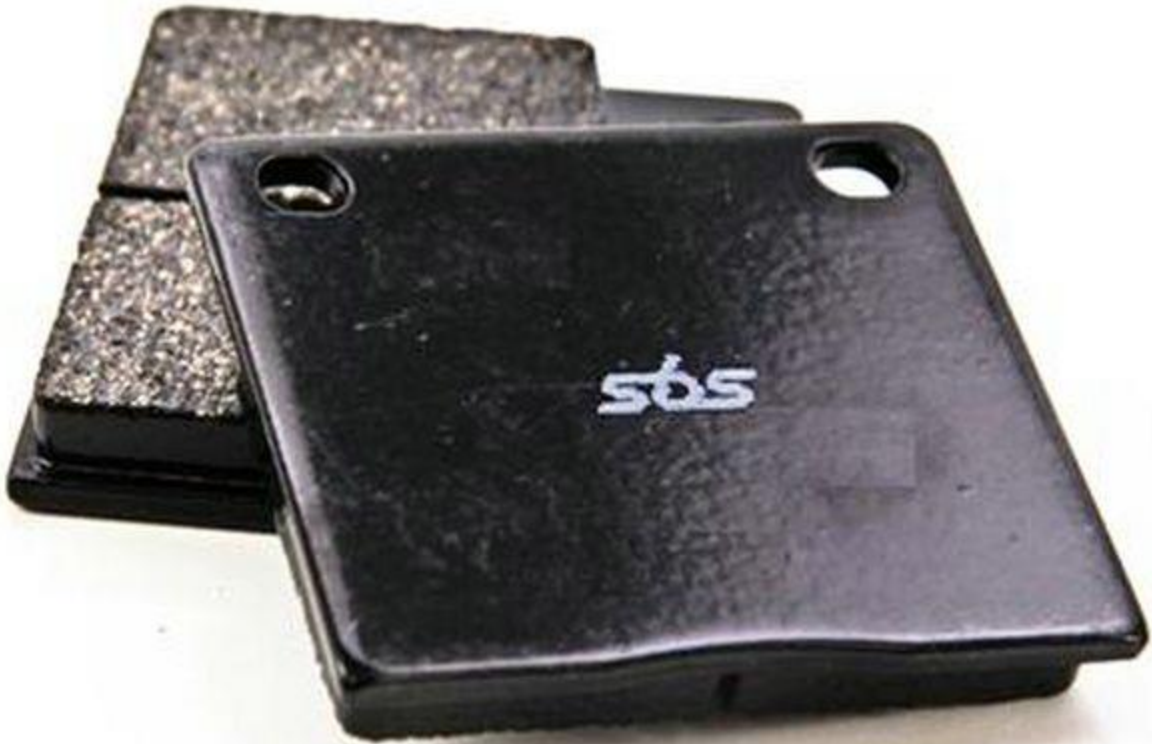
Part number for brake pads:

[60100201](#) - BRAKE PADS, SBS C-023

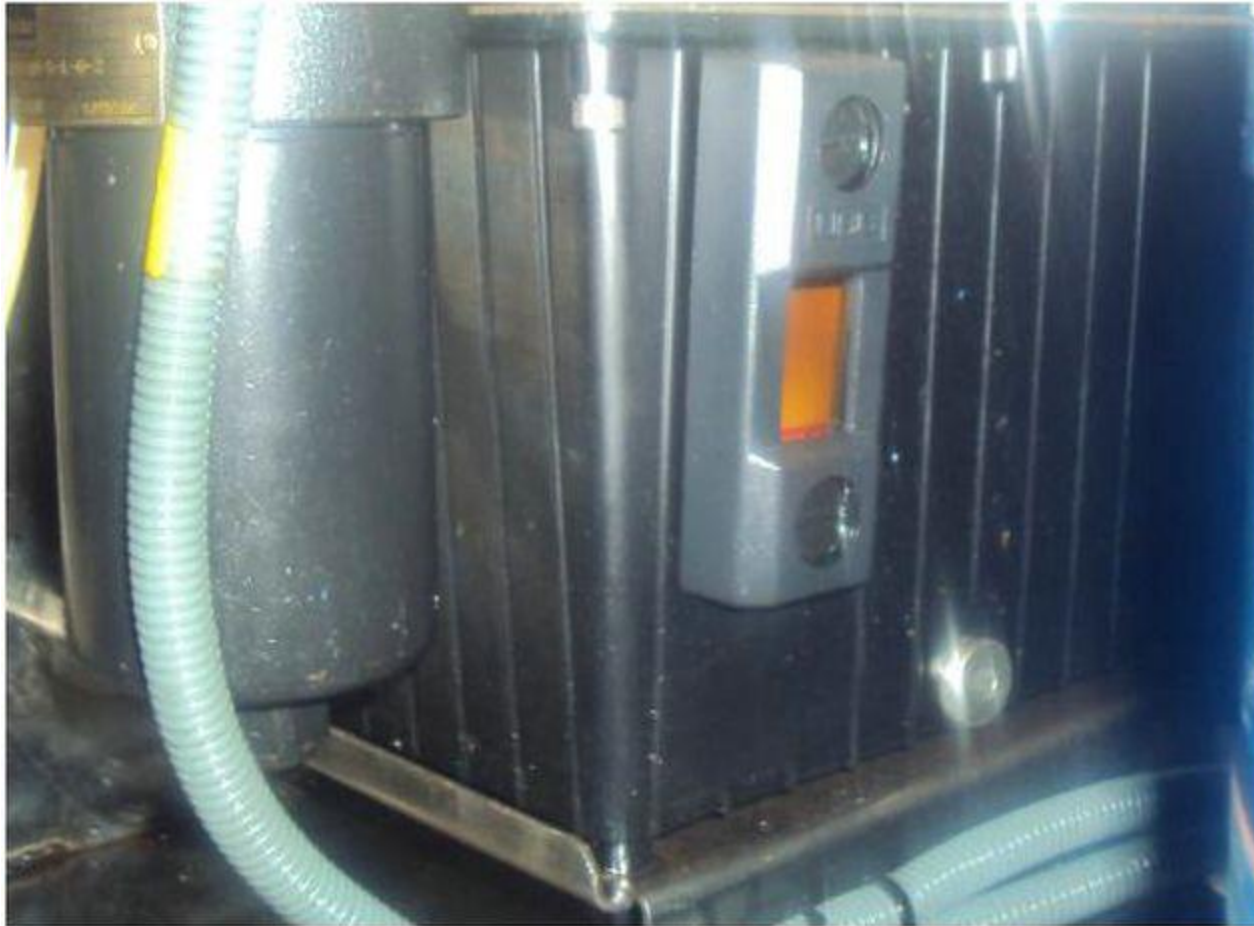
Check oil level (with system pressurized and brake applied oil should be visible in oil window)

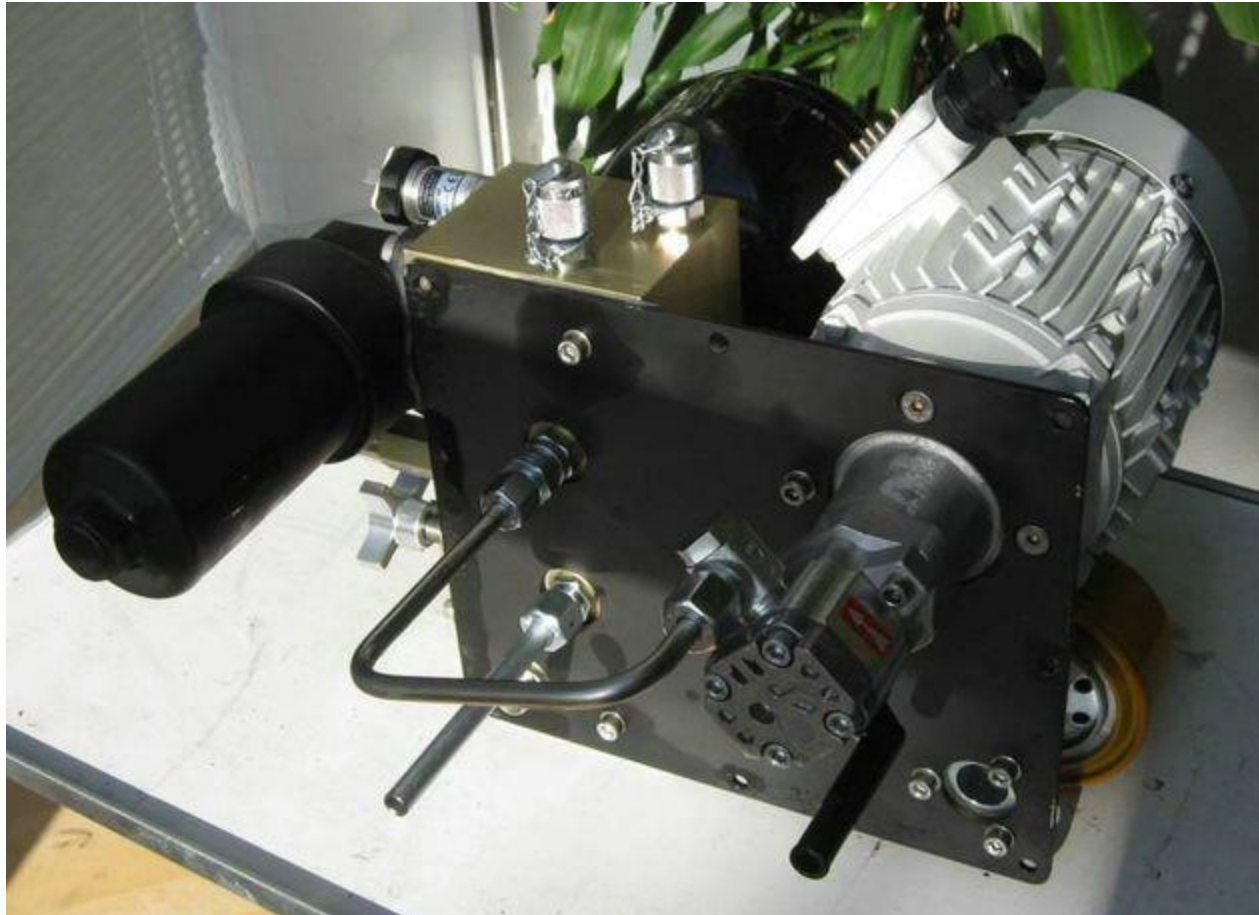
Item number for hydraulic pump:

[60103470](#) - GEAR PUMP P1 AAn 0050 FL 20-B0

If found hydraulic pump is defect replace it

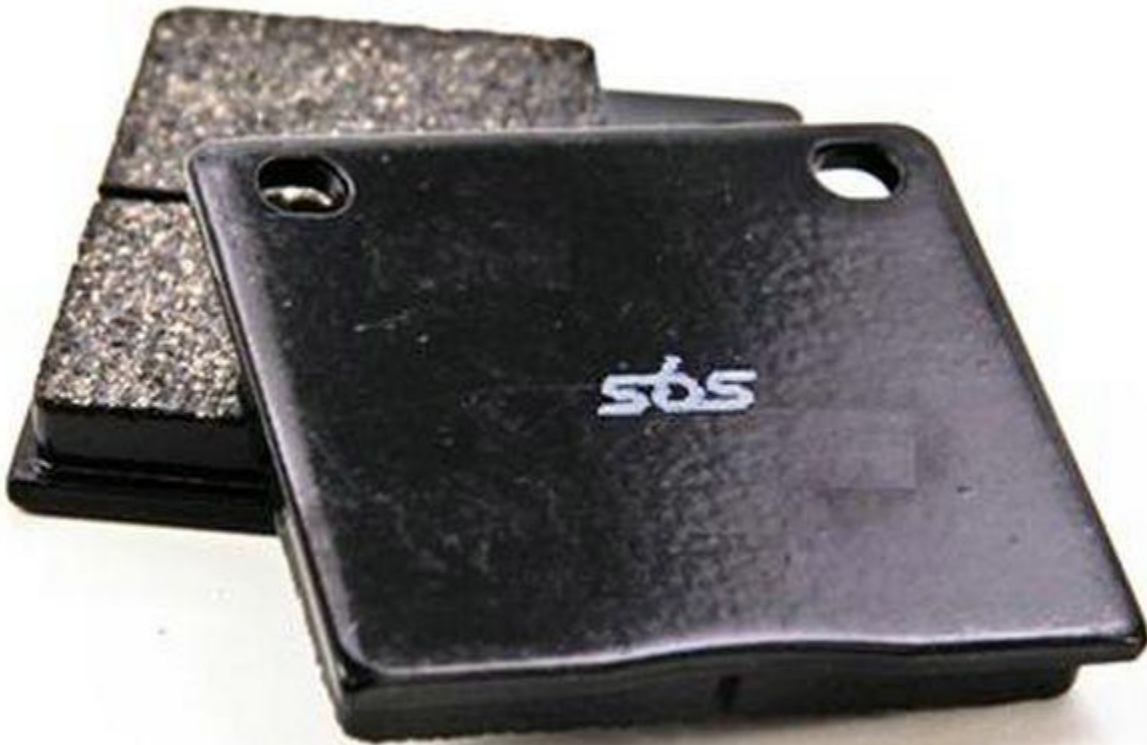
Part number for brake pads:

60100201 - BRAKE PADS, SBS C-023

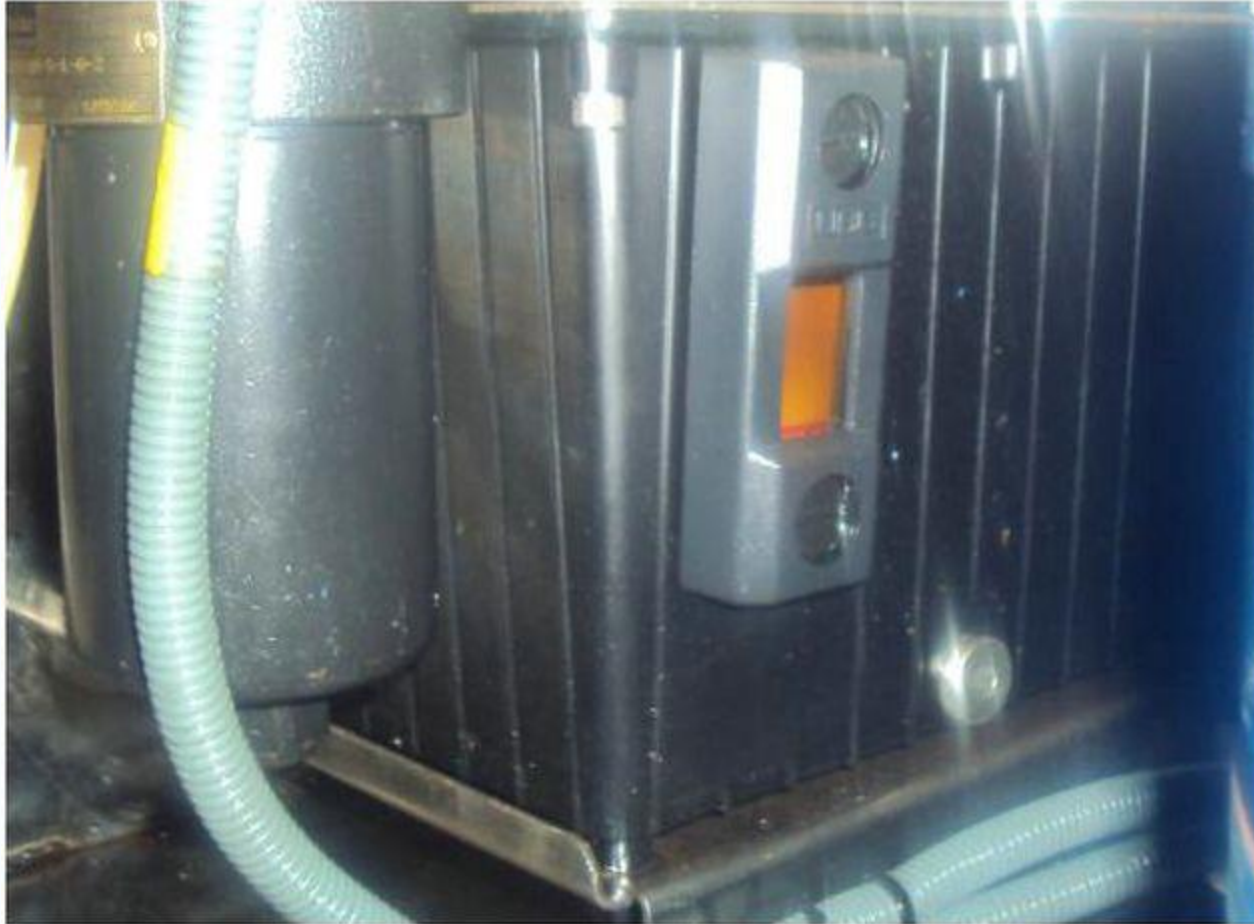
Check oil level (with system pressurized and brake applied oil should be visible in oil window)

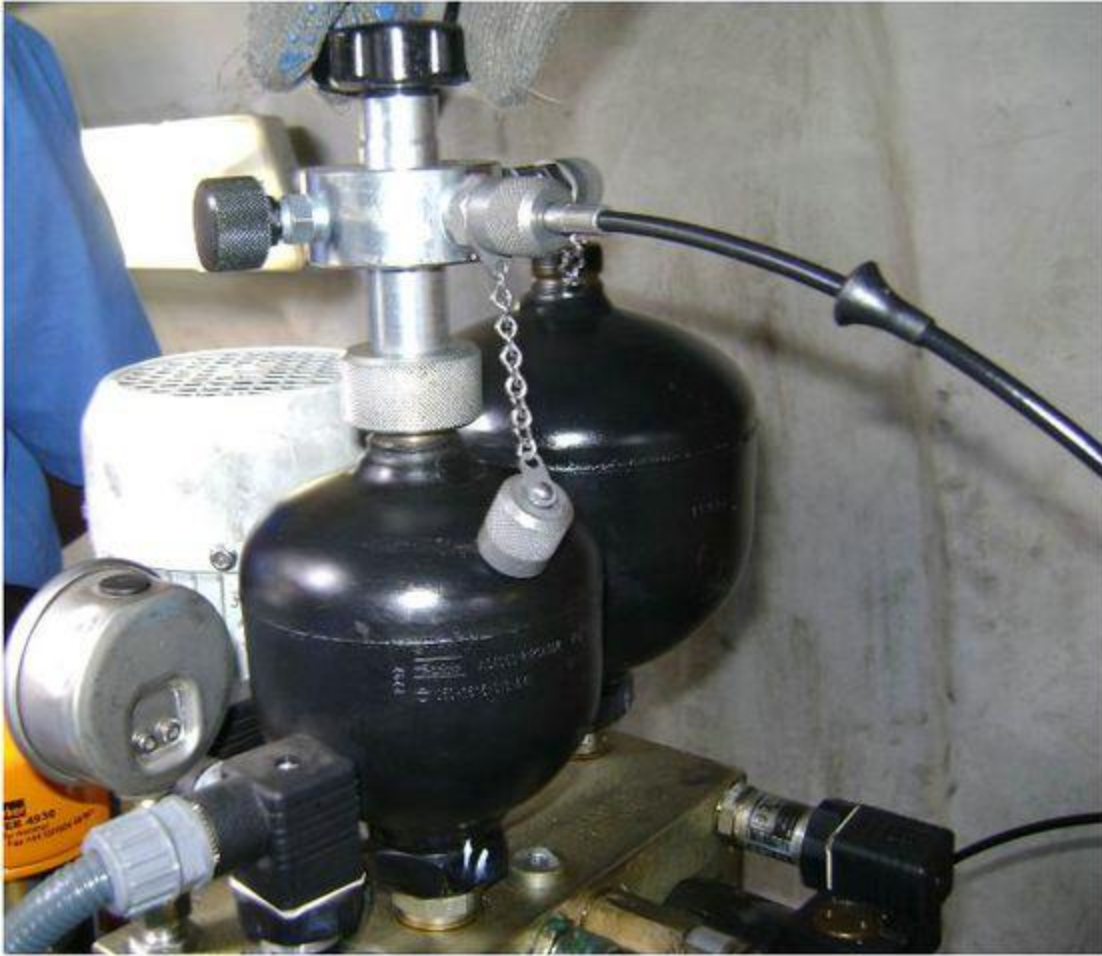
Check pre-charge of accumulator.

Reference DMS [941918](#) Charging of Nitrogen Accumulators for instructions. Reference the following service instructions depending on which type the turbine is equipped with:
