## Replace the defective Bypass contactor

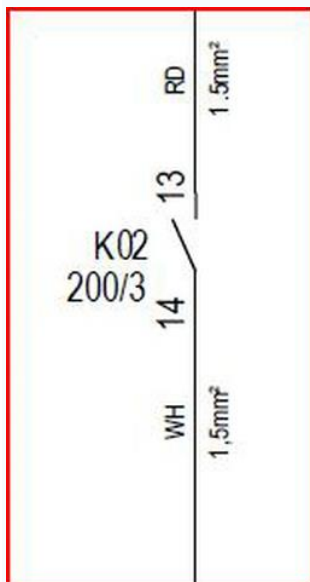
Check the contactor function K02.

Check the contactor input supply.

If defective replace the contactor:

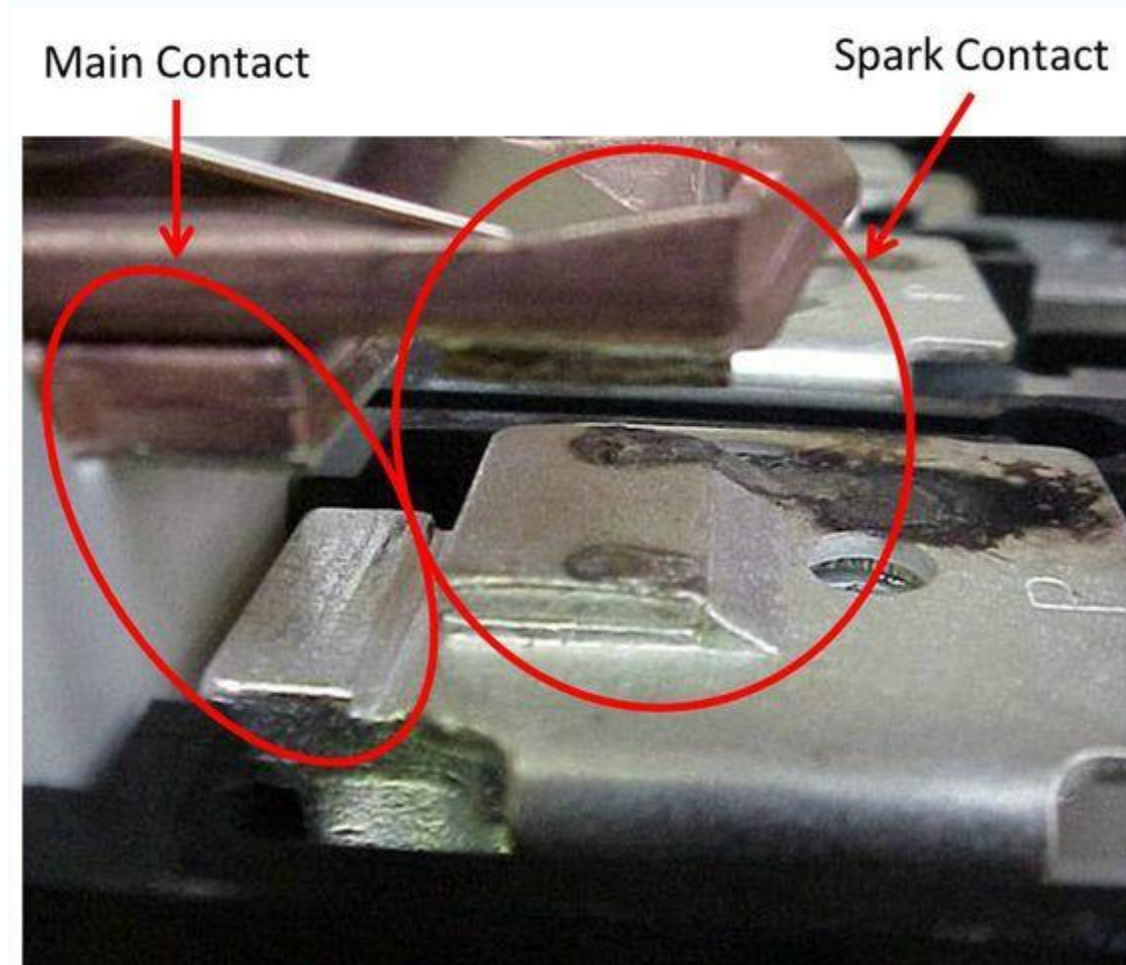
Picture 1.

There is 2 contact set for each phase.

A Main contact and a spark contact (See picture 1 below)

The main contact set must be in a good looking condition. This is where the full load is to be transferred through the contactor.

The Spark contact is designed to handle the unavoidable sparks and arcs that will be developed when opening and closing this amount of energy. (Up to 2-3MW). So burn marks on the spark contact set is not only allowed, it is expected.

A complete melt down of the spark contact set is of course not allowed, but most important is it to make sure that the main contact set is not burned.

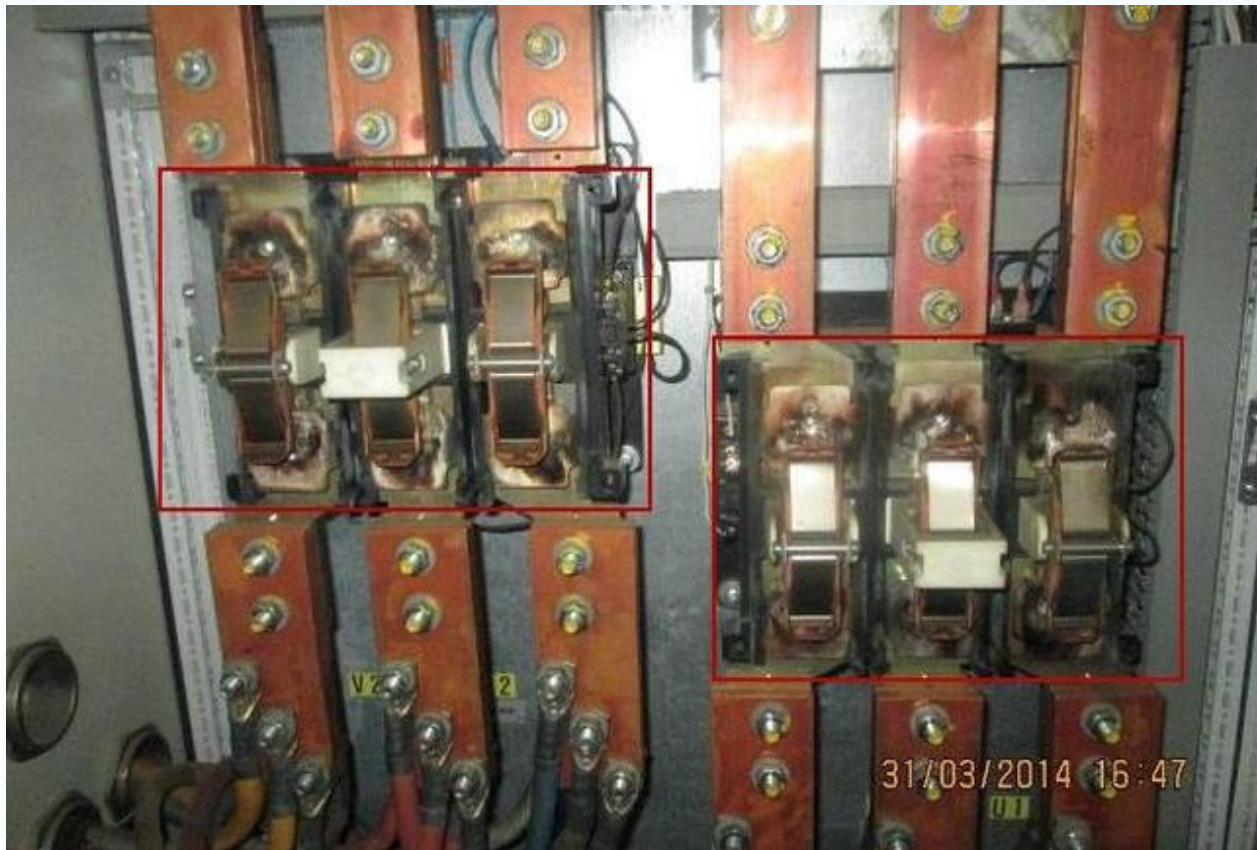
The contactors below show clearly burn marks, but all burn marks that can be seen from this view are placed on

the **Spark contact set** where it is supposed to be like this.

Only a closer look from the side of the contactor will show if the **Main contact set** is damaged.

If the **spark contact set** has suffered a complete melt down or have extreme burn damage making the spark contact fall apart, then a replacement is required.

If the **main contact set** has burn marks making the surface un-even, then a replacement is required.

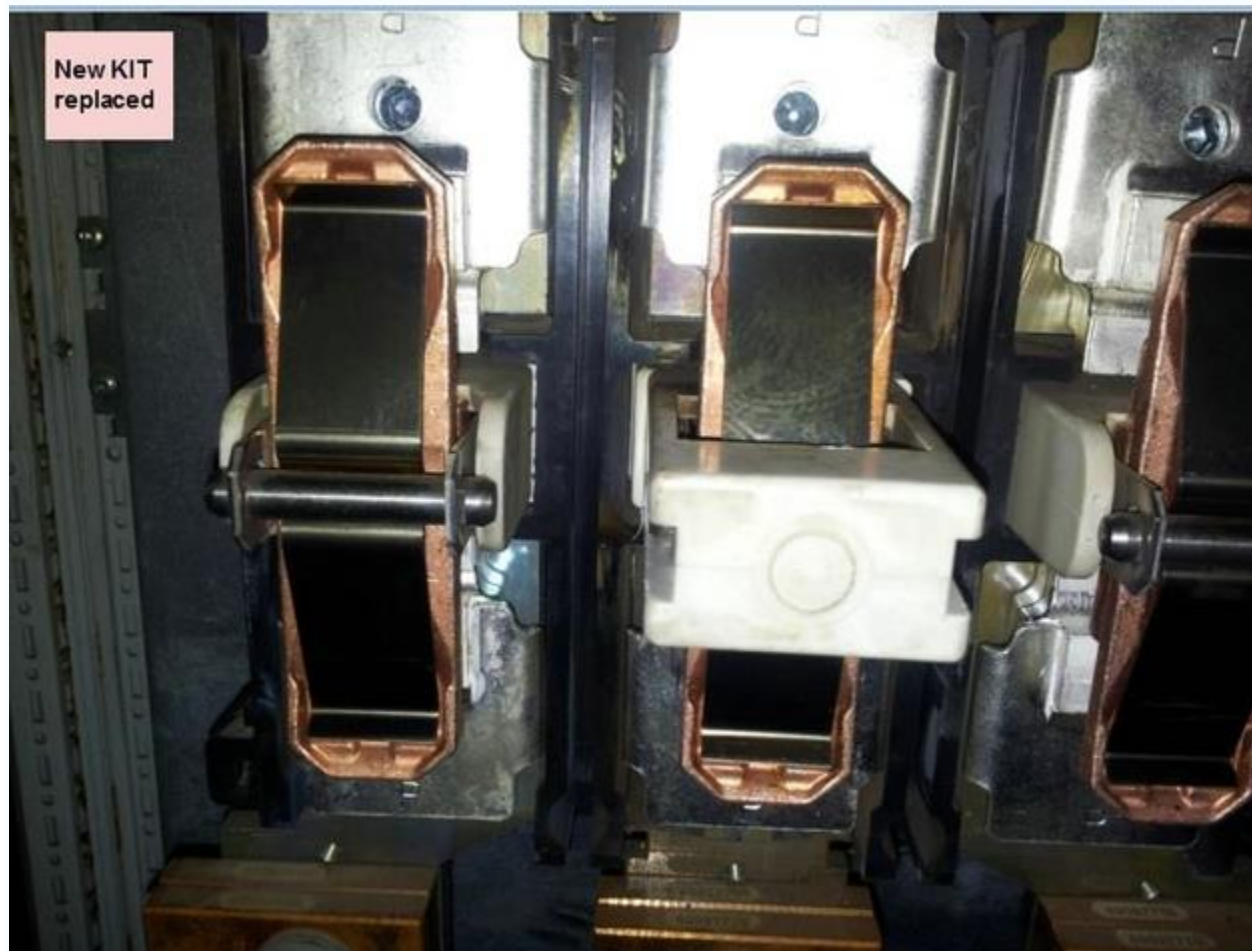
The picture below show a EK1200 contactor, where a new contact set (repair kit) have been mounted.

CONTACTOR EH1200	<a href="#">S093693</a>	<a href="#">60004316</a>
CONTACT SET FOR EH1200	<a href="#">S093466</a>
