Replace the defect pressure transmitter

- **Explanation**
IN THE NACELLE:

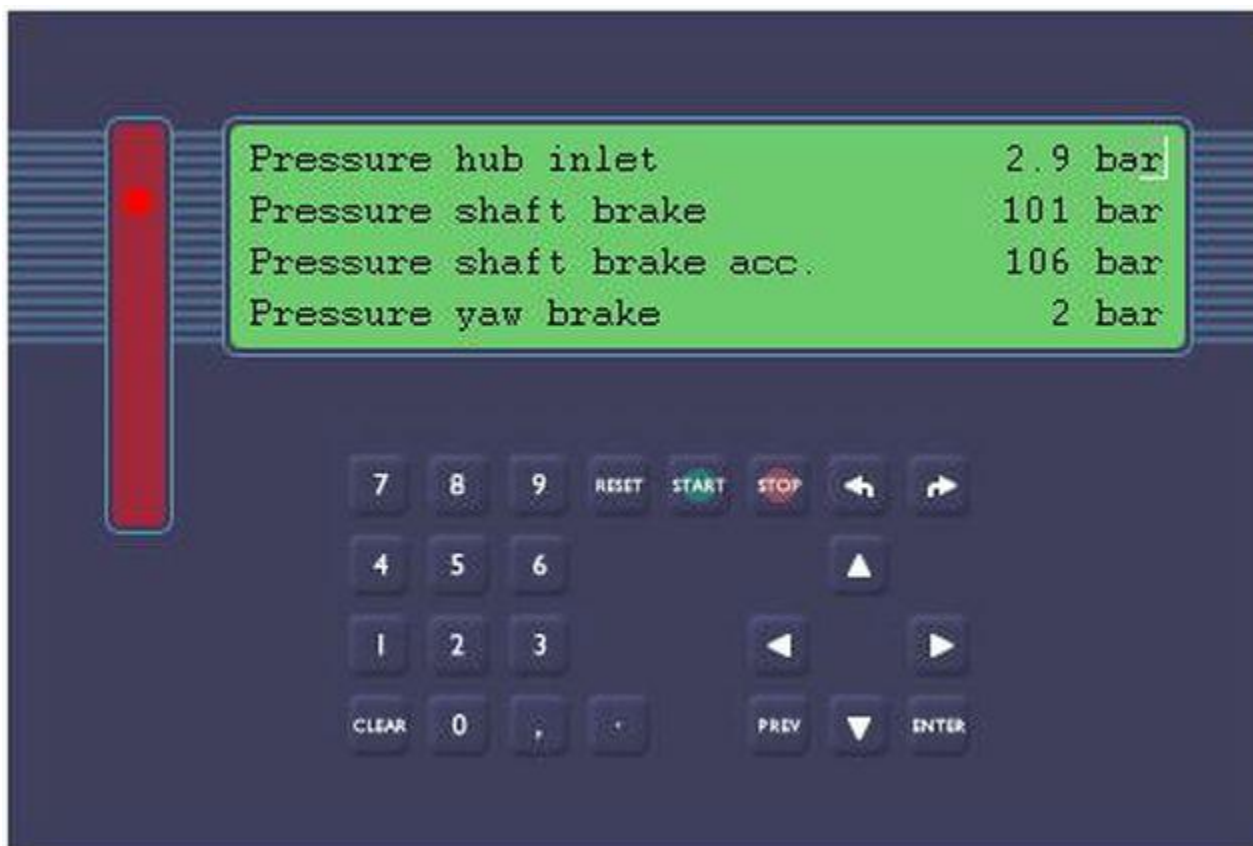
Check the pressure value through the TAC -II controller,

Status→ Pressure→ Pressure shaft brake

If the displayed pressure shows as a negative value the pressure transmitter is may be defective and has to be replaced

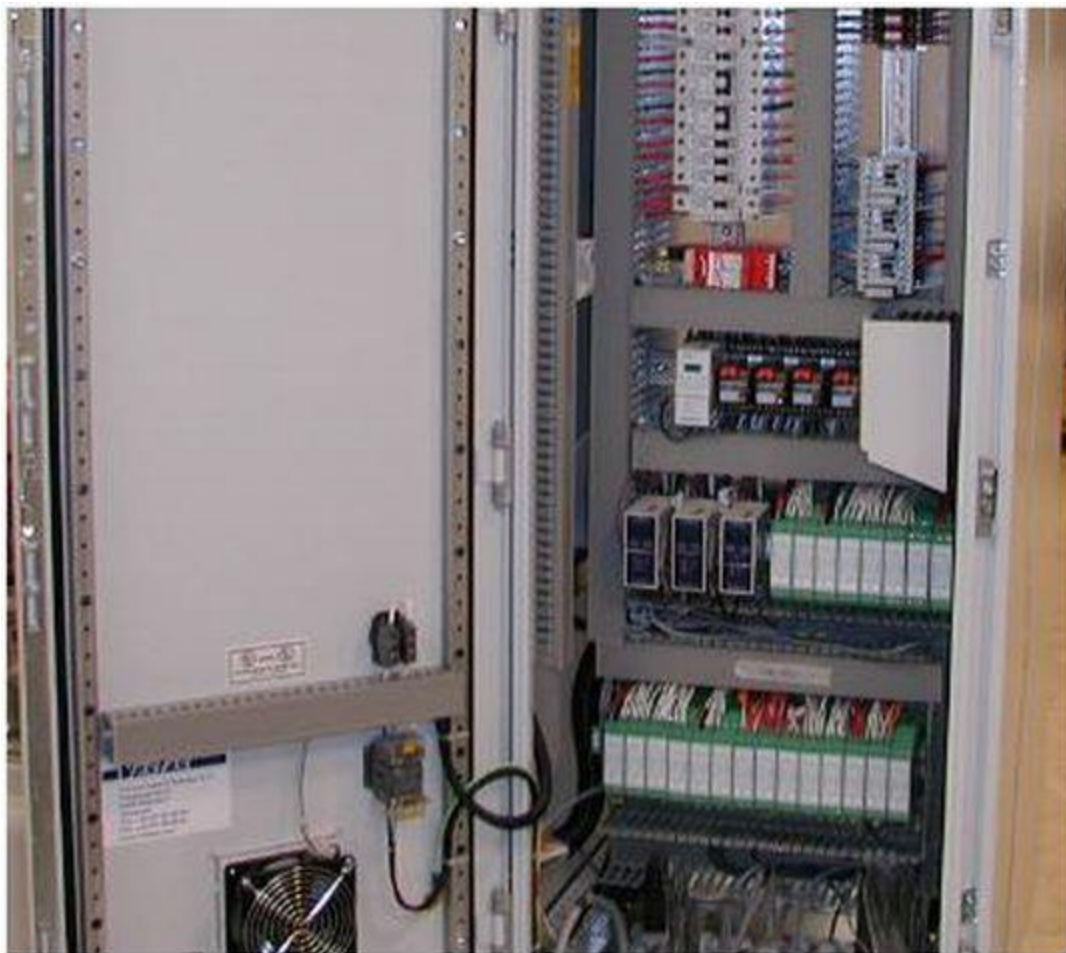
Varistors (F32 MkIII+ or F09 MkII and below) can be tested individually by placing a multimeter (set to measure Ω) lead on the common (earth) side of the varistors and the other on the individual varistor terminals. The resistance value over the varistor should be ∞ or in the high M Ω range. If the resistance is lower, the varistor has been damaged by an over voltage in the circuit and must be replaced

INPUT2
0-10V
0-20mA

ANALOG INPUT 100-104

SHAFT BRAKE PRESSURE

Replace the defect Varistor

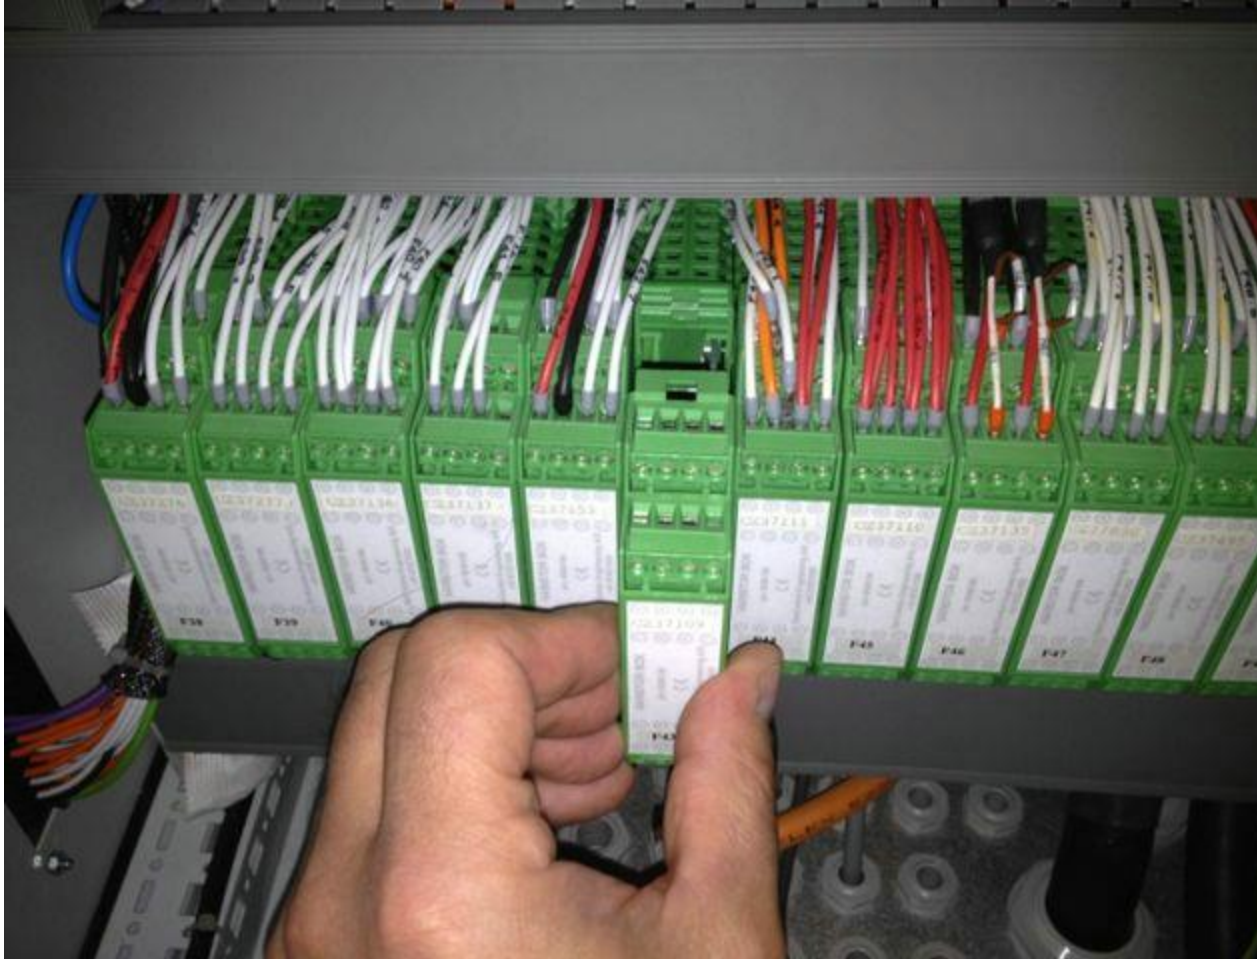
Item Number : 51706201 VARISTOR BOX X8

Varistor box F32/F09:

(F32 MkIII+ or F09 MkII and below).

Press clip on top and bottom of varistor box and remove varistor assembly from housing:

The varistor box is made up of eight varistors and has provisions for 16 wire connections (protection for 8 signals)

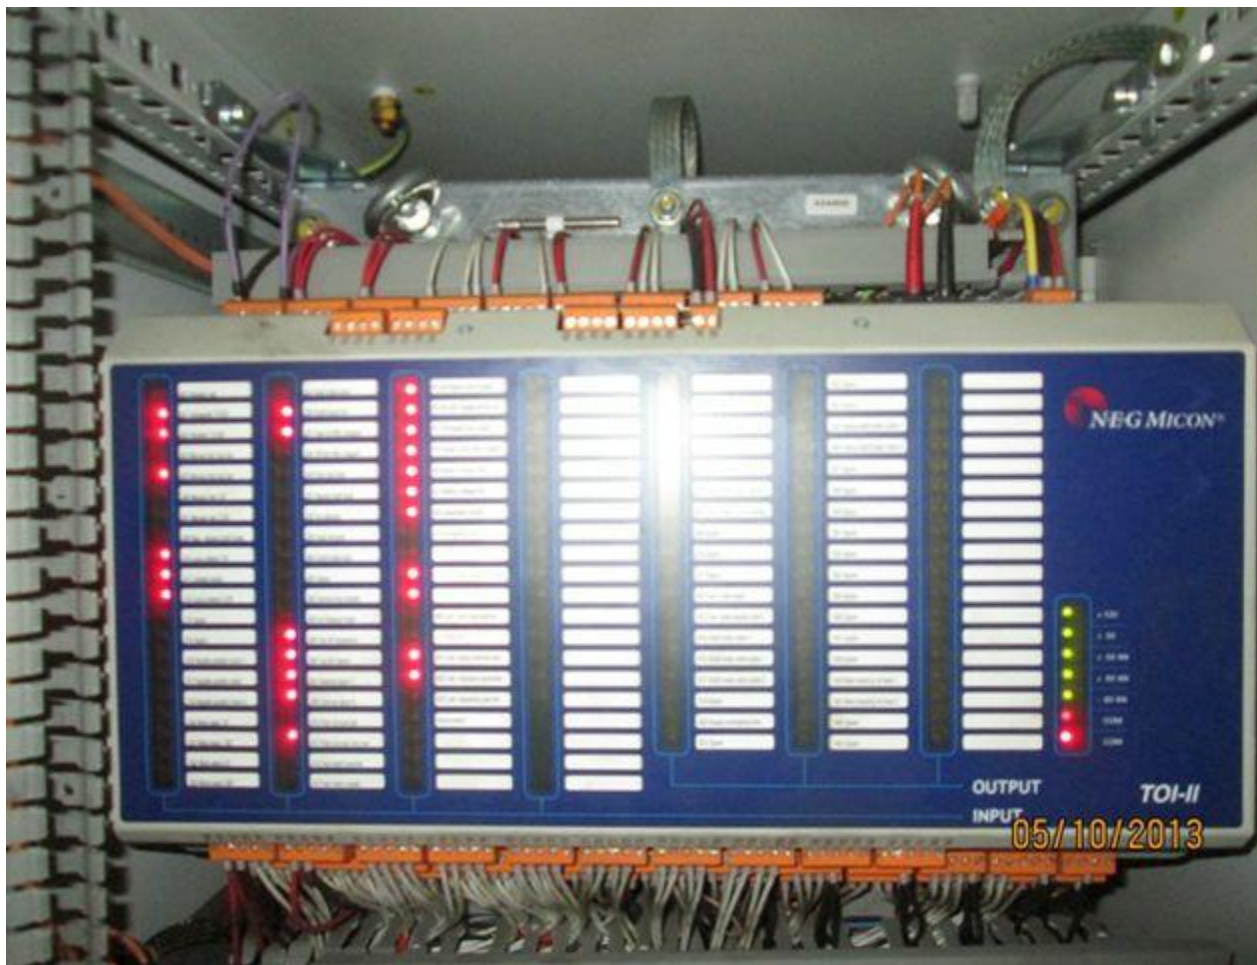
Item Number: 51701601- TOI-II INTERF EXT POC

Check the pressure value through the TAC-II controller if the value does not showing correct then the cause is likely a faulty Nacelle TOI

Replace the defect TOI

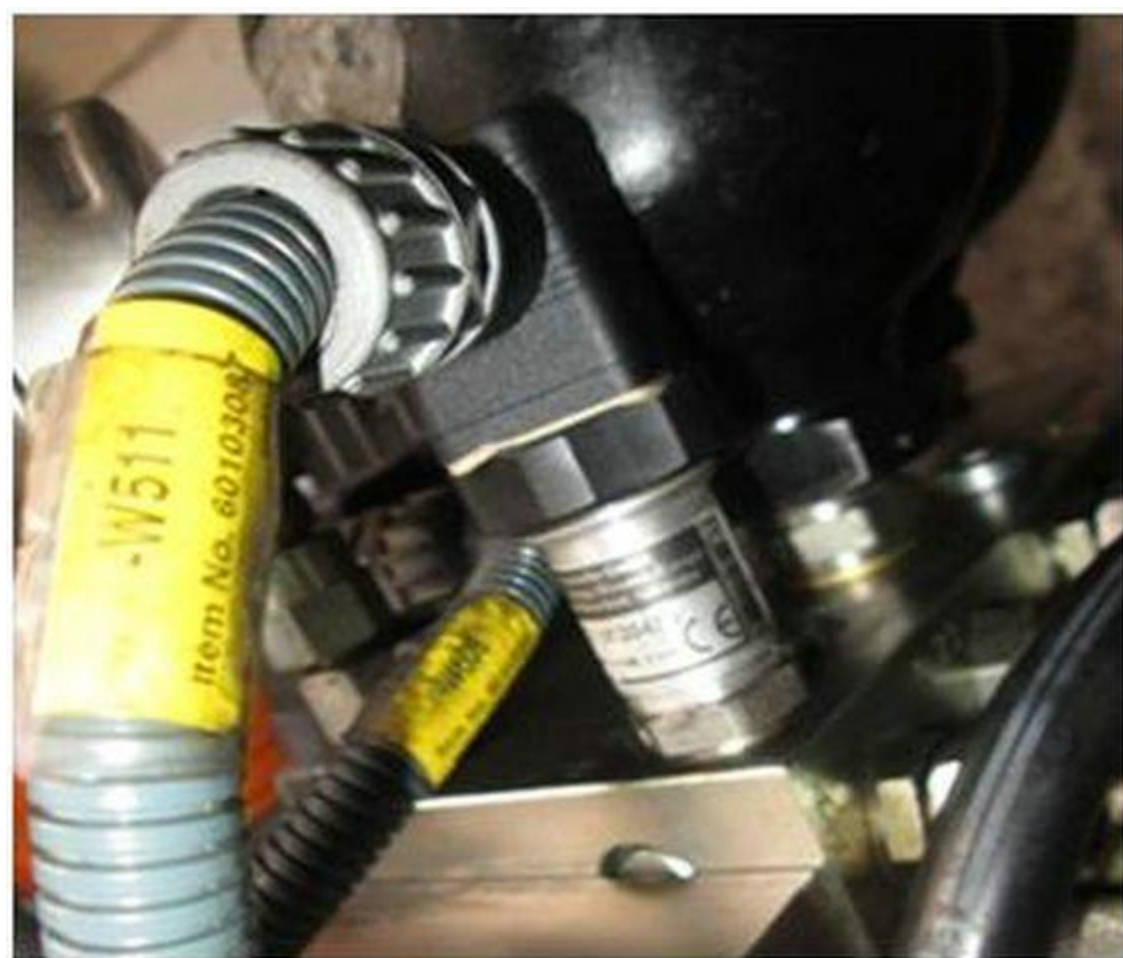
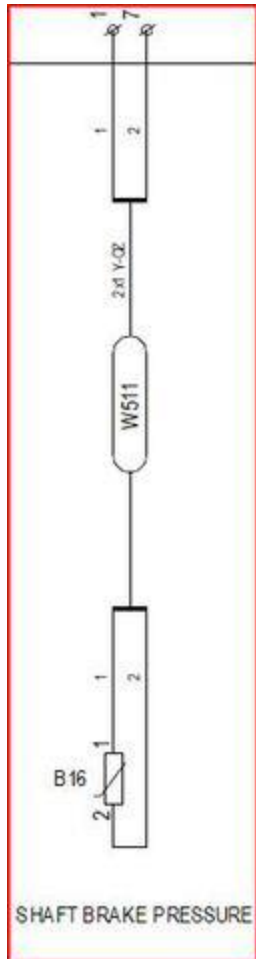
Check the pressure transmitter cable (W511) connections and connectivity.

Replace the defect cable

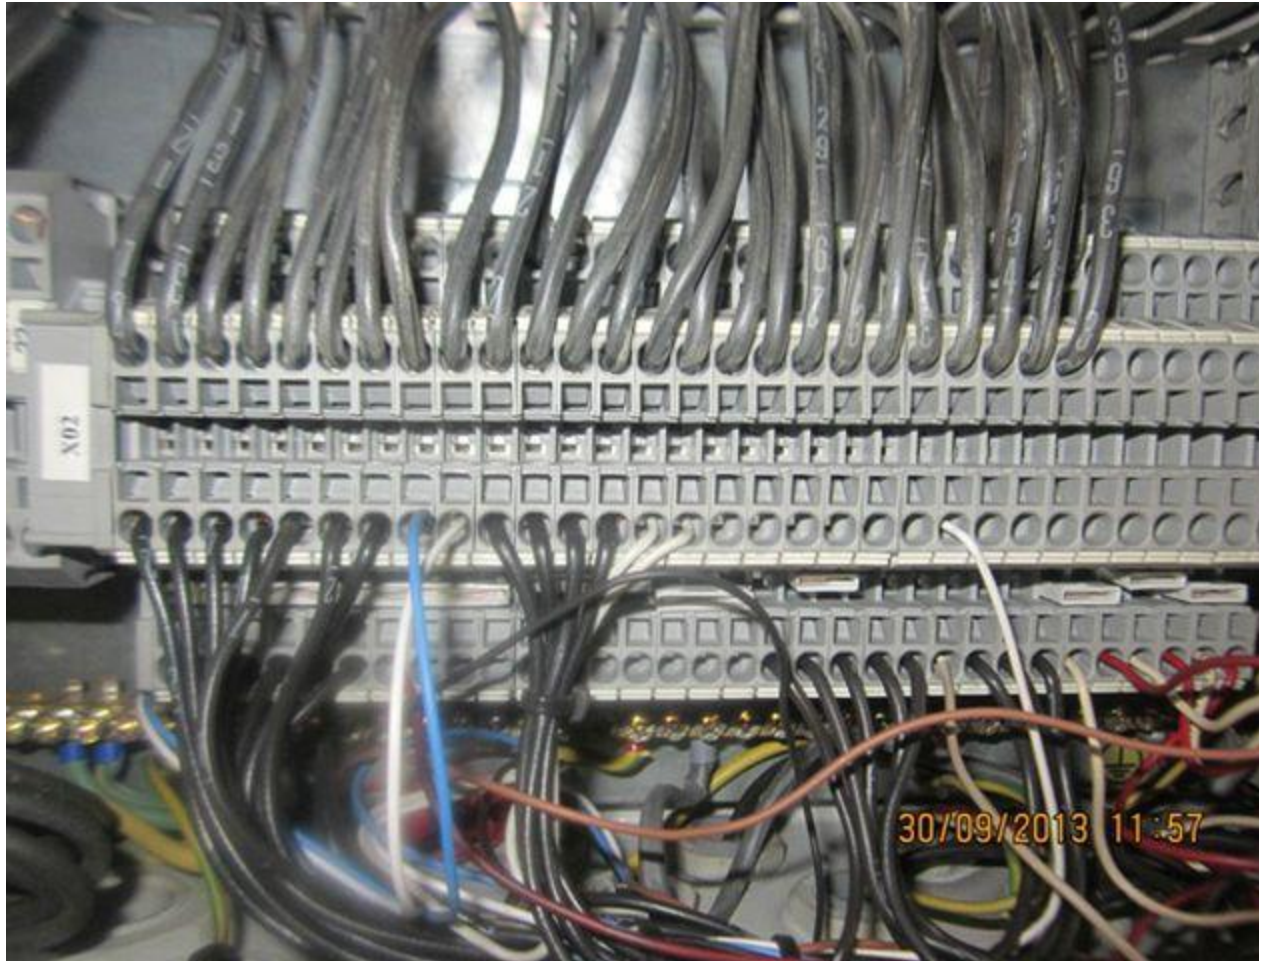
IN THE AN12 CABINET:

Check the terminal connection if any loose X02- 07
