- **Explanation**
Flow-chart for trouble-shooting alarm 499

499 - Unbalanced Pitch Generation - V82 Mk1-5

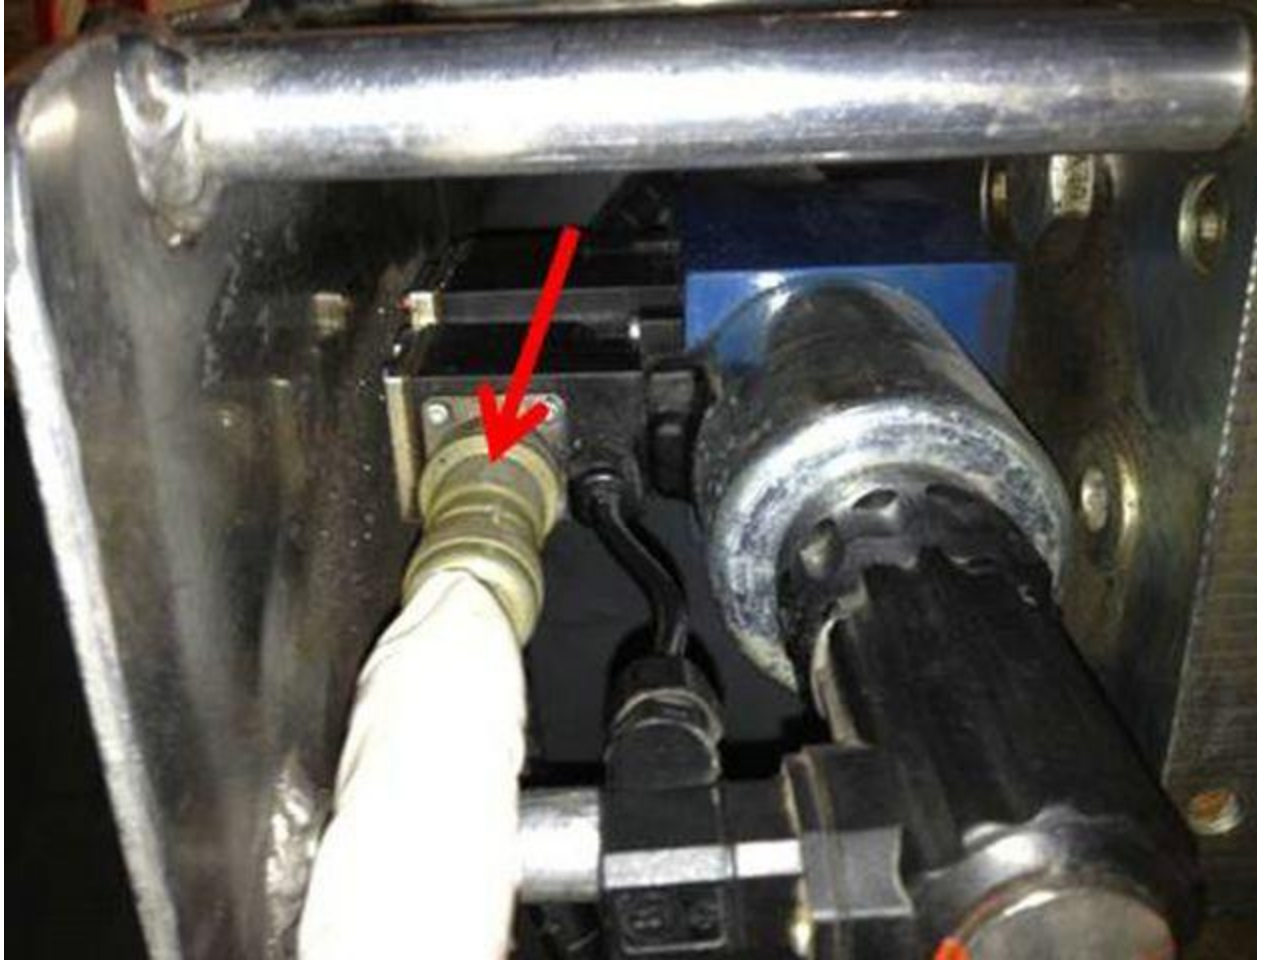
The wires in the cable to the shutdown valve (pos.215) and locking valve (pos.210) tend to break inside the insulation directly beneath the strain-relief near the connector.

Flex the cable at this point on the cable while pitching to detect if a wire within the cable is broken.

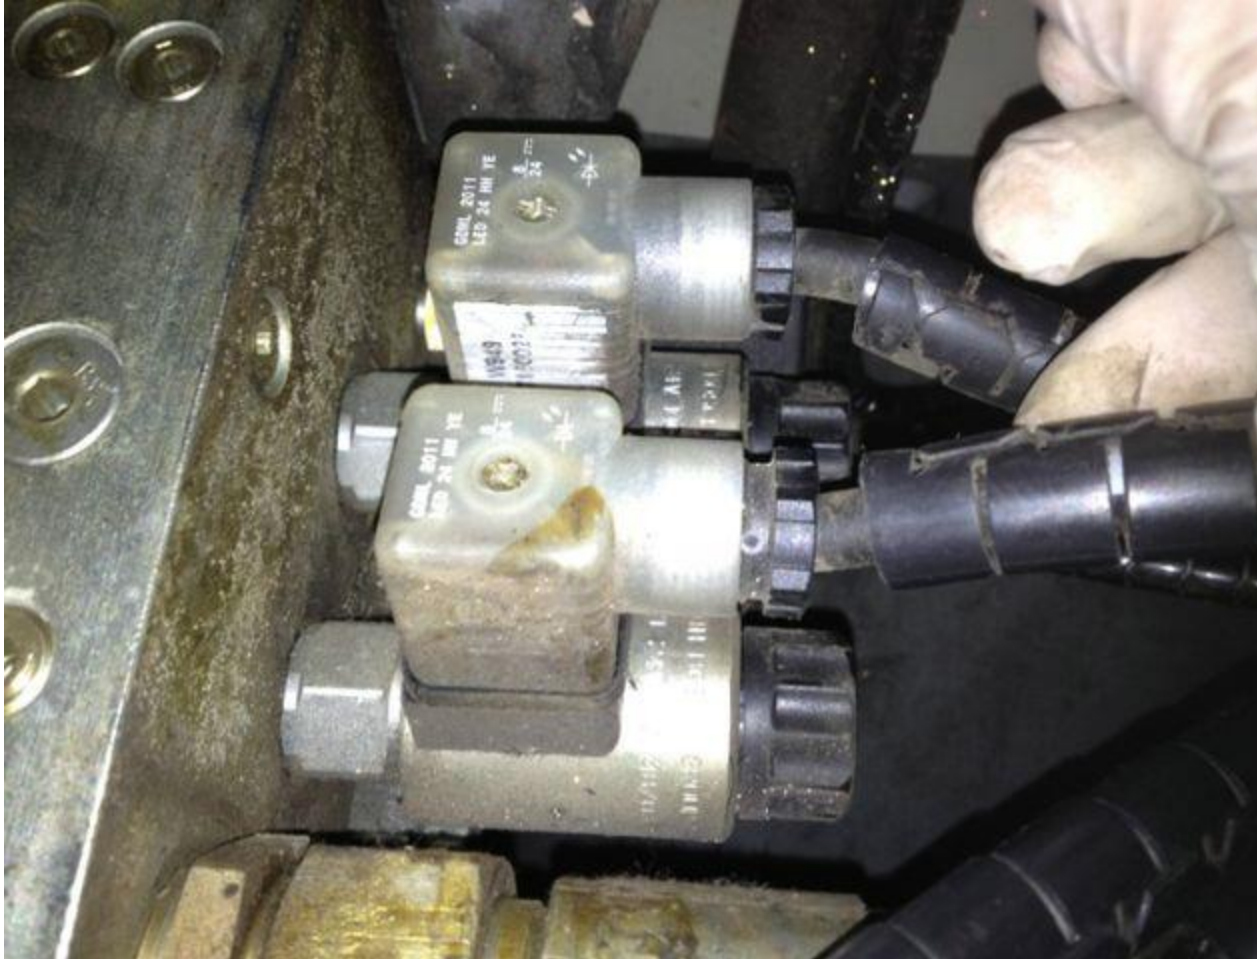
During operation the offending blade will "flutter" a bit as the wire flexes in the hub. If it is broken badly enough you will hear the blade "hammer" as power to the valve is interrupted.

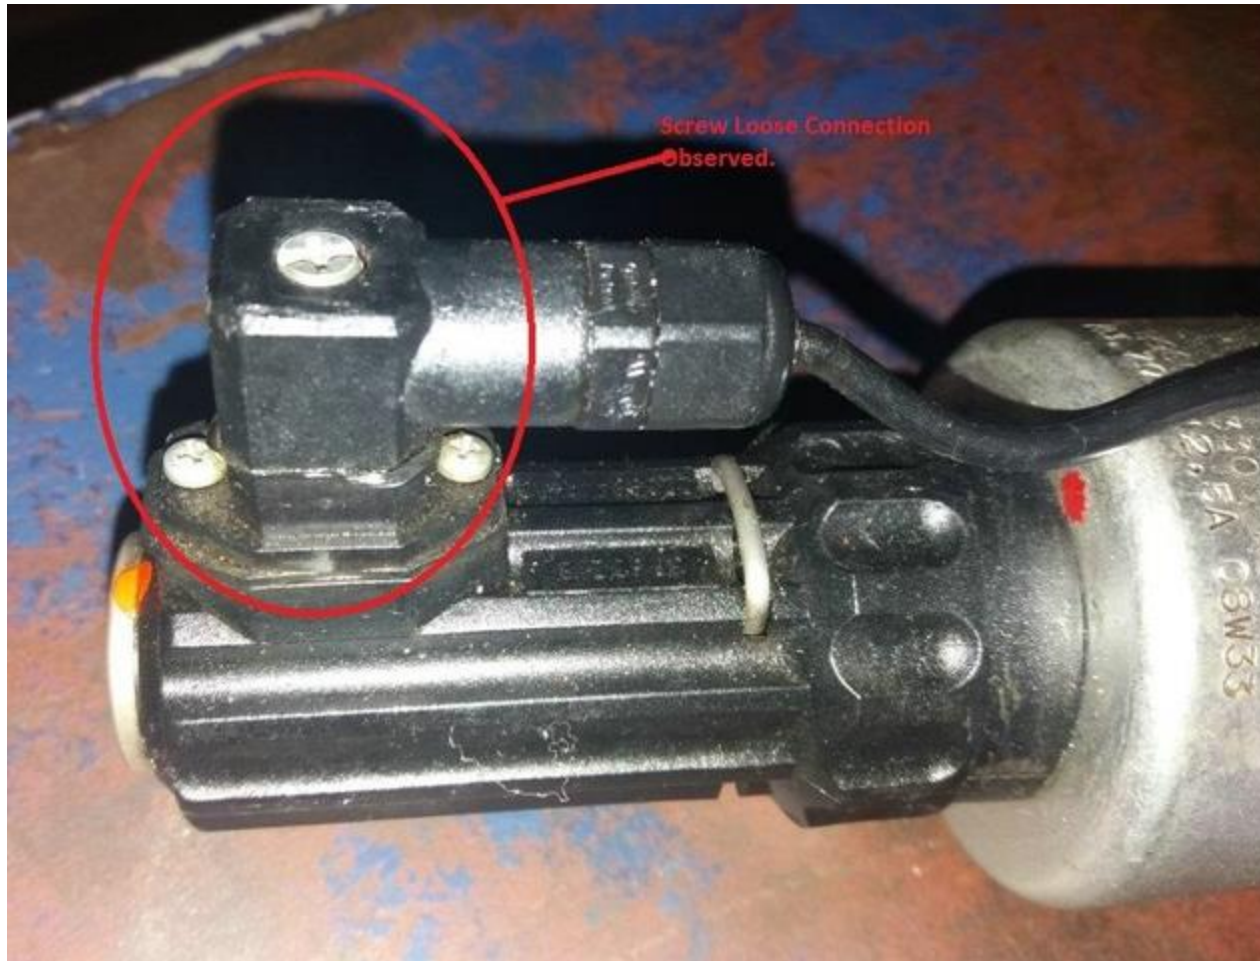
Loose connection in the proportional valve cable:

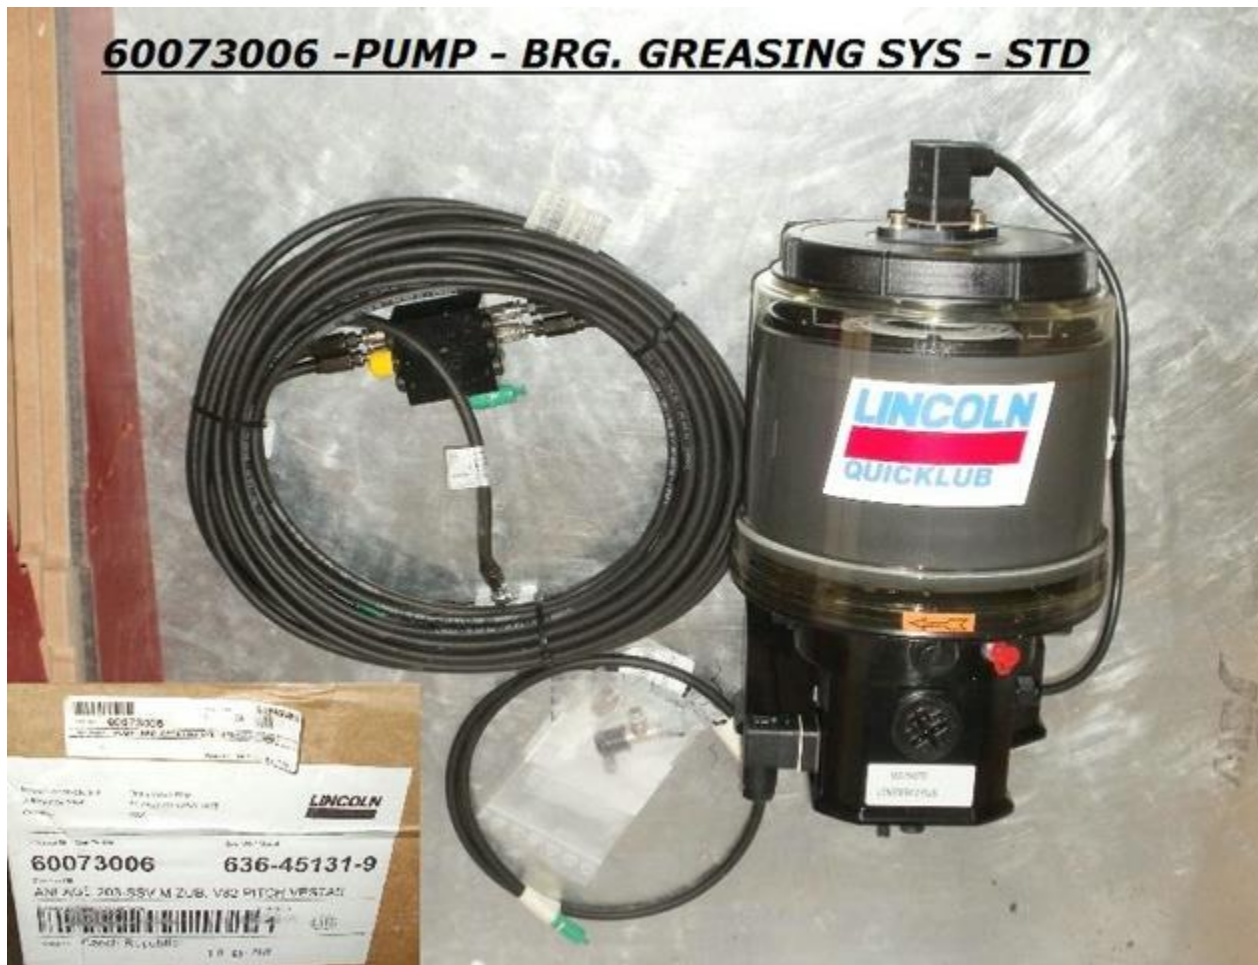
If Pump failure or power supply cable W953 for pump failure, replace the same.

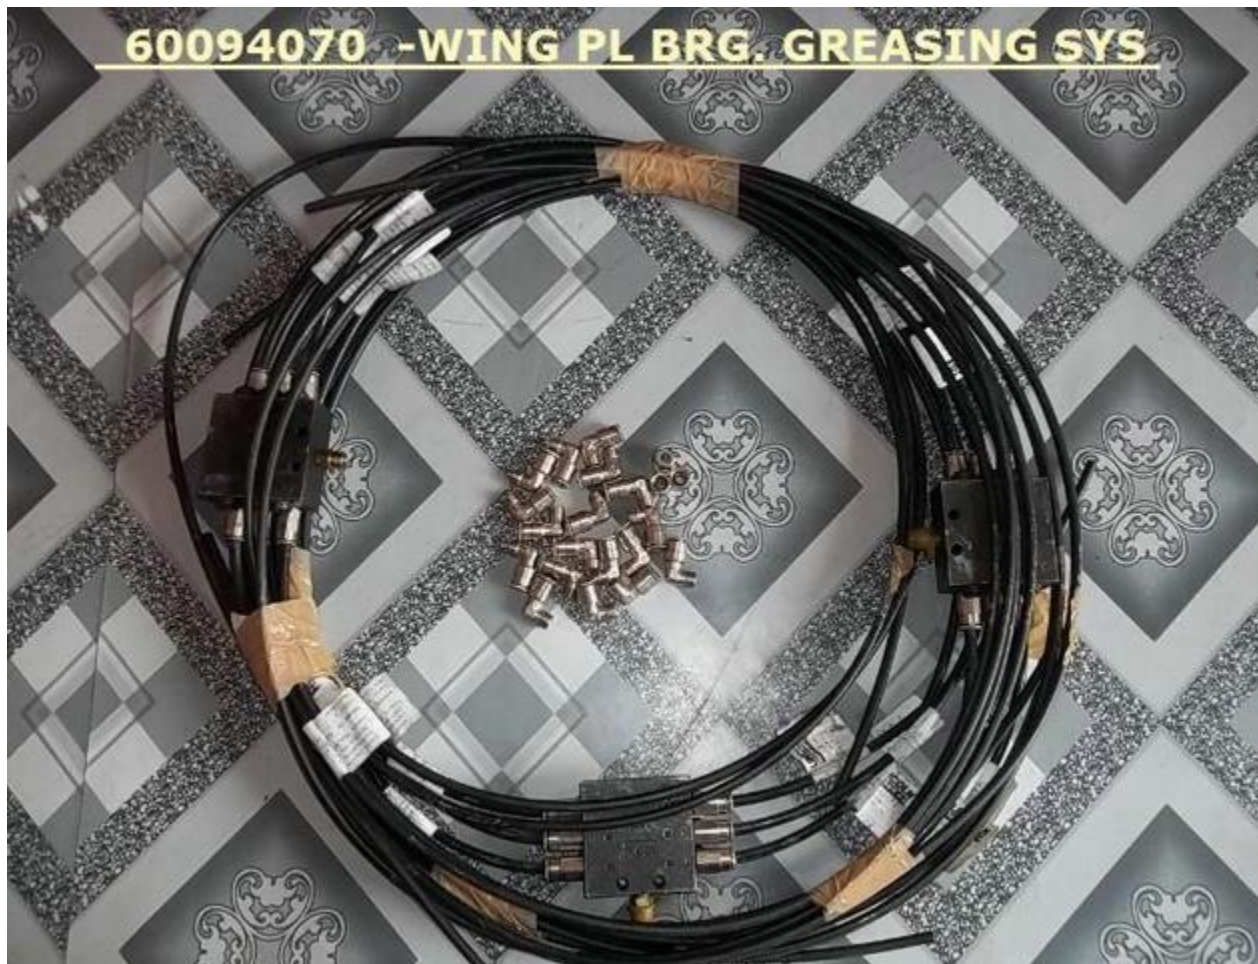
Drawing for Grease pump complete assembly:

Part number for sub-assemblies:

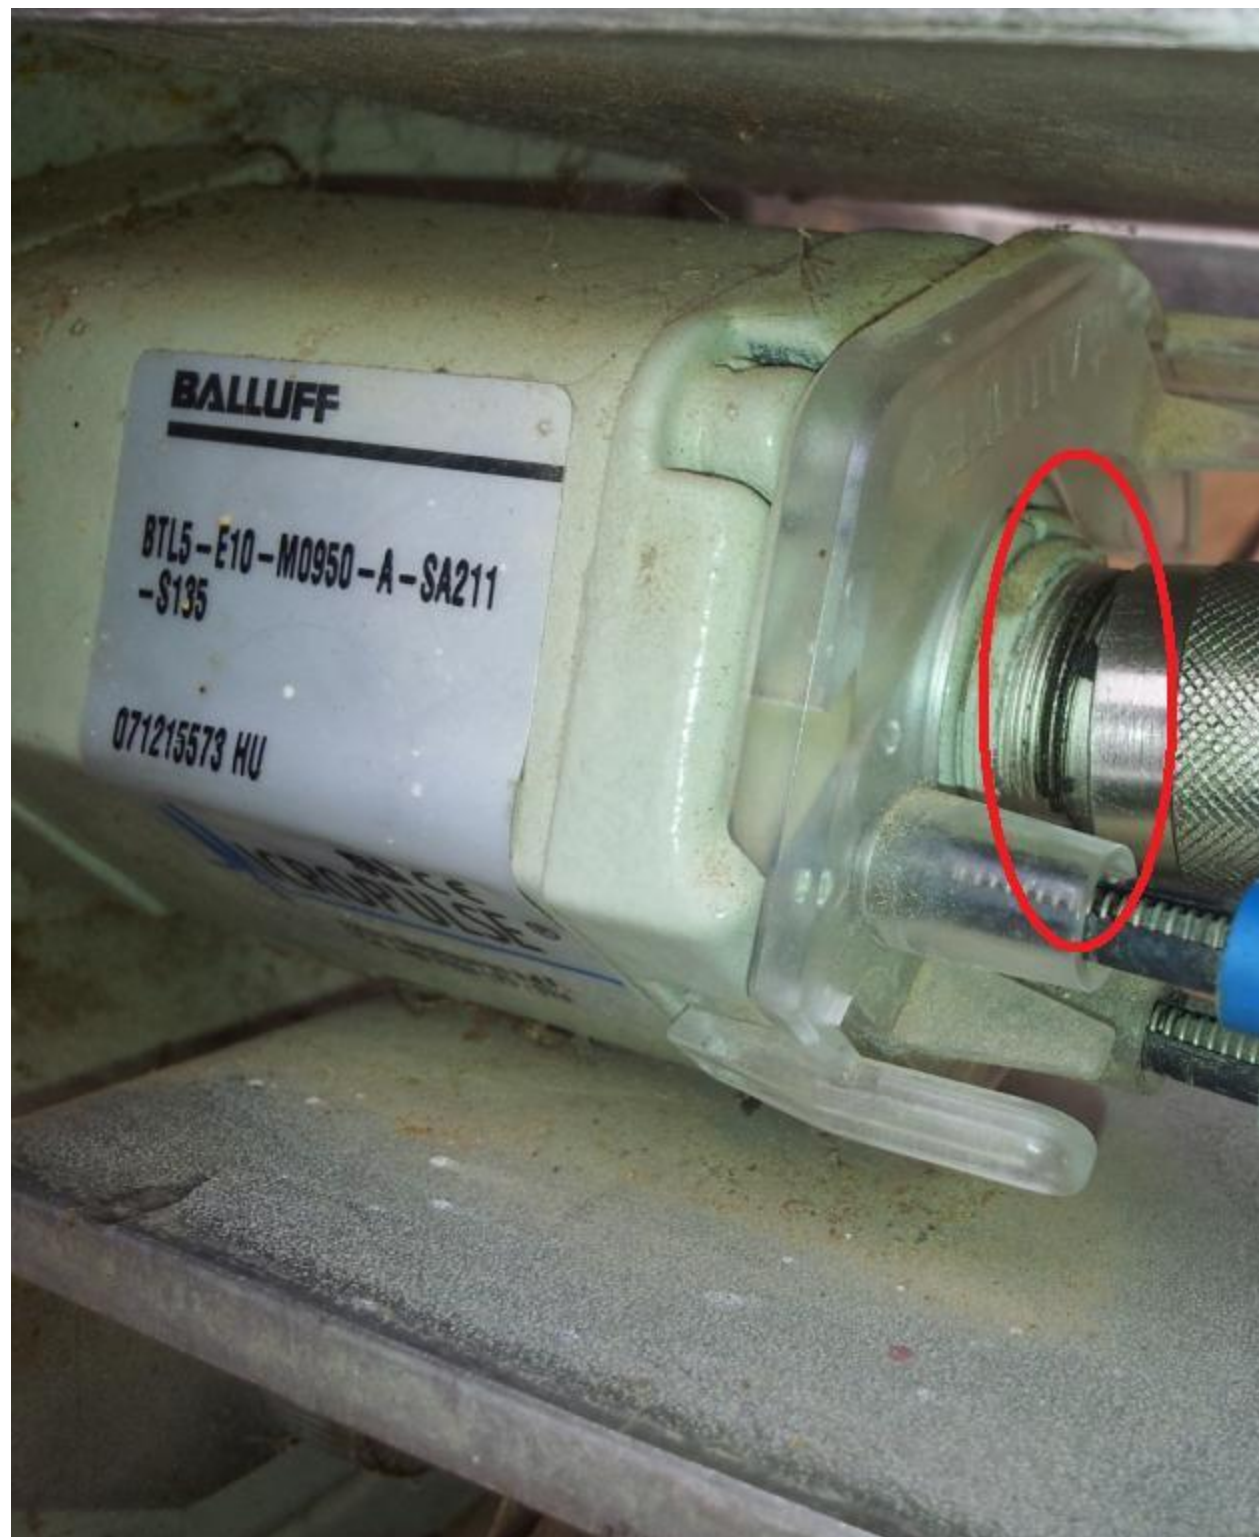
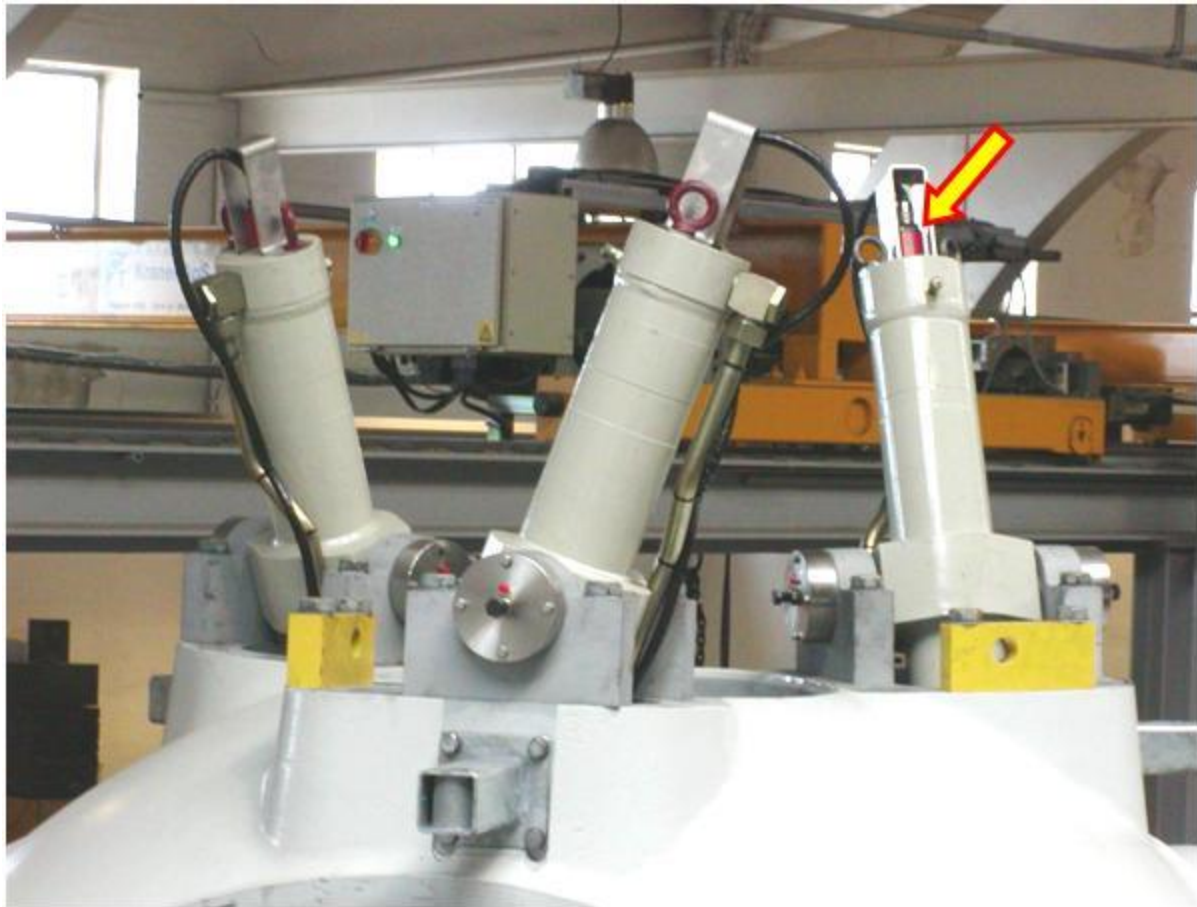
Check for any loose connections in the hub computer terminals for the blade position sensors (X19).

Check for any loose connections on the blade position sensors.
