Troubleshoot error 468

This function was introduced in the 2011 software update to reduce lost production without losing visibility of potential accumulator problems. This is done by eliminating the need for manual reset if pitch accumulator pressure differential is less than 50 bar. If the differential exceeds 50 bar, error [468](#) 'Pitch ac. Pressure mismatch' is raised.

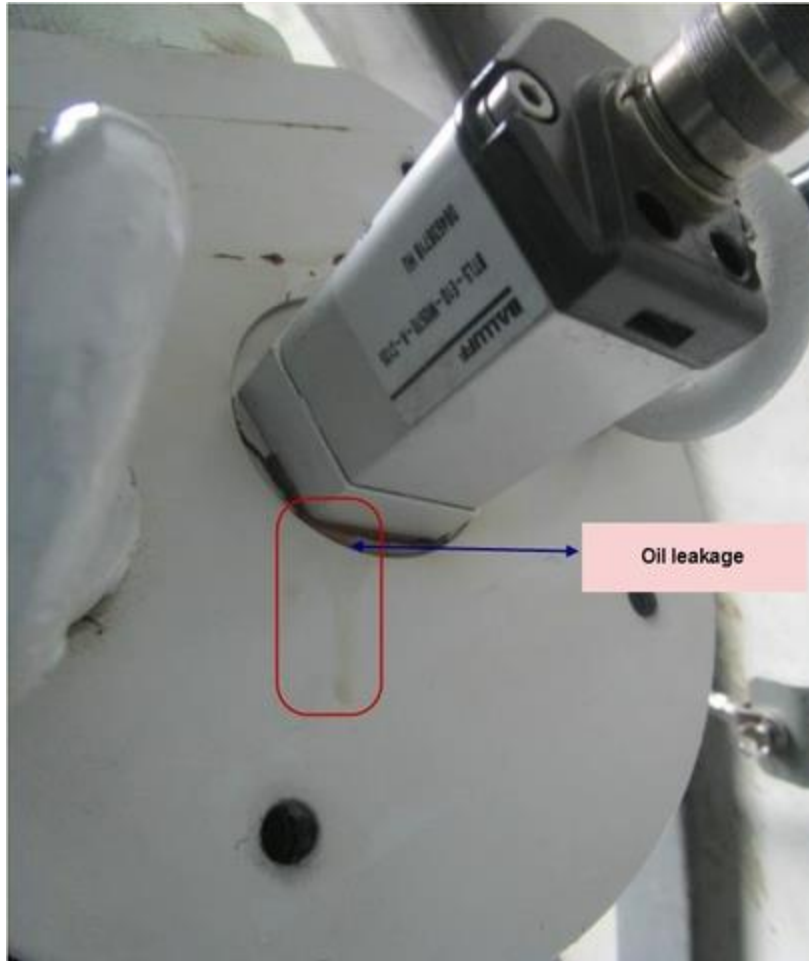
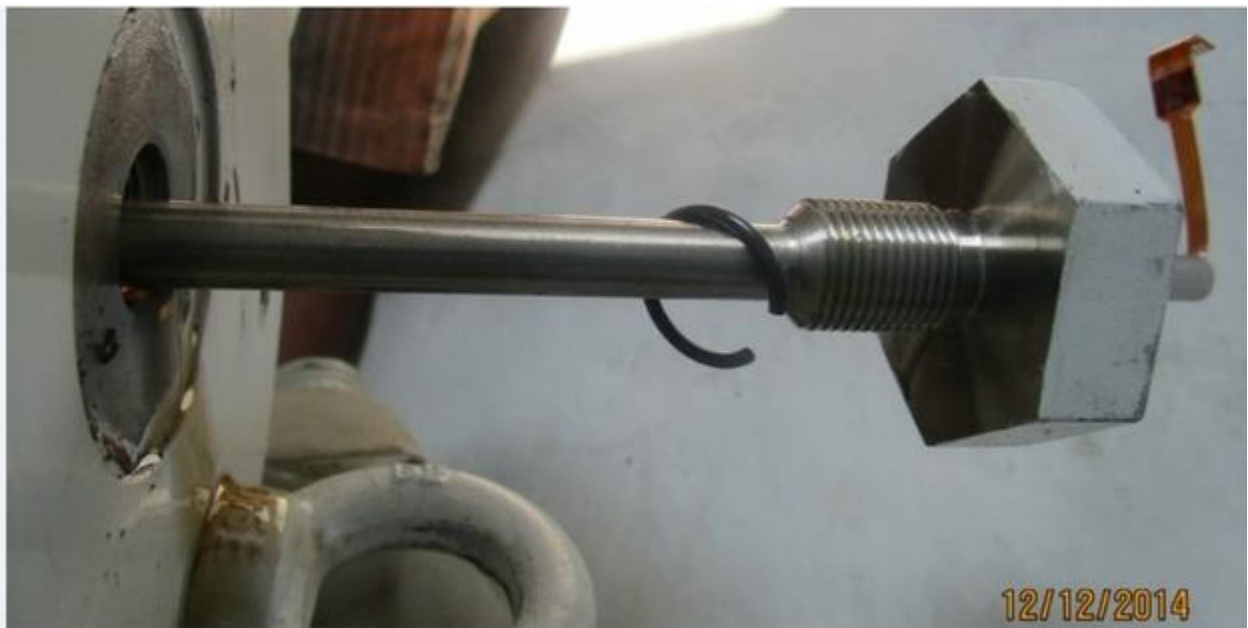
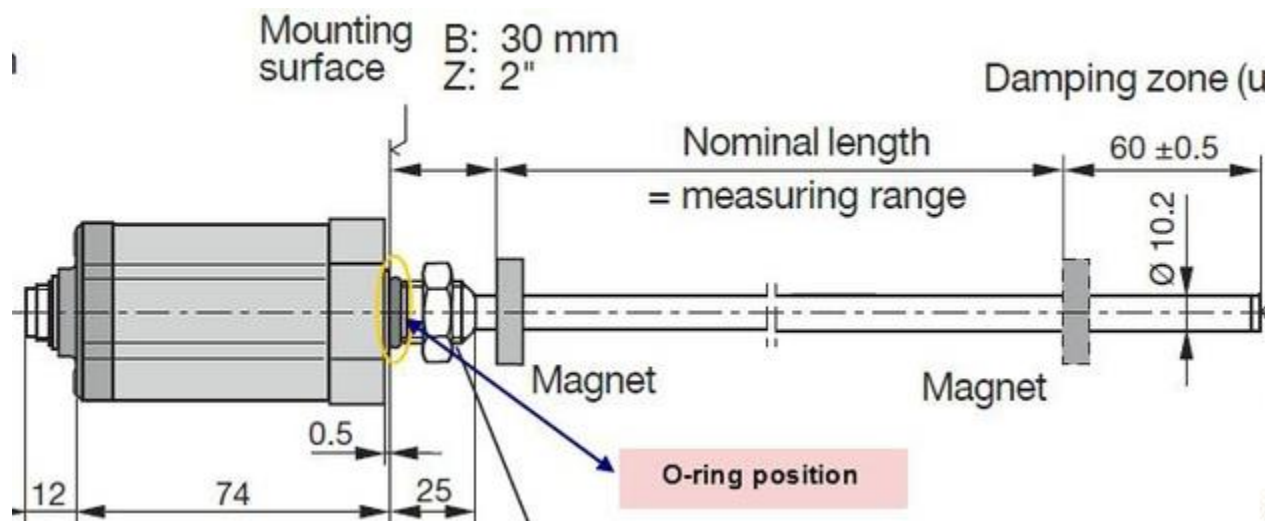
Check for oil leakage from pitch position sensor (Balluf sensor). If oil leakage noticed fix the same by replacing the seal (O- ring) as shown below;

Relevant Spare parts	
Description	Item No.
O-RING 2,10 x 15,40 F/LA41	60065665

CAUTION: Oil under pressure on A side of ram

Oil in the hydraulic system is under high pressure.

If the pressure is not relieved prior to removing the Balluff sensor, oil splashes or oil vapor will occur.

Ω **Do not** open with pressure on.

Ω It is important to start by opening the 222 valves and then screwing one end of a measuring hose onto test nipple MX2 which is the one without pressure.

Ω Screw the other end onto MA.

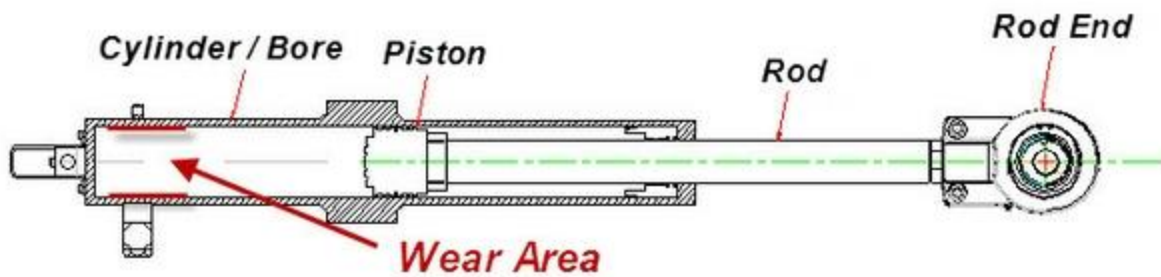
The back 250 mm of the pitch cylinder bore may be susceptible to excessive wear. This area of the cylinder is where the piston operates during production. When excessive wear occurs in the cylinder barrel, the piston seals are also subjected to accelerated wear, and internal leakage will occur in both run and stop positions. The effect of this leakage is excessive pump run time during operation as well as during stop. In the event of a pump failure, grid outage or certain turbine faults, pressure within the accumulators will bleed off, and blades may be at risk of being pushed into the run position under high wind conditions. Check the back of the bore for abnormal wear.

Actions:

Refer to DMS doc 0059-1574 for inspection instructions and criteria for running the turbine if wear is found.

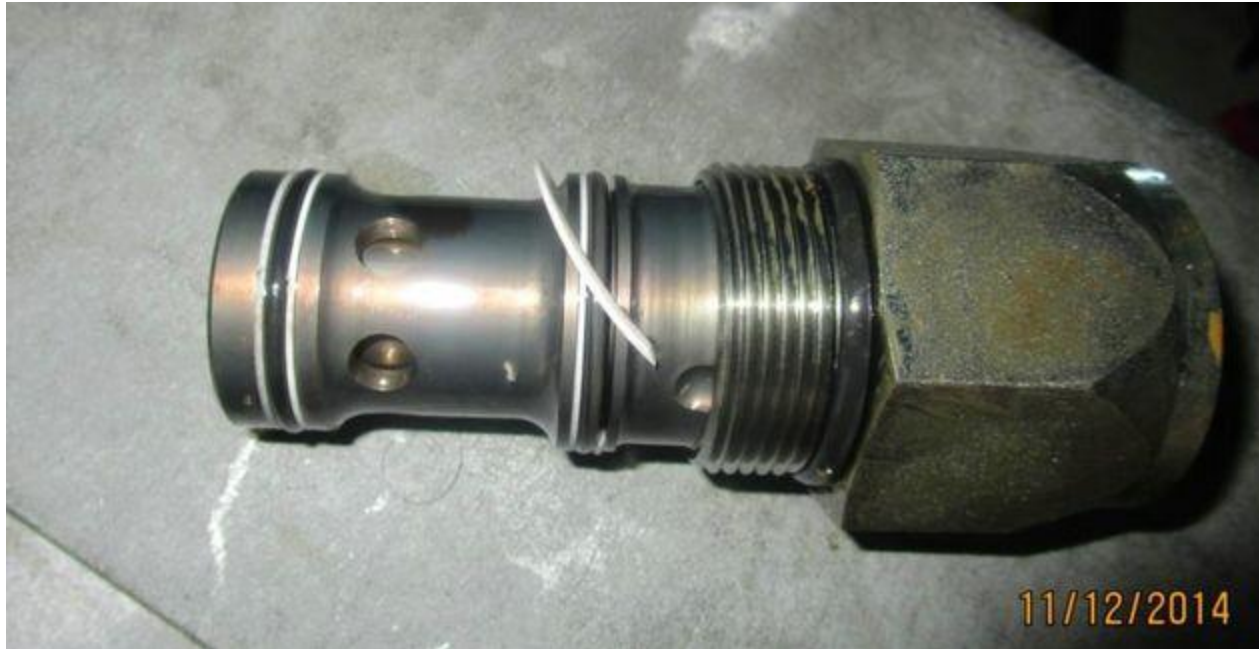
Figure 13-3: Fast Active Stall System (Bosch-Rexroth).

REXROTH SYSTEM -PITCH MANIFOLD:

Relevant spare parts		
Description	Item No.	Pos.
VALVE CHECK PILOT COFA-XAN A30	60096493	240, 245
